PISTON DAMAGE – RECOGNISING AND RECTIFYING

MOTORSERVICE GROUP

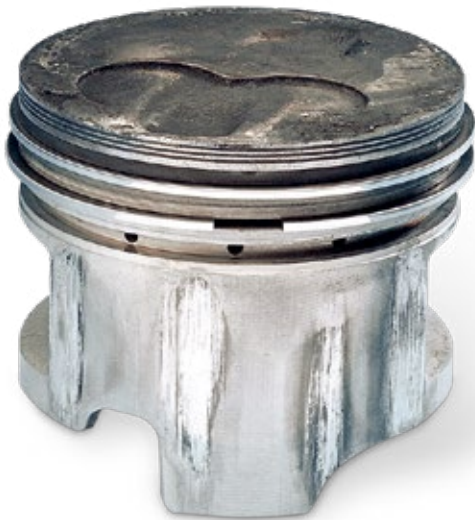
- Several similar areas of seizure marks around the piston skirt.
- Seizure marks on both the pressure and anti-thrust sides of the piston skirt, i.e. seizure marks on opposite sides.
- Surface changes from bright wear marks to smooth, darkly discoloured areas of wear caused by rubbing.
- Undamaged ring zone.

- Cylinder bore too small.
- Cylinder head over-tightened or tightened unevenly (cylinder distortion).
- Uneven mating surfaces on the cylinder block or cylinder head.
- Dirty or damaged threaded bores or cylinder head bolts.
- Seized or insufficiently lubricated seating surfaces.
- Use of incorrect or unsuitable cylinder head gaskets.
- Cylinder distortion caused by uneven heating due to lime deposits, dirt or other malfunctions in the cooling system.

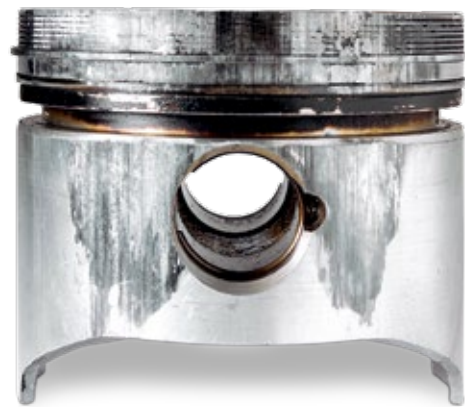
Fig. 1

- Seizure marks on both the pressure and anti-thrust sides, offset at approximately 45° to the piston pin axis.
- The seizure areas change from bright wear marks to relatively smooth, darkly discoloured areas of wear caused by rubbing (Fig. 1).
- Piston pin displays blue tempering colour (Fig. 3). Reason: piston pin bed has become hot due to insufficient clearance or a lack of oil.

- Mechanical overload of the connecting rod bearing, e.g. due to abnormal combustion.
- Malfunction/fracture in the oil injection jet.
- Insufficient or no oil pump pressure.
- Insufficient lubrication when the engine was first taken into operation. The piston pin was not or was insufficiently lubricated when it was assembled.
- Failure of the connecting rod bush (piston pin seizure) due to insufficient clearance or lubrication.
- Installation fault during the process of shrinking the piston pin (shrink-fit connecting rod).

During the shrinking process, care must be taken to ensure that, immediately after the piston pin has been inserted, the piston pin bed is not checked for freedom of movement by tilting the piston back and forth. The temperatures are equalized between the two components immediately after the cool piston pin is inserted into the hot connecting rod. The heat introduction increases the thermal expansion of the piston pin as is the case during engine operation. If the bed is moved in this state, it can cause initial rubbing marks or seizure marks. This may cause stiffness or failure of the piston pin bed during engine operation. For this reason, allow the assembled components to cool down before checking the freedom of movement.

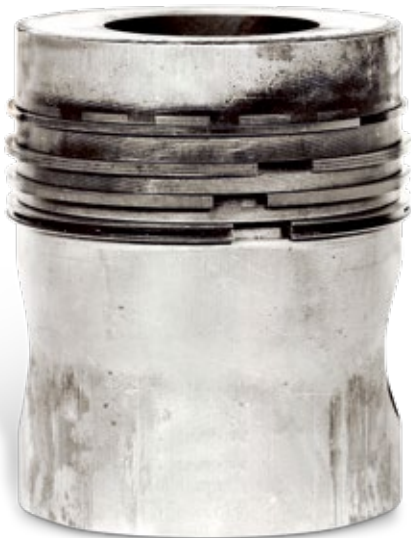
Fig. 1

- Seizure due to insufficient clearance at the bottom skirt ends, with wear marks and counter-wear marks.
- The marks change from bright wear marks to smooth, darkly discoloured areas of wear caused by rubbing (Fig. 1).
- There is nothing unusual about any of the remaining parts of the piston.
- Seizure marks in the cylinder liner in the area around the lower O-rings (Fig. 2).

The piston seizure at the bottom edge of the piston skirt was caused by distortion/restricted clearances in the lower area of the cylinder liner.

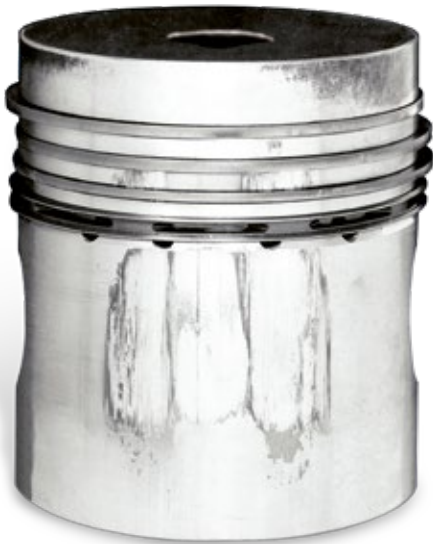
- Seizure marks on the piston skirt on the pressure side, which in some cases extend into the piston ring zone.
- Slight seizure marks on the anti-thrust side.
- Surface of the seizure areas is light-coloured and has an almost pure metallic finish.

There was an acute lack of lubricant between the piston and the cylinder bore. The fact that the surface of the seizure areas has an almost pure metallic finish indicates that the oil film was present but significantly weakened at the time of the seizure. Due to the limited extent of the damage, this concerns a temporary lack of oil or the early stages of damage. The damage would have been even more severe if engine had been operated further.

- Insufficient engine oil.
- Oil pressure in the engine too low (oil pump, pressure relief valve, etc.): not enough oil emerges at the crankshaft bearings. This means that not enough lubricating oil is supplied to the cylinder running surface, which is lubricated with splash oil and centrifugal oil from the crankshaft.
- Failure of the oil injection jet for cooling the piston.

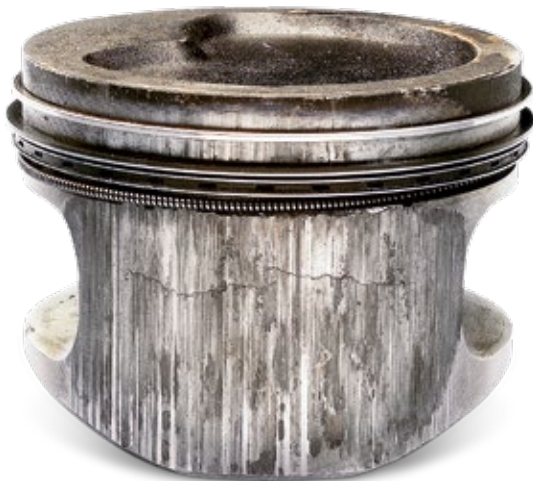
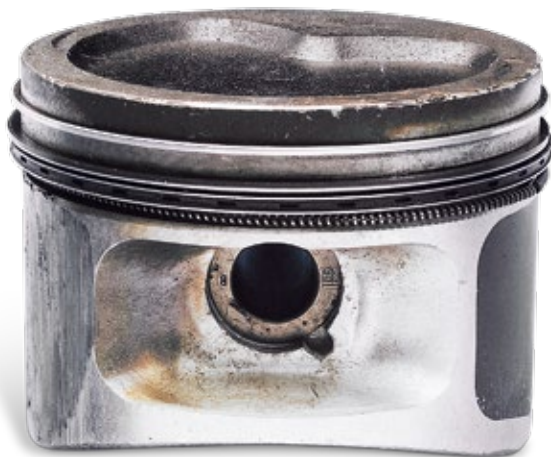
- Severe, darkly discoloured seizure areas with a heavily worn surface on the pressure side of the piston.
- Opposite side of the piston skirt free of damage.
- Piston ring zone usually undamaged in the early stages.

This is a typical example of seizure due to lack of lubrication. It usually occurs on the pressure side and is less common on the anti-thrust side. This damage is caused when the lubricating film breaks down on only one half of the cylinder. It is caused either by a lack of lubrication within a locally confined area or by the affected side of the cylinder overheating. Lack of clearance can be excluded as the potential cause here as, despite the severity of the seizure marks, there are no wear marks on the opposing counter-side.

- Partial collapse of the cooling mechanism due to lack of coolant, air bubbles, dirt deposits or other malfunctions in the cooling circuit.
- On ribbed cylinders, dirt deposits on the outside can lead to localised overheating and, consequently, a breakdown of the oil film.
- On air-cooled engines: defective, missing or incorrectly installed air baffles.
- Failure of the oil injection jet for cooling the piston.
- Insufficient oil pressure: insufficient lubrication on the cylinder pressure side for connecting rods with oil injection jets.
- Insufficient lubrication on the cylinder pressure side (which is subjected to greater loads) as a result of oil dilution or oil grades that are not suited to the intended purpose.

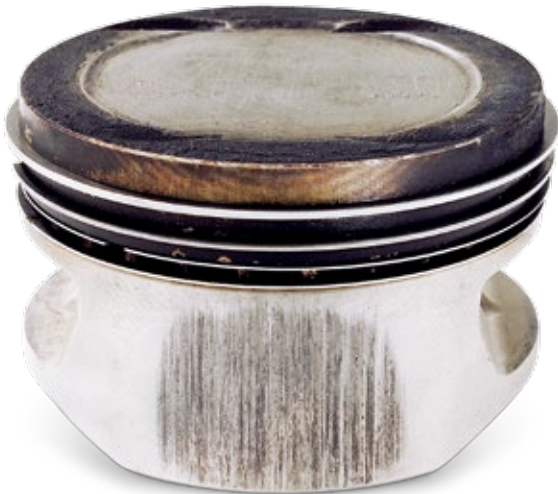
- Narrow, sharply defined longitudinal friction marks on the piston skirt instead of the normal piston wear pattern.

In the case of damage caused by unburned fuel, the damage occurs at the load-bearing areas on the piston skirt. These are the points at which the normal wear pattern would have formed on an undamaged piston.

- Overrich engine operation and abnormal combustion caused by faults in the mixture preparation or in the ignition system.
- Insufficient compression and, as a result, incomplete combustion.
- Coldstart device defective or operated for too long (carburettor engines).
- Oil dilution caused by frequent shortdistance driving or an overly rich mixture.

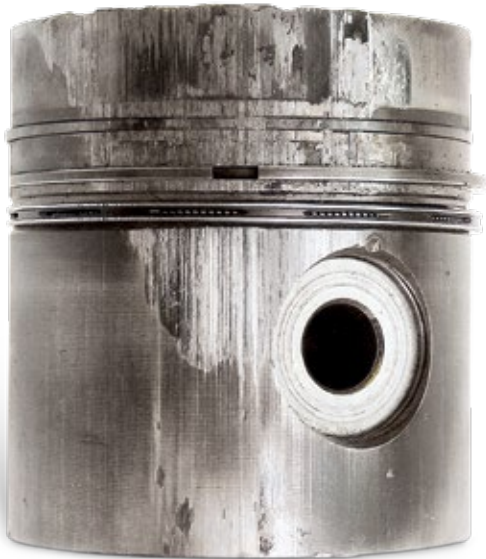
- Localised seizures that mainly occur on the piston top land.
- Surface of the seizure areas is rough and worn, in some cases larger pieces of material have been torn out.

Due to a fault on the injection nozzle, non-atomised fuel was able to reach the cylinder wall, where it weakened the oil film to the point where the piston was running dry without any lubrication at all. As a result, the piston top land seized so severely that it was temporarily welded to the cylinder wall. This caused chunks to be torn from the piston head.

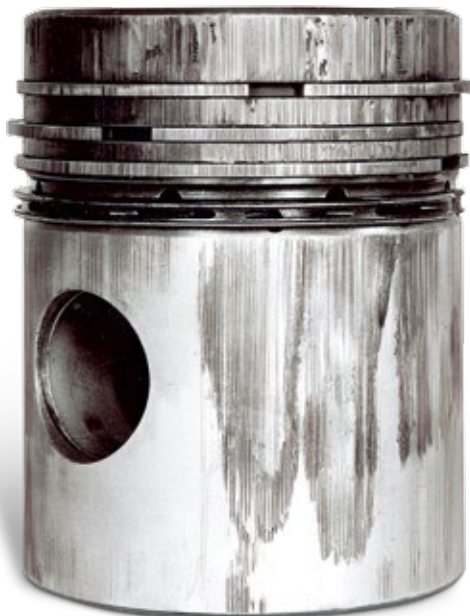
- Severe seizure starting from the piston head and lessening as it progresses towards the skirt end.
- Seizure marks are distributed around the entire circumference of the piston head.
- Surface of the seizure areas has a dark discolouration with severe scoring marks, and has broken up in places.
- Piston ring running surfaces show signs of seizure, which decrease in intensity towards the oil control ring.

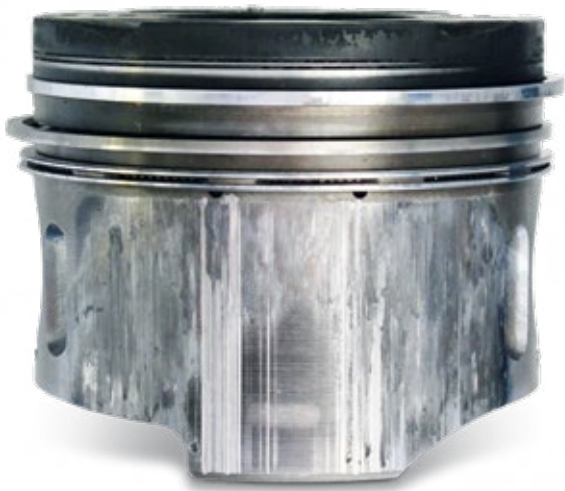
- The piston skirt has seized on both sides.
- The surface of the seizure marks has a dark discolouration and is rough and severely broken up.
- The piston ring zone is often only slightly damaged or not damaged at all.

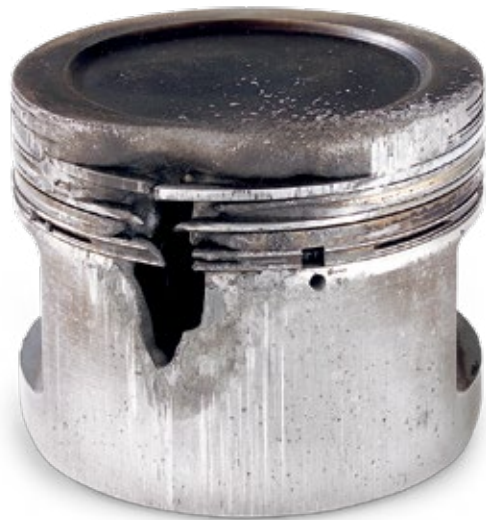
- The piston head has melted through behind the piston rings.
- The piston skirt has not seized; melted material has been worn away off the damaged area onto the piston skirt.

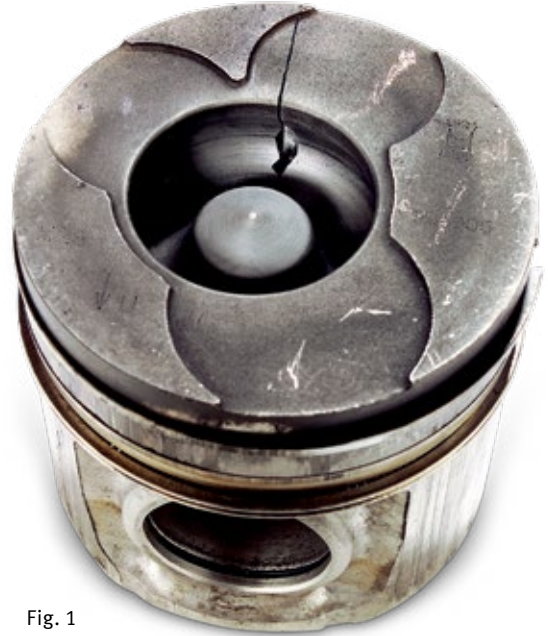
Fig. 1

- Stress cracks on the edge of the bowl.
- Major crack extends to the piston pin boss.
- Channel burned from the bowl to below the oil control ring by combustion gases streaming through the major crack.

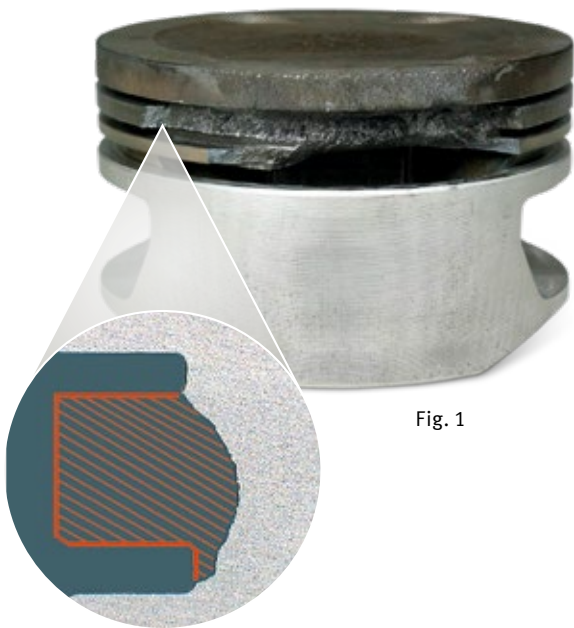
Fig. 1

- Ring land fracture on one side of the piston between the first and second compression ring (Fig. 1).
- Fracture, starting at the groove base at the top and running at a diagonal angle into the piston material, emerging at the groove base underneath (Fig. 2).
- Fracture is extended downwards.
- No piston seizure marks or signs of overheating.

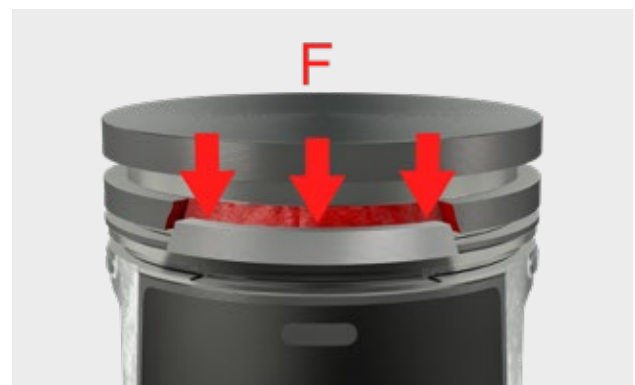
Fig. 3 shows the course of a fracture that occurs with knocking combustion and hydraulic locks: the force causing the fracture and acting from above on the ring land causes the fracture surfaces to extend downwards.

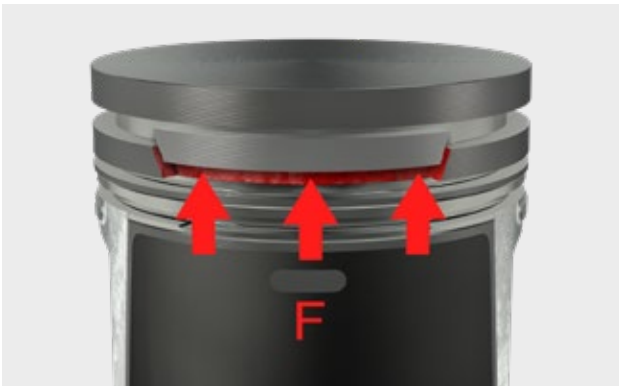
Fig. 4

If the piston rings are incorrectly compressed, more force is required when installing the piston. Forcibly pressing in or knocking in the piston causes pre-damage to the ring lands in the form of fine hairline cracks. The ring lands fracture in the reverse direction as the pressure comes from below in this case (Fig. 4).

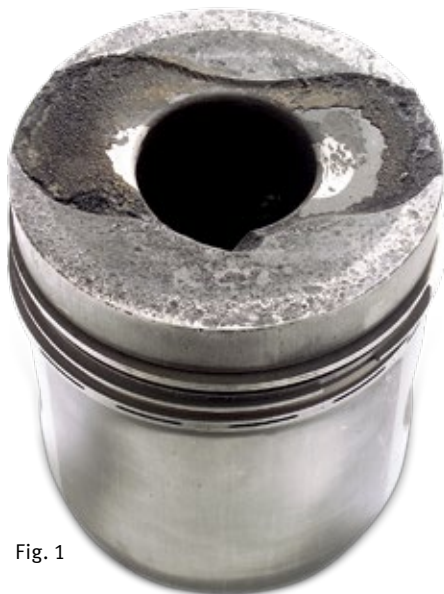
Fig. 1

- Severe impact marks on the piston head (Fig. 1). Nearly all oil carbon deposits removed.
- Scarring and oil carbon deposits pressed into the piston crown.
- Severe wear on the piston rings, particularly on the oil control ring.
- Imprint of the swirl chamber on the front edge of the piston crown (Fig. 2).
- Imprint of the valve on the right-hand side of the crown.
- First indicators of initial dry running damage due to lack of lubrication on the piston skirt (Fig. 4).

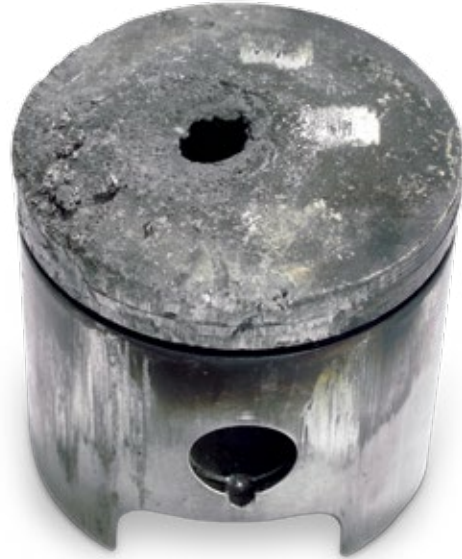
- Piston crown has a hole that penetrates all the way through, covered by the molten material.
- Skirt area displays seizure marks. Reason: the high temperatures and the piston material that has been ground down.

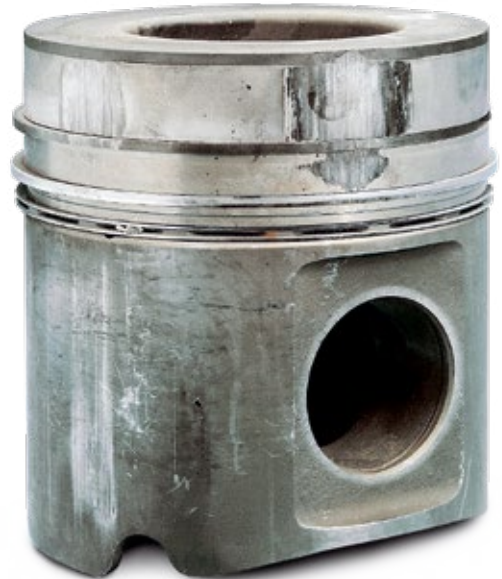
- Localised score marks can be seen on the piston head, going all around the circumference of the piston.
- Score marks start at the piston crown and end at the second compression ring.
- Score marks are centred around the piston top land.

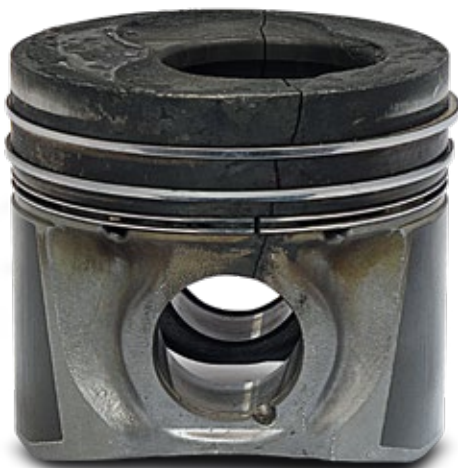
Fig. 1

- Formation of a cleavage fracture that leads to the piston crown. This results in the piston being split into two parts (Fig. 1).
- Boss fatigue crack in the centre axis of the piston pin bore (Fig. 2 and 3).

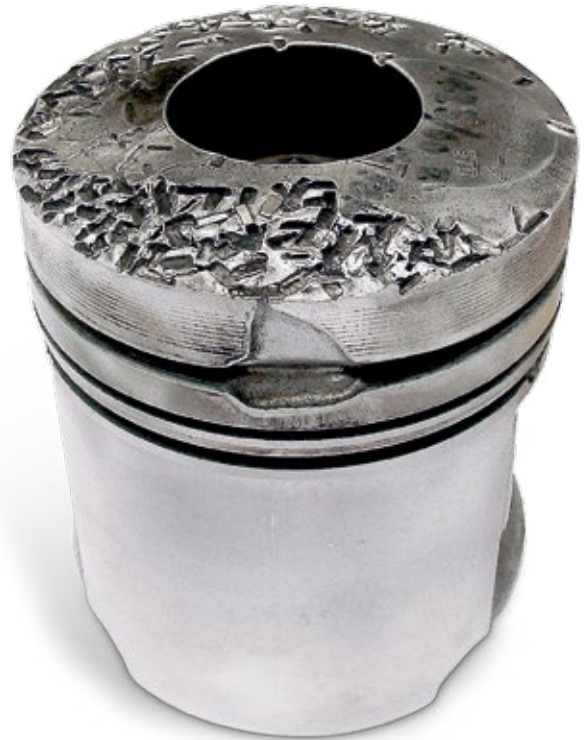
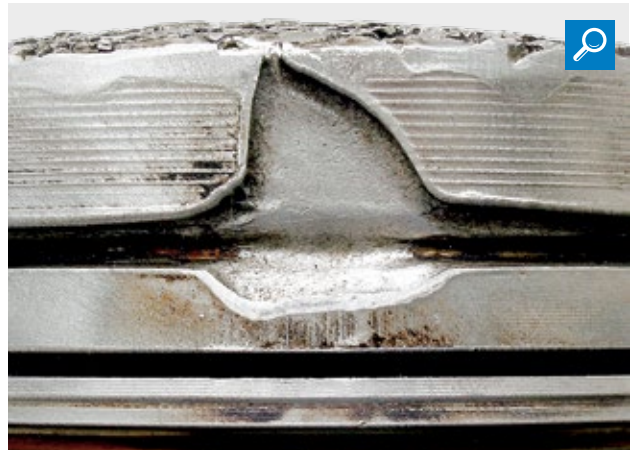
- Severe material washout reaching as far as the piston crown in the ring zone in the area of the first ring groove.
- Severe axial wear on the first ring groove.
- Severe mechanical damage on the piston crown.
- Running pattern of the piston skirt has a matt, buffed appearance.

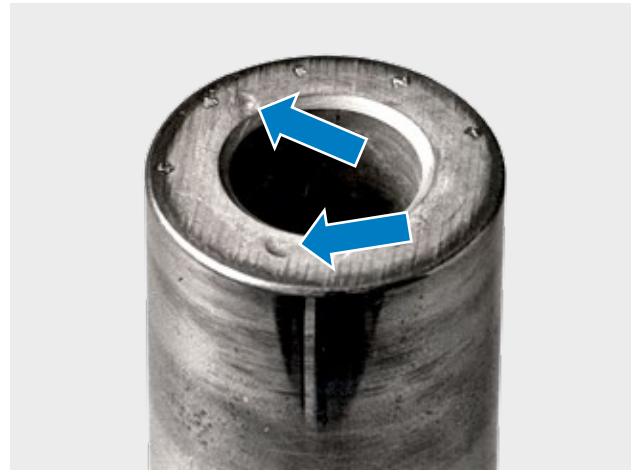
Fig. 2 shows that an incipient crack may not only be caused by overstressing, but also as a result of improper installation of the piston pin. The end face of the broken piston pin clearly shows that the incipient crack was caused by impact damage (hammer blow). An incipient crack can lead to breakage of the piston pin, even under normal load conditions.

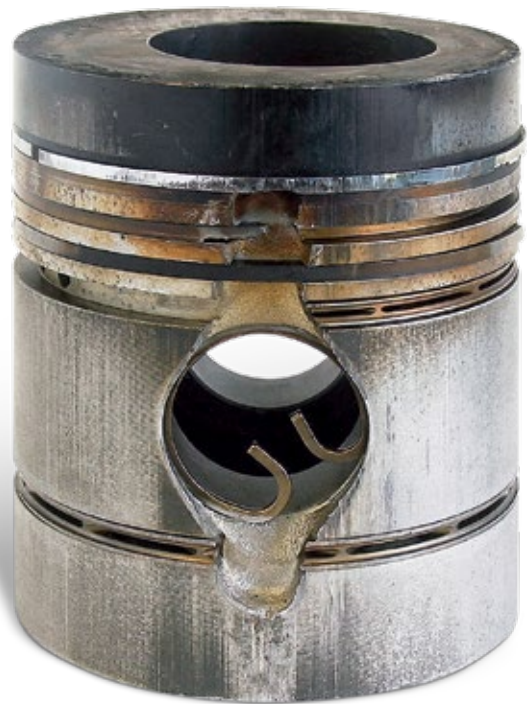
Fig. 1

- End of the piston pin bore on both sides of the piston suffered serious damage, in some places as far as the ring zone (Fig. 1).
- Circlip jumped out of the retaining groove and broke into fragments.
- Second circlip damaged.
- Due to the lack of retention, the piston pin has wandered outwards towards the cylinder running surface.
- Front face of the piston pin worn to a convex shape due to prolonged contact with the cylinder running surface (Fig. 2).
- Asymmetrical running pattern of the piston.

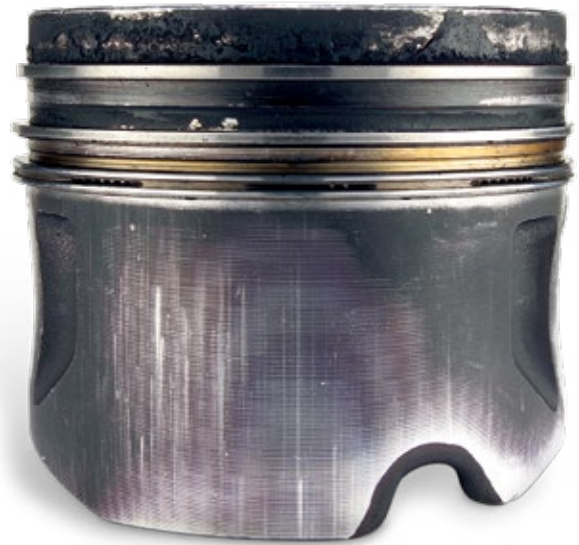
Fig. 4

- Asymmetrical piston wear pattern (Fig. 4).
- Piston pin boss and piston pin broken (Fig. 5 and 6).
- Pin bore hammered out in the area of the circlips.

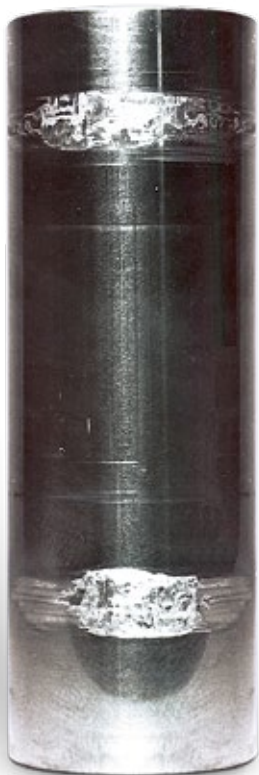
Fig. 1

- Piston pin has seized in the piston pin bores.
- Piston material has been welded onto the piston pin (Fig. 1).
- Piston pin displays a blue discolouration in the area of the connecting rod bush.

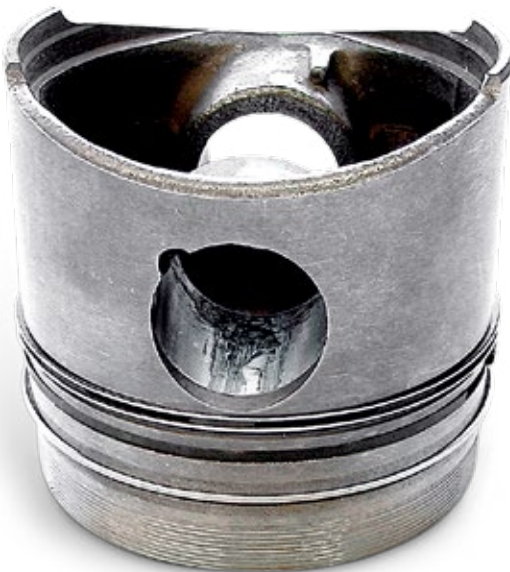
Fig. 1

- Piston has only run for a short length of time.
- No wear marks on the piston skirt.
- The piston pin bosses have seized on the upper side, i.e. the side under pressure load (Fig. 1).
- The surface at the seizures is clean bare metal; no traces of burned-in oil.

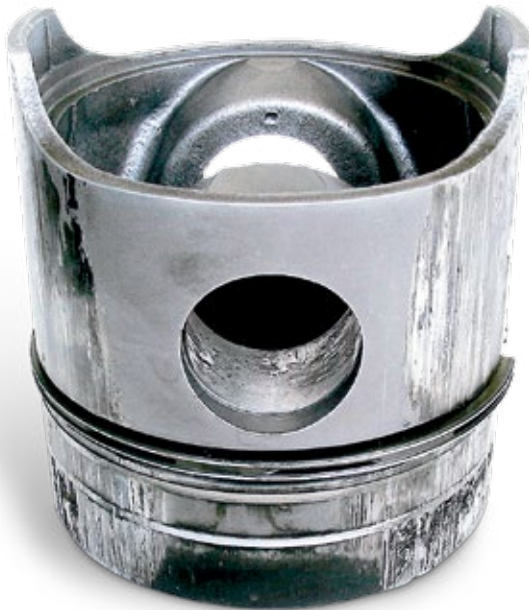
- Piston skirt has seized on both sides, starting at the piston head.
- Compression rings have become blocked in the ring grooves.
- Seizure marks are present in the piston pin bosses.

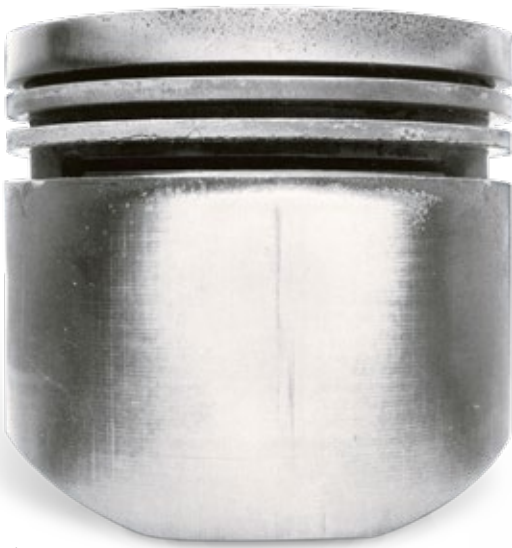
Fig. 1

- Piston top land has impact marks in the tilting direction (Fig. 1).
- The piston skirt displays a more pronounced running pattern to the top and bottom than in the middle of the skirt.

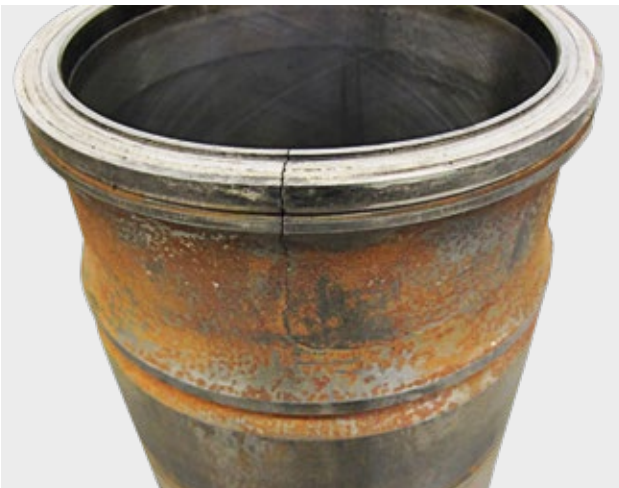
- Vertical crack, extending from the liner flange.
- Dry cylinder liners can also be affected because of their relatively thin cylinder wall thickness.

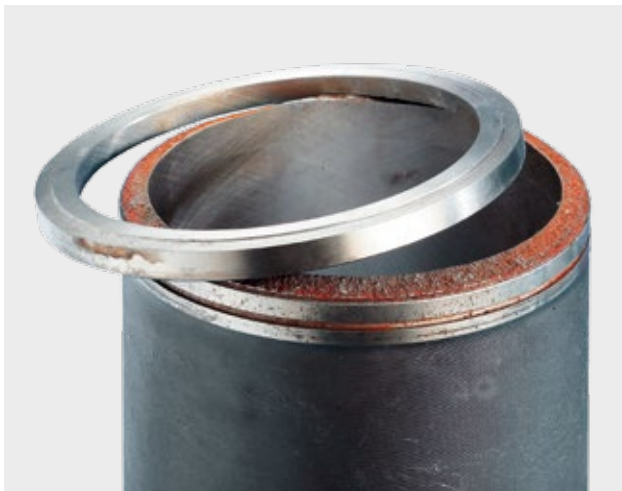
Fig. 1

- Liner flange has been torn off.
- The flange crack starts at the base of the bottom edge of the liner flange and extends upwards at an angle of approx. 30°.

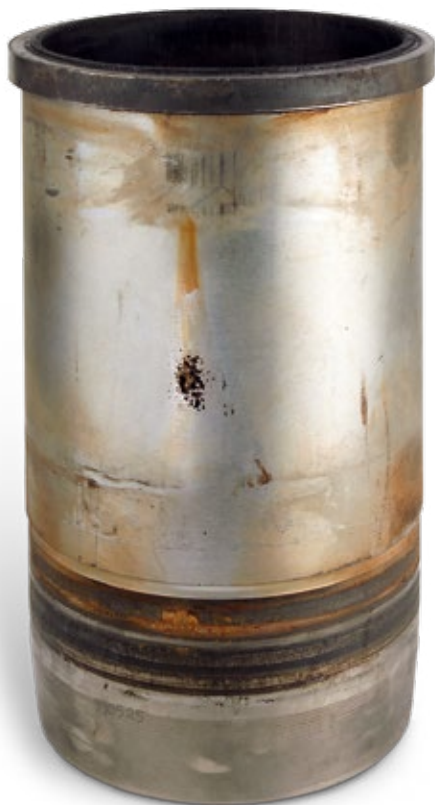
Fig. 1

- Severe cavitation on the water jacket of the wet cylinder liner (Fig. 1 and 2).
- Coolant has penetrated through into the combustion chamber.

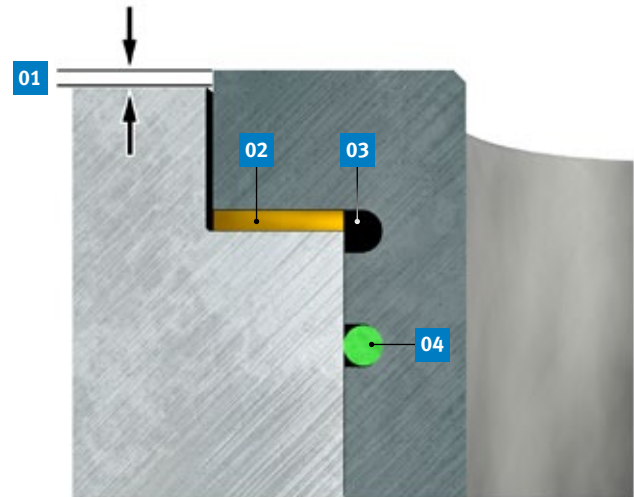
Fig. 4

- Installation of additional sealing rings in the undercut on the liner flange (Fig. 4): sealing rings may only be installed at this position if they are specifically required by the manufacturer.

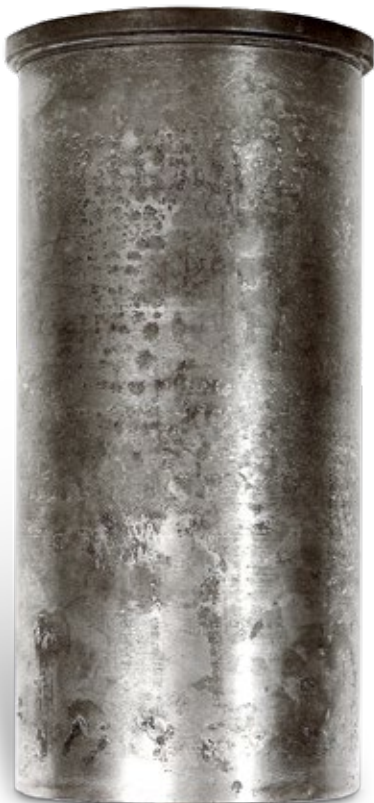
Fig. 1

- Corrosion on the outside diameter of the cylinder liner (Fig. 1).
- Uneven wear pattern with individual bright areas on the cylinder surface (Fig. 2).
- Piston undamaged.
- Oil loss at the sealing points, in particular the radial oil seals.

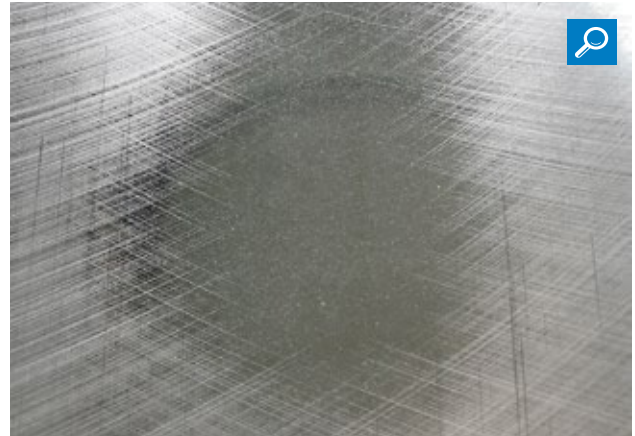
Fig. 2

- Bright, bare areas with no honing structure on cylinder sliding surface (Fig. 1 and 2).
- No signs of wear on the piston.
- Oil carbon deposits on the piston top land.
- Increased oil consumption.

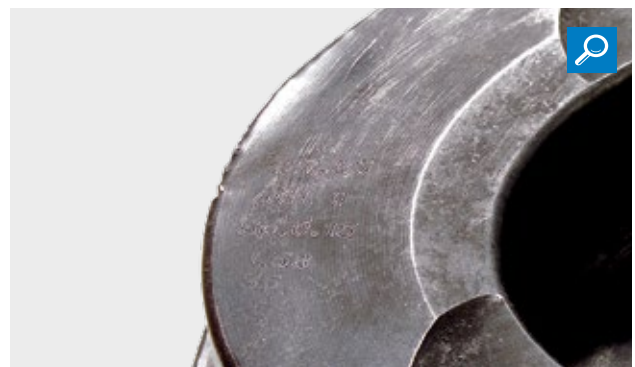
Fig. 4

- Upper area of cylinder liner displays severe damage due to a crack and seizure marks on the sliding surface (Fig. 2 and 3).
- Piston displays seizure marks on the pressure and anti-thrust sides.
- In the piston crown: bowl-shaped recess in the area of the seizure marks (Fig. 4).

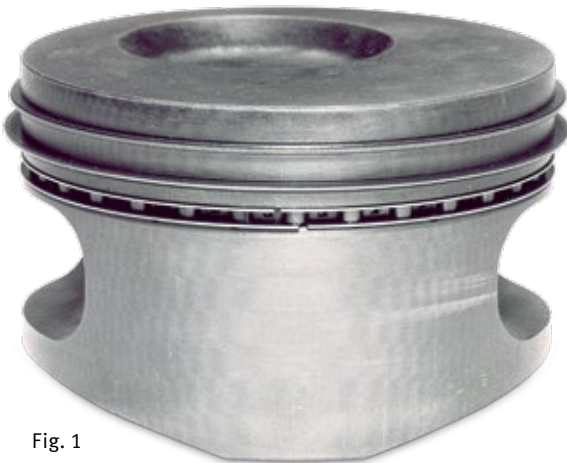
Fig. 1

- No signs of wear on piston rings or piston (Fig. 1).
- End of the expander spring of the 3-piece oil control ring broken off.
- Scratches in the groove base of the oil control ring.

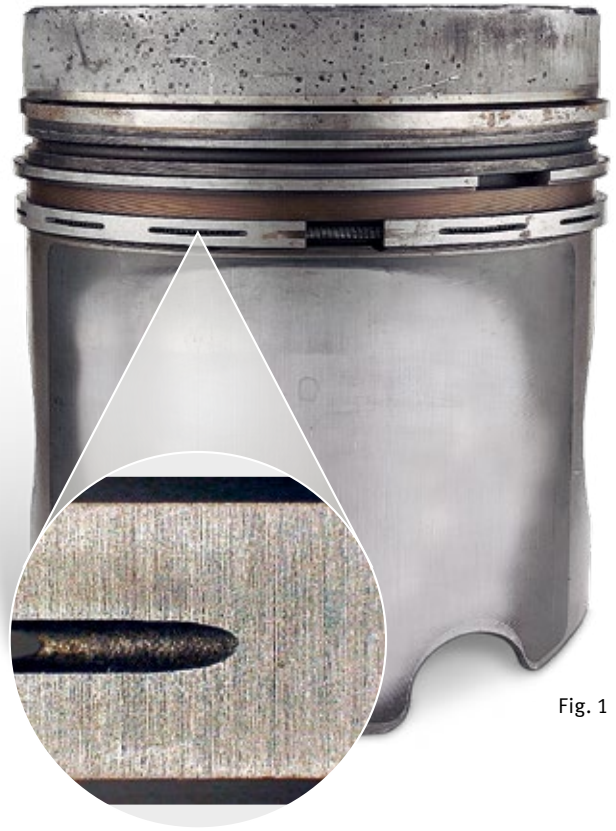
Fig. 1

- Severe signs of wear on the piston top land and piston skirt.
- Friction marks on the piston skirt, characteristic of dry running due to fuel flooding.
- Piston rings display severe radial wear (Fig. 1). Both webs (support surfaces) on the oil control ring have been worn down (Fig. 2). By way of comparison in Fig. 3: profile of a new and worn oil control ring (double-bevelled spiral expander ring).
- Increased oil consumption.

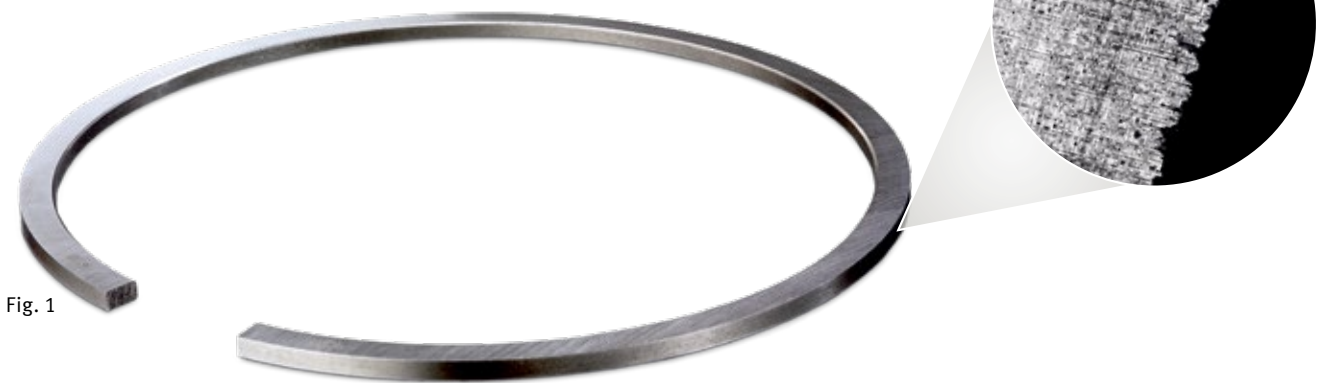
Fig. 1

- No damage or wear on piston.
- Superficial inspection of piston rings reveals no wear marks, however, closer inspection reveals abnormal wear on the oil-scraping ring edges, mostly on the bottom ring edges (see magnified image).
- Tangible burr on the bottom edge of the piston ring running surface.
