# KNOWLEDGEPOOL

## DAMAGE TO ENGINE BEARINGS

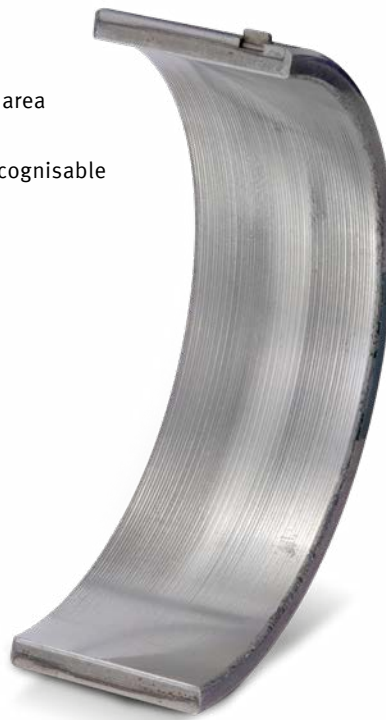
**Lower main bearing shell  
steel-aluminium composite  
(without coating)**

In the centre of the bearing, a bright stripe of wear can be seen. In the area of the relief and the edges of the bearing, no traces of operation are visible, however. Here, the machining structure of the bearing can still be recognised.

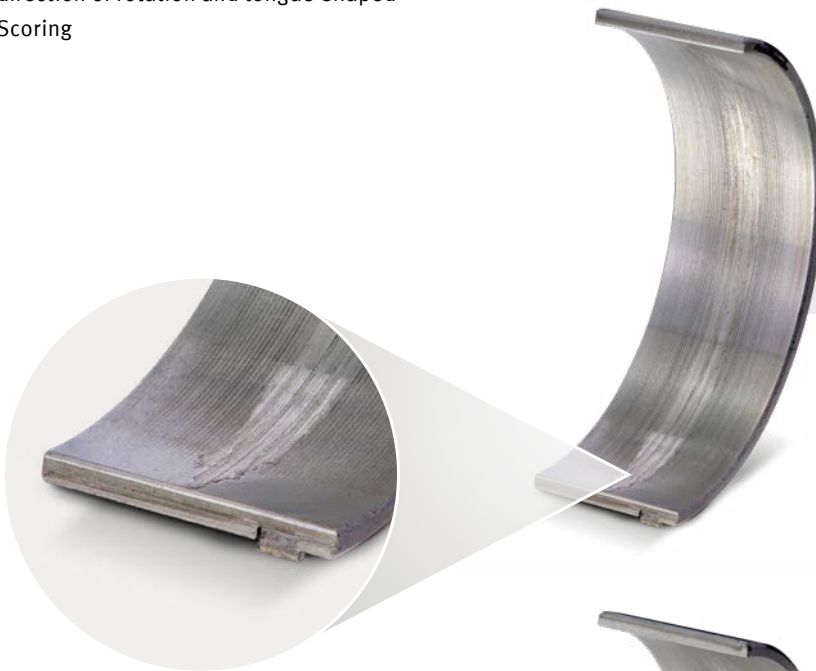
**Cap-side conrod bearing shell  
steel-aluminium composite**

In the centre of the bearing a clear bright mark of mixed friction, with associated scoring, is recognisable. The wear pattern is displaced out into the relief area.

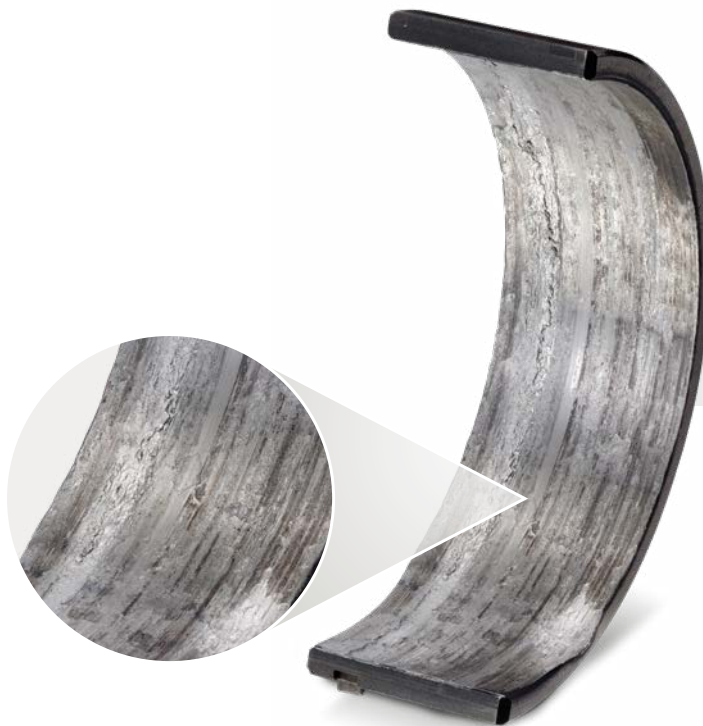
**Lower main bearing shell  
steel-aluminium composite**

High temperatures in the area of high mixed friction cause localised welding between the journal and bearing. These welded areas break up again, whereby the bearing material – which is softer compared to the crankshaft – is torn off. An acute lack of lubricant is the cause here. The temperature development caused by this causes overheating damage – a common side effect of bearing seizure.

Seizure is amongst the most serious types of bearing damage. The bearing is destroyed and has to be replaced. If use of the bearing is continued, other engine components may be damaged.

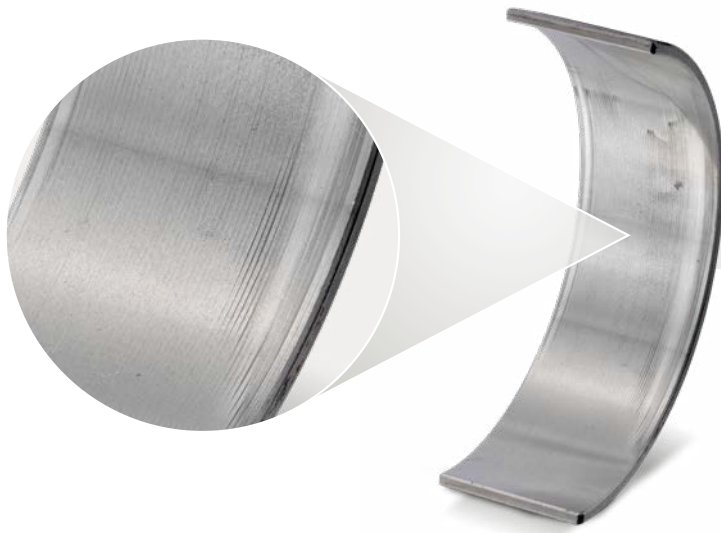
**Cap-side conrod bearing shell  
steel-aluminium composite**

Two-sided edge wear in the early stages – wear in the form of adaptive run-in wear.

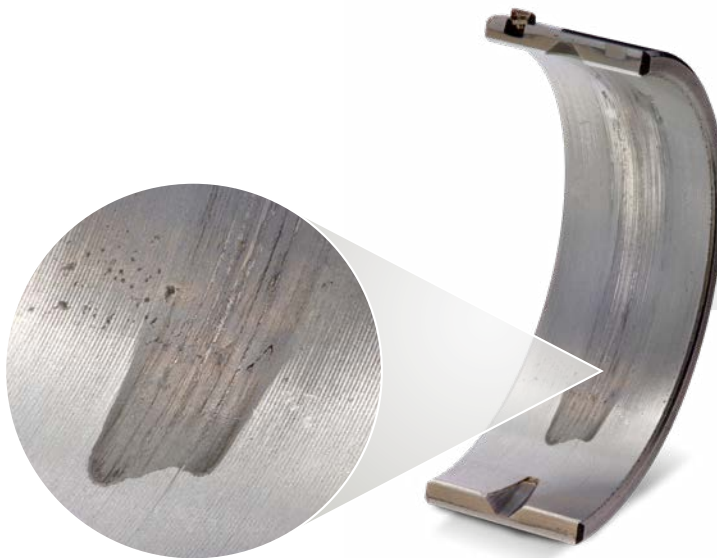
**Lower main bearing shell  
steel-aluminium composite**

Clear wear marks in the centre of the bearing which taper off towards the relief can be identified. They are already noticeable as initial rubbing marks in the sliding layer.

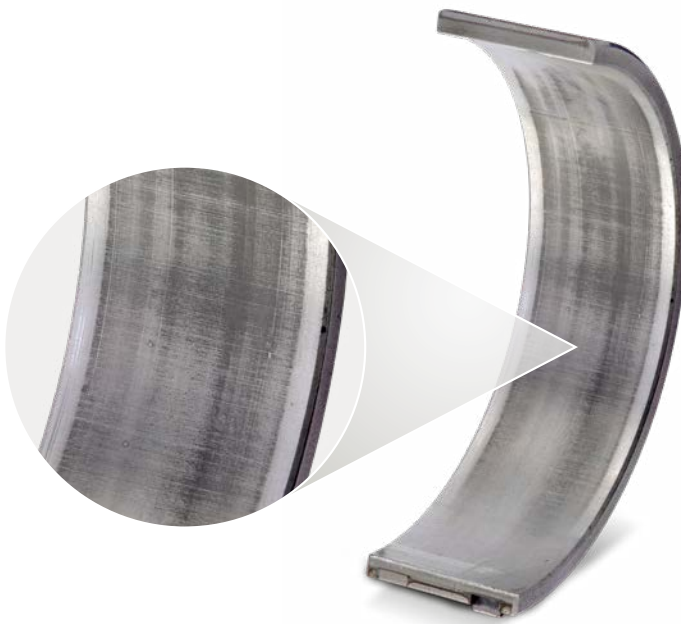
**Lower main bearing shell  
steel-aluminium composite**

Two wear-free strips are recognisable at the edges of the bearings without any visible wear marks. The remaining part of the bearing has a slight black discoloration, possibly due to corrosion or wear.

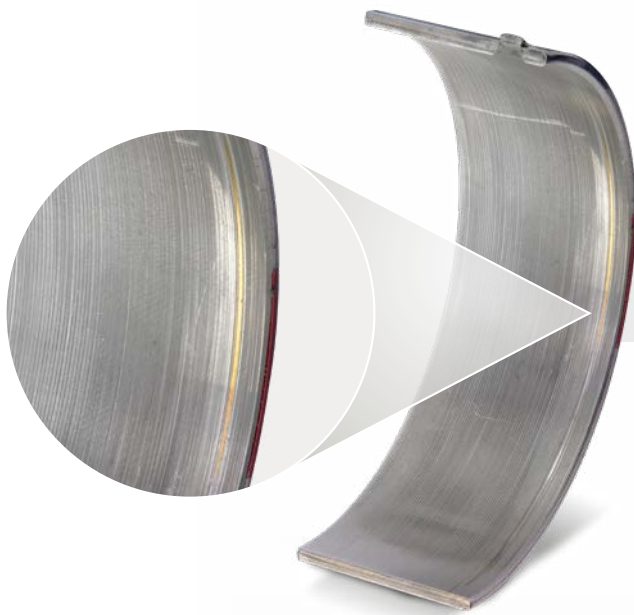
**Rod-side conrod bearing shell  
steel-brass composite with  
sputter coating**

The groove extends up to the brass layer.  
Light wear marks occur next to the scoring  
due to smoothed material accumulation.

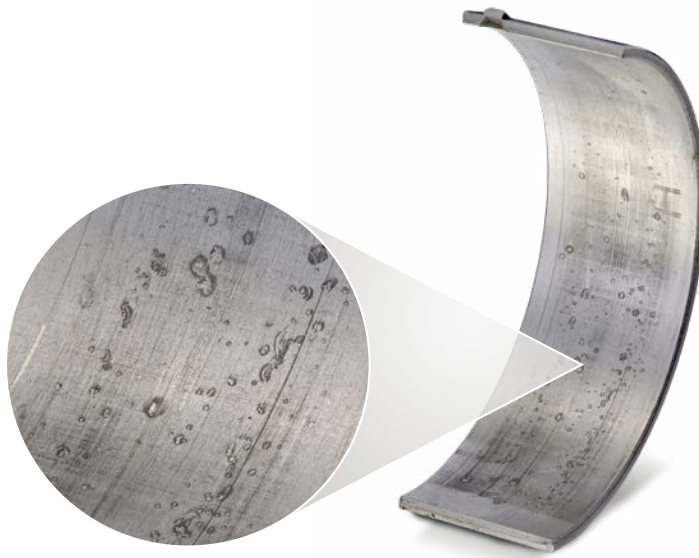
**Cap-side conrod bearing shell  
steel-aluminium composite**

Fine particle imprints and individual scoring marks are visible.

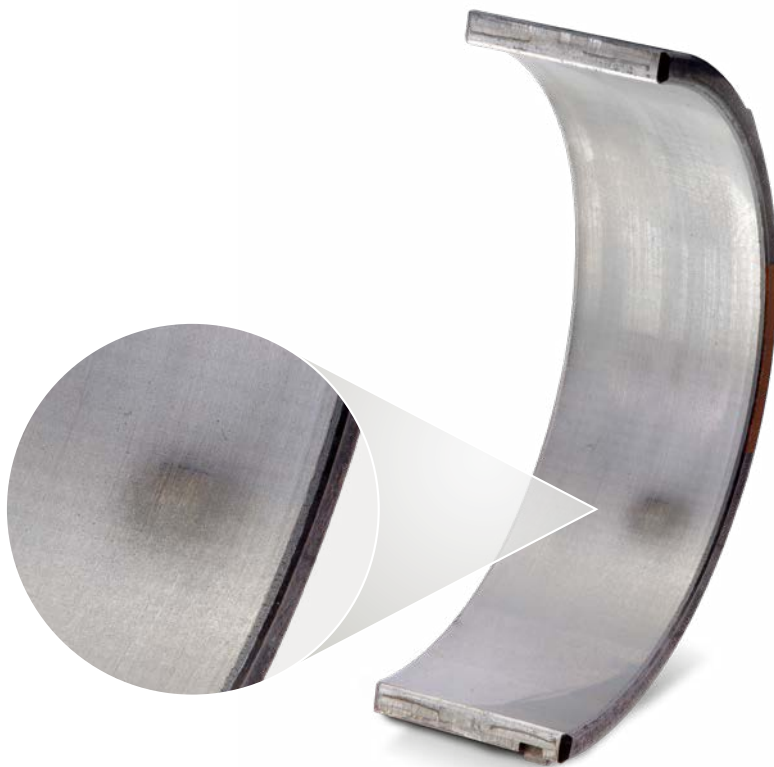
**Lower main bearing shell  
steel-aluminium composite**

A clear deviation in the wear pattern, as well as point-like wear in the sliding surface can be recognised. The pressure mark is the result of particles at the back of the bearing.

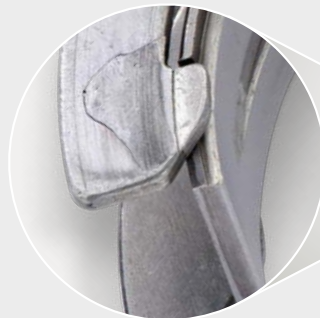
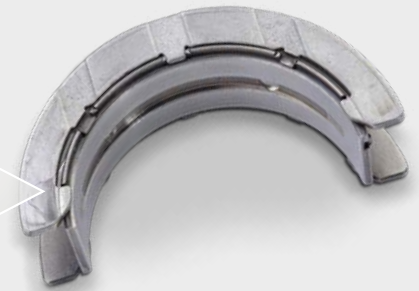
Crack formation from outer edge to outer edge

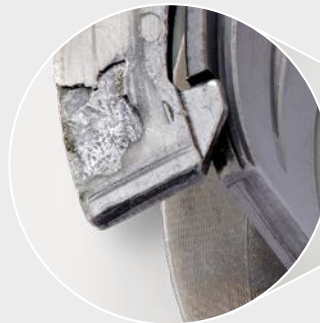
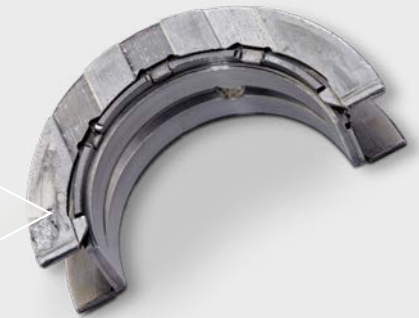
Large-scale material nick at the outer edge of the thrust washer
