KOLBENSCHMIDT

## PISTON DAMAGE – RECOGNISING AND RECTIFYING

## MOTORSERVICE GROUP

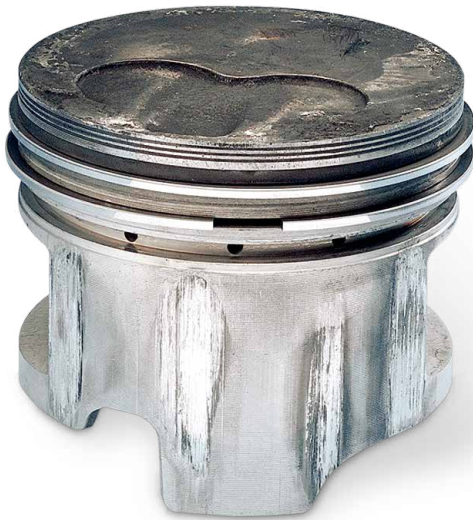
- Several similar areas of seizure marks around the piston skirt.
- Seizure marks on both the pressure and anti-thrust sides of the piston skirt, i.e. seizure marks on opposite sides.
- Surface changes from bright wear marks to smooth, darkly discoloured areas of wear caused by rubbing.
- Undamaged ring zone.

The clearance between the piston skirt and the cylinder running surface was either too narrow by design, or it was restricted by distortion that possibly did not occur until the engine was operating.

- Cylinder bore too small.
- Cylinder head over-tightened or tightened unevenly (cylinder distortion).
- Uneven mating surfaces on the cylinder block or cylinder head.
- Dirty or damaged threaded bores or cylinder head bolts.
- Seized or insufficiently lubricated seating surfaces.
- Use of incorrect or unsuitable cylinder head gaskets.
- Cylinder distortion caused by uneven heating due to lime deposits, dirt or other malfunctions in the cooling system.

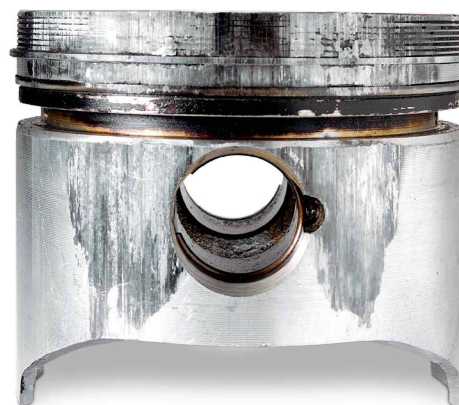
Fig. 1

- Seizure marks on both the pressure and anti-thrust sides, offset at approximately 45° to the piston pin axis.
- The seizures areas change from bright wear marks to relatively smooth, darkly discoloured areas of wear caused by rubbing (Fig. 1).
- Piston pin displays blue tempering colour (Fig. 3). Reason: piston pin bed has become hot due to insufficient clearance or a lack of oil.

- Mechanical overload of the connecting rod bearing, e.g. due to abnormal combustion.
- Malfunction/fracture in the oil injection jet.
- Insufficient or no oil pump pressure.
- Insufficient lubrication when the engine was first taken into operation. The piston pin was not or was insufficiently lubricated when it was assembled.
- Failure of the connecting rod bush (piston pin seizure) due to insufficient clearance or lubrication.
- Installation fault during the process of shrinking the piston pin (shrink-fit connecting rod).

During the shrinking process, care must be taken to ensure that, immediately after the piston pin has been inserted, the piston pin bed is not checked for freedom of movement by tilting the piston back and forth. The temperatures are equalized between the two components immediately after the cool piston pin is inserted into the hot connecting rod. The heat introduction increases the thermal expansion of the piston pin as is the case during engine operation. If the bed is moved in this state, it can cause initial rubbing marks or seizure marks. This may cause stiffness or failure of the piston pin bed during engine operation. For this reason, allow the assembled components to cool down before checking the freedom of movement.

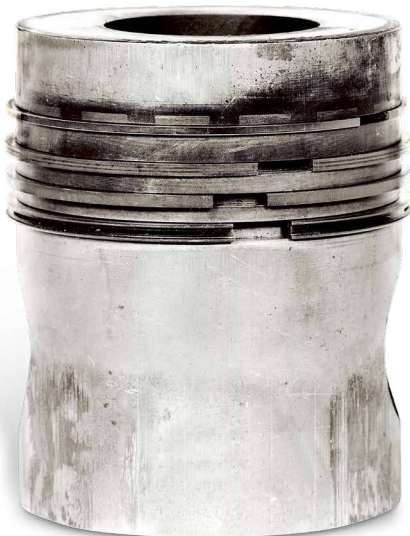
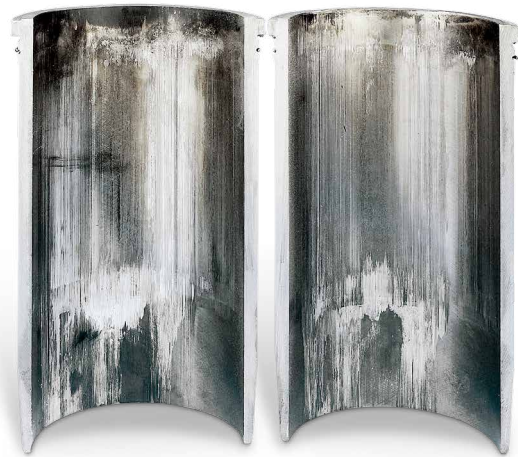
- Seizure due to insufficient clearance at the bottom skirt ends, with wear marks and counter-wear marks.
- The marks change from bright wear marks to smooth, darkly discoloured areas of wear caused by rubbing (Fig. 1).
- There is nothing unusual about any of the remaining parts of the piston.
- Seizure marks in the cylinder liner in the area around the lower O-rings (Fig. 2).

The piston seizure at the bottom edge of the piston skirt was caused by distortion/restricted clearances in the lower area of the cylinder liner.

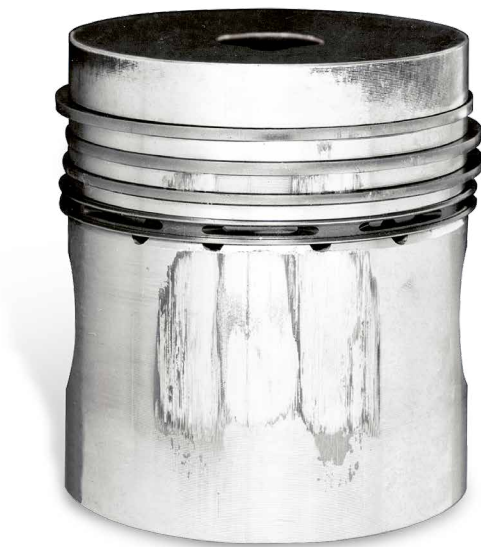
- Seizure marks on the piston skirt on the pressure side, which in some cases extend into the piston ring zone.
- Slight seizure marks on the anti-thrust side.
- Surface of the seizure areas is light-coloured and has an almost pure metallic finish.

There was an acute lack of lubricant between the piston and the cylinder bore. The fact that the surface of the seizure areas has an almost pure metallic finish indicates that the oil film was present but significantly weakened at the time of the seizure. Due to the limited extent of the damage, this concerns a temporary lack of oil or the early stages of damage. The damage would have been even more severe if engine had been operated further.

- Insufficient engine oil.
- Oil pressure in the engine too low (oil pump, pressure relief valve, etc.): not enough oil emerges at the crankshaft bearings. This means that not enough lubricating oil is supplied to the cylinder running surface, which is lubricated with splash oil and centrifugal oil from the crankshaft.
- Failure of the oil injection jet for cooling the piston.

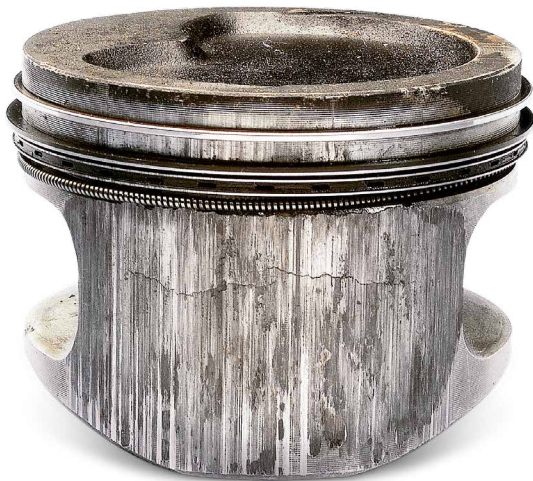
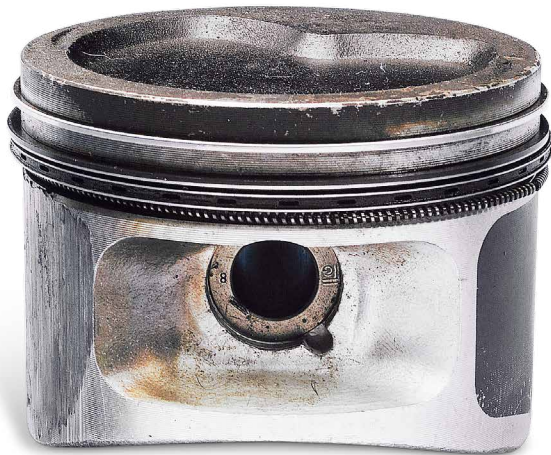
- Severe, darkly discoloured seizure areas with a heavily worn surface on the pressure side of the piston.
- Opposite side of the piston skirt free of damage.
- Piston ring zone usually undamaged in the early stages.

This is a typical example of seizure due to lack of lubrication. It usually occurs on the pressure side and is less common on the anti-thrust side. This damage is caused when the lubricating film breaks down on only one half of the cylinder. It is caused either by a lack of lubrication within a locally confined area or by the affected side of the cylinder overheating. Lack of clearance can be excluded as the potential cause here as, despite the severity of the seizure marks, there are no wear marks on the opposing counter-side.

- Partial collapse of the cooling mechanism due to lack of coolant, air bubbles, dirt deposits or other malfunctions in the cooling circuit.
- On ribbed cylinders, dirt deposits on the outside can lead to localised overheating and, consequently, a breakdown of the oil film.
- On air-cooled engines: defective, missing or incorrectly installed air baffles.
- Failure of the oil injection jet for cooling the piston.
- Insufficient oil pressure: insufficient lubrication on the cylinder pressure side for connecting rods with oil injection jets.
- Insufficient lubrication on the cylinder pressure side (which is subjected to greater loads) as a result of oil dilution or oil grades that are not suited to the intended purpose.

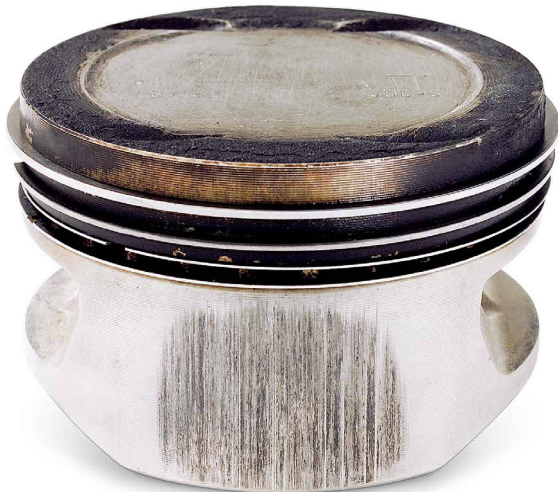
- Narrow, sharply defined longitudinal friction marks on the piston skirt instead of the normal piston wear pattern.

In the case of damage caused by unburned fuel, the damage occurs at the load-bearing areas on the piston skirt. These are the points at which the normal wear pattern would have formed on an undamaged piston.

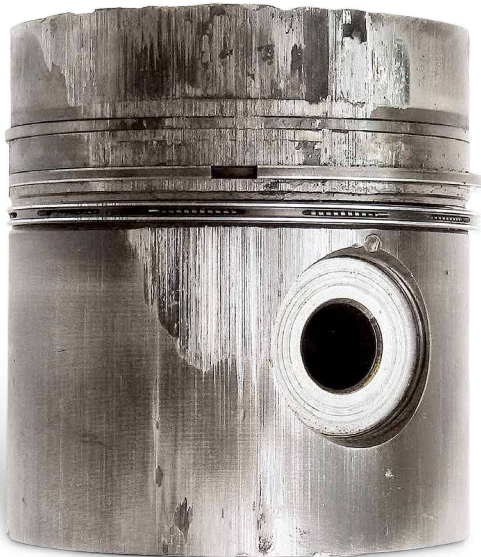
- Localised seizures that mainly occur on the piston top land.
- Surface of the seizure areas is rough and worn, in some cases larger pieces of material have been torn out.

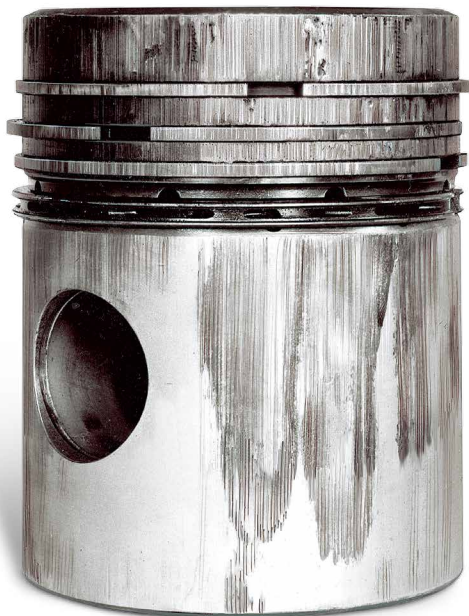
- Severe seizure starting from the piston head and lessening as it progresses towards the skirt end.
- Seizure marks are distributed around the entire circumference of the piston head.
- Surface of the seizure areas has a dark discolouration with severe scoring marks, and has broken up in places.
- Piston ring running surfaces show signs of seizure, which decrease in intensity towards the oil control ring.

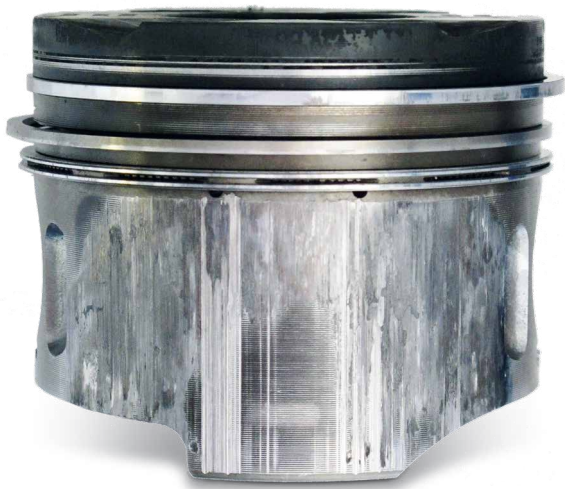
- The piston skirt has seized on both sides.
- The surface of the seizure marks has a dark discolouration and is rough and severely broken up.
- The piston ring zone is often only slightly damaged or not damaged at all.

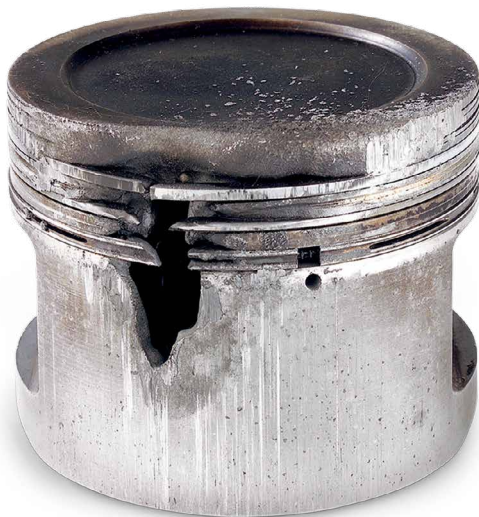
- The piston head has melted through behind the piston rings.
- The piston skirt has not seized; melted material has been worn away off the damaged area onto the piston skirt.

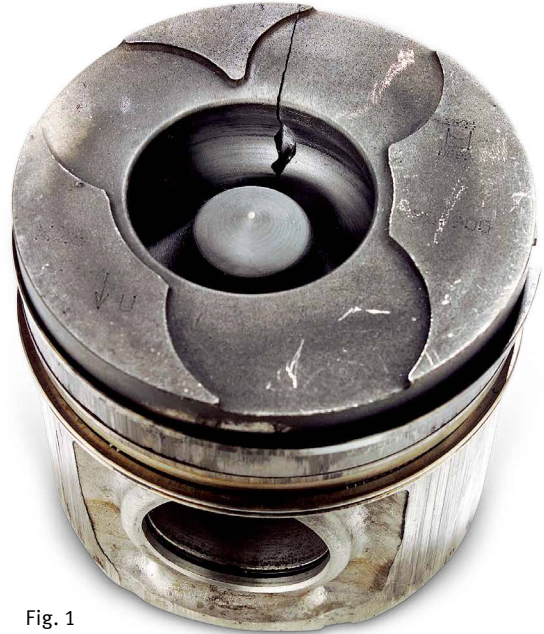
- Stress cracks on the edge of the bowl.
- Major crack extends to the piston pin boss.
- Channel burned from the bowl to below the oil control ring by combustion gases streaming through the major crack.

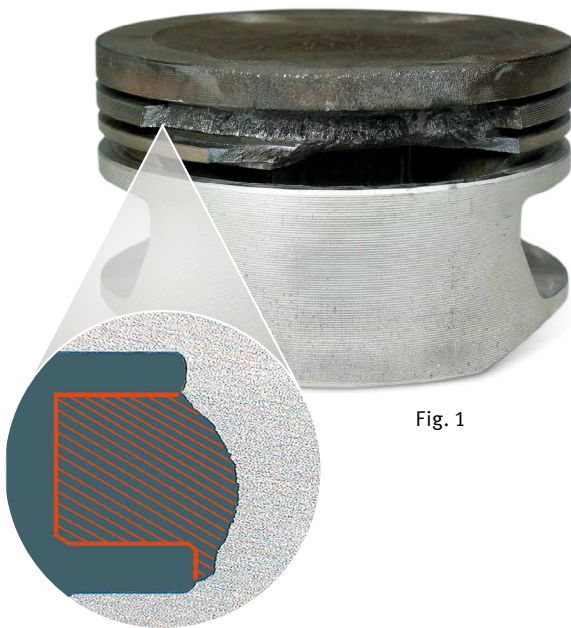
Fig. 1

- Ring land fracture on one side of the piston between the first and second compression ring (Fig. 1).
- Fracture, starting at the groove base at the top and running at a diagonal angle into the piston material, emerging at the groove base underneath (Fig. 2).
- Fracture is extended downwards.
- No piston seizure marks or signs of overheating.

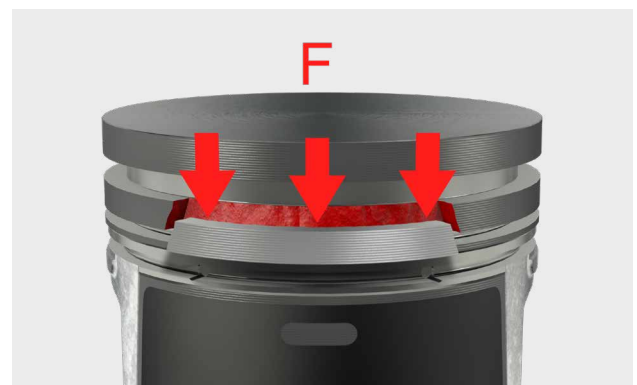
Fig. 3 shows the course of a fracture that occurs with knocking combustion and hydraulic locks: the force causing the fracture and acting from above on the ring land causes the fracture surfaces to extend downwards.

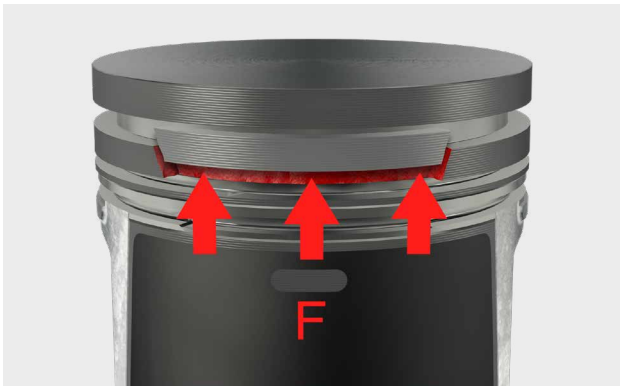
Fig. 4

If the piston rings are incorrectly compressed, more force is required when installing the piston. Forcibly pressing in or knocking in the piston causes pre-damage to the ring lands in the form of fine hairline cracks. The ring lands fracture in the reverse direction as the pressure comes from below in this case (Fig. 4).

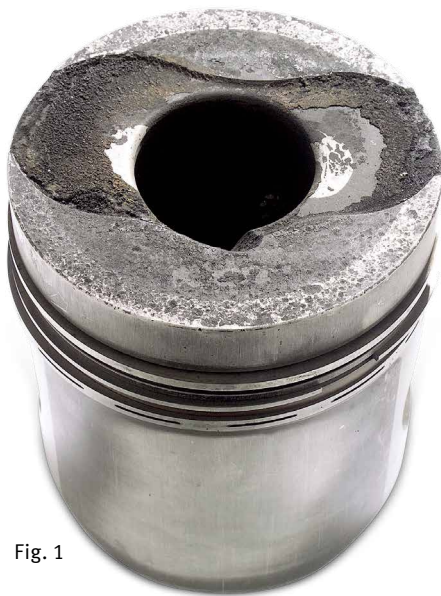
Fig. 1

- Severe impact marks on the piston head (Fig. 1). Nearly all oil carbon deposits removed.
- Scarring and oil carbon deposits pressed into the piston crown.
- Severe wear on the piston rings, particularly on the oil control ring.
- Imprint of the swirl chamber on the front edge of the piston crown (Fig. 2).
- Imprint of the valve on the right-hand side of the crown.
- First indicators of initial dry running damage due to lack of lubrication on the piston skirt (Fig. 4).

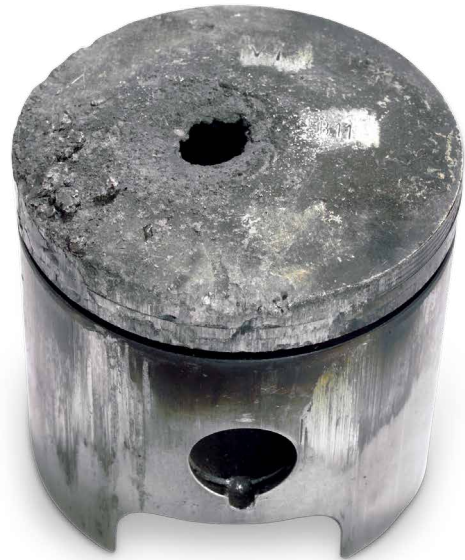
- Piston crown has a hole that penetrates all the way through, covered by the molten material.
- Skirt area displays seizure marks. Reason: the high temperatures and the piston material that has been ground down.

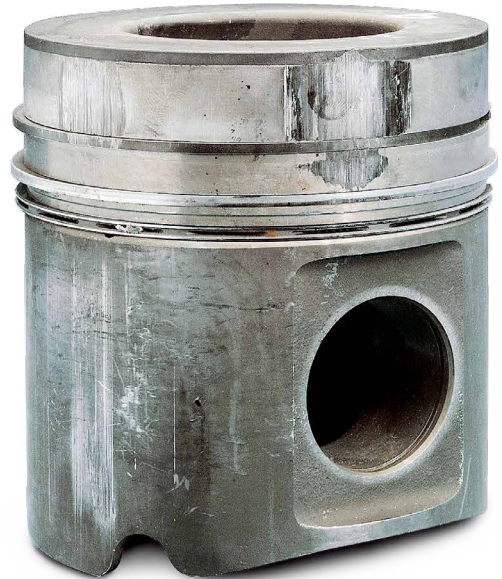
- Localised score marks can be seen on the piston head, going all around the circumference of the piston.
- Score marks start at the piston crown and end at the second compression ring.
- Score marks are centred around the piston top land.

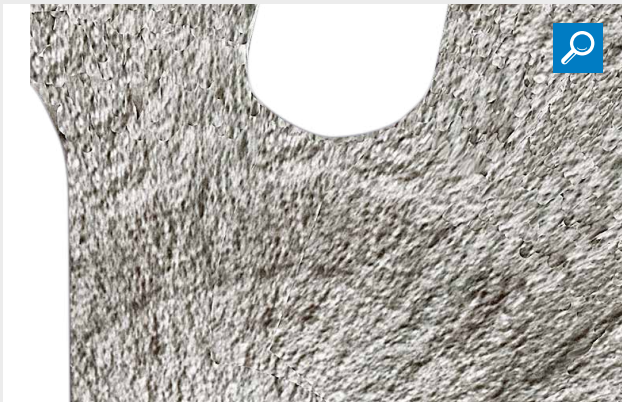
Fig. 2

The fracture surfaces of a forced fracture appear grey. They are not worn down and display no line markings. The piston breaks suddenly without any fracture development.

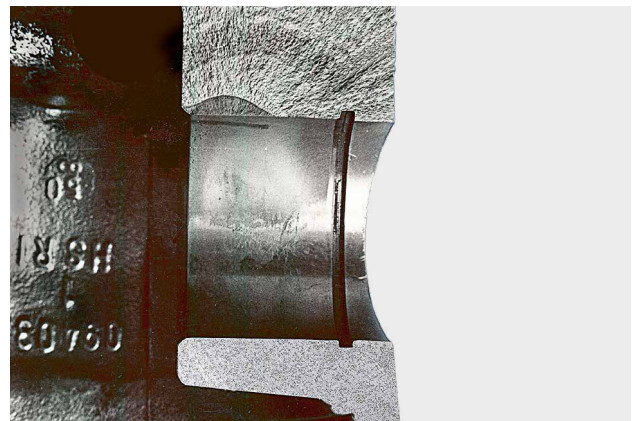
- Formation of a cleavage fracture that leads to the piston crown. This results in the piston being split into two parts (Fig. 1).
- Boss fatigue crack in the centre axis of the piston pin bore (Fig. 2 and 3).

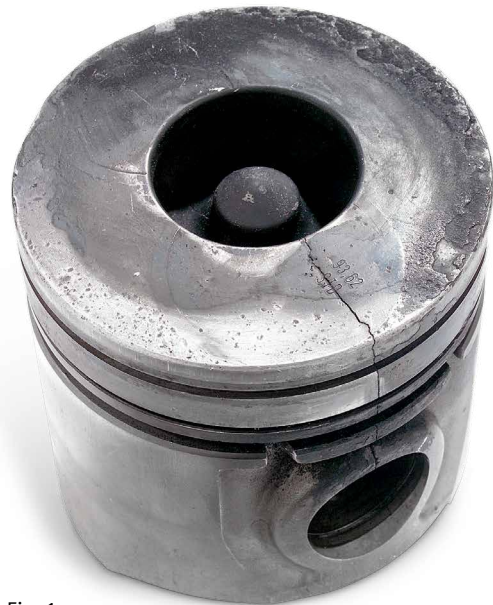
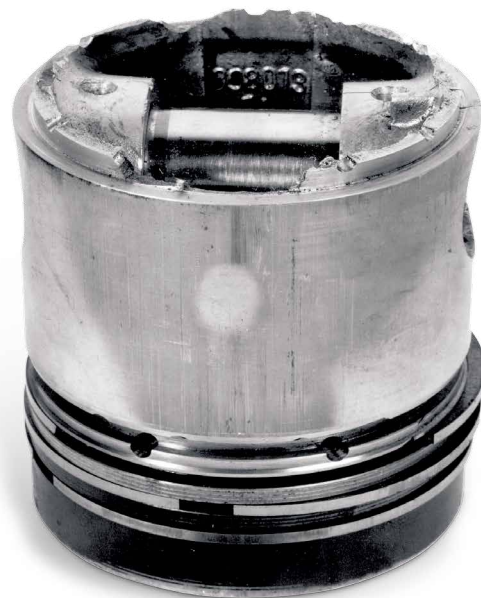
The cause is an exceptionally fast sequence of hard impacts as the piston crown strikes the cylinder head, which subjects the piston to such violent shock vibrations that cracks are generated. The piston also no longer runs straight in the cylinder and subsequently strikes the cylinder wall with its skirt. On pistons with a lower oil control ring (Fig. 2) the skirt often breaks in the area of the lower oil ring groove.

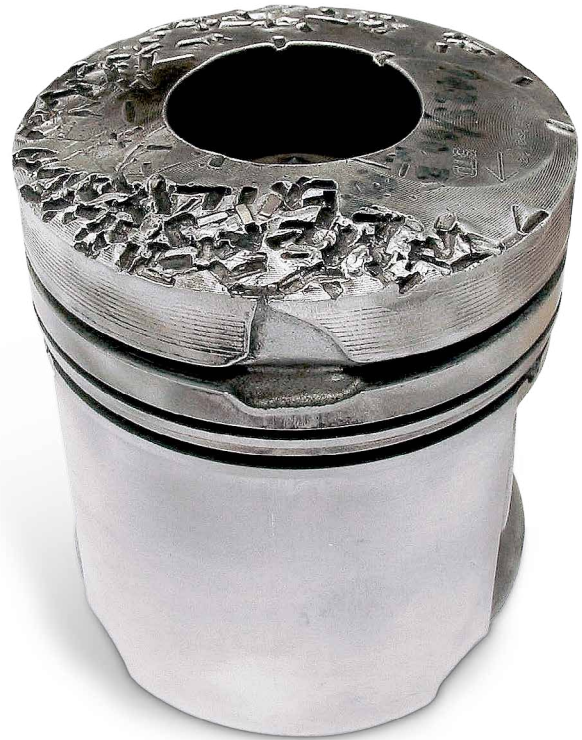
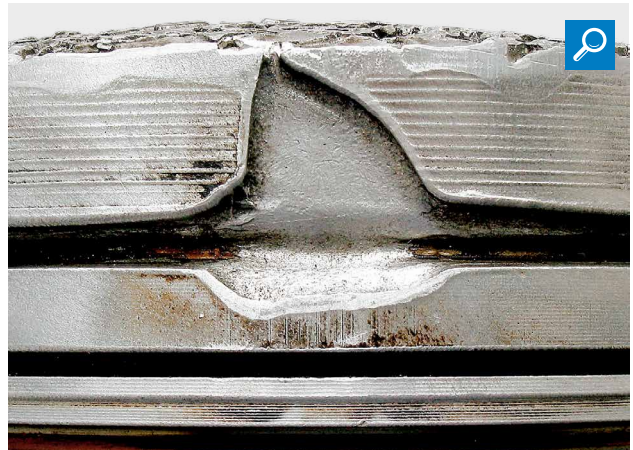
- Severe material washout reaching as far as the piston crown in the ring zone in the area of the first ring groove.
- Severe axial wear on the first ring groove.
- Severe mechanical damage on the piston crown.
- Running pattern of the piston skirt has a matt, buffed appearance.

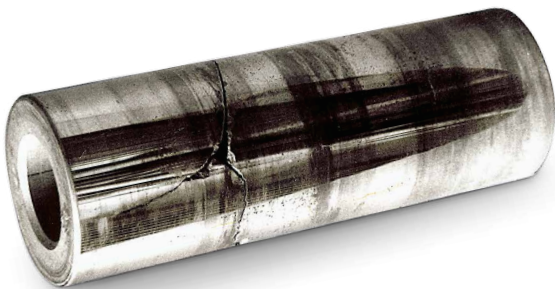
Fig. 1

- Lateral fracture on the piston pin (Fig. 1) at the transition between the connecting rod and the piston pin boss.
- Shorter fragment split along its length.
- Fracture surfaces display the characteristics of a fatigue fracture.

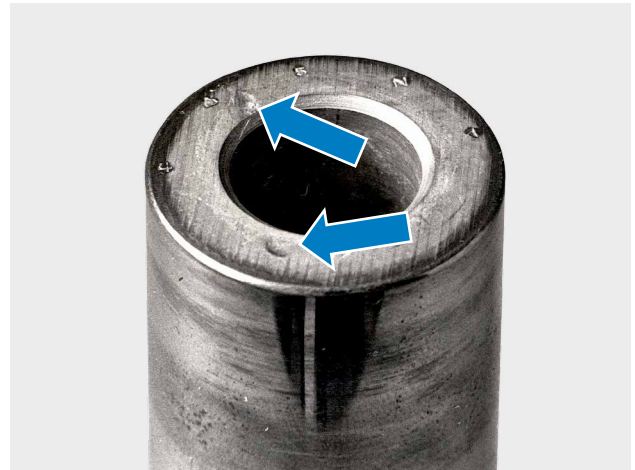
Fig. 2 shows that an incipient crack may not only be caused by overstressing, but also as a result of improper installation of the piston pin. The end face of the broken piston pin clearly shows that the incipient crack was caused by impact damage (hammer blow). An incipient crack can lead to breakage of the piston pin, even under normal load conditions.

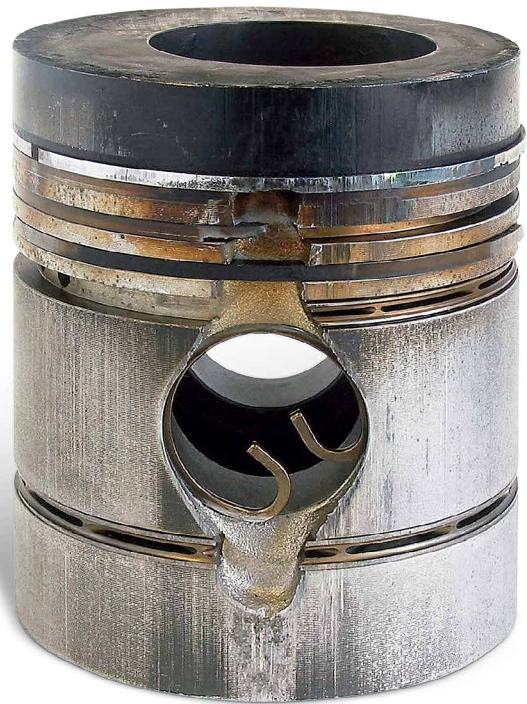
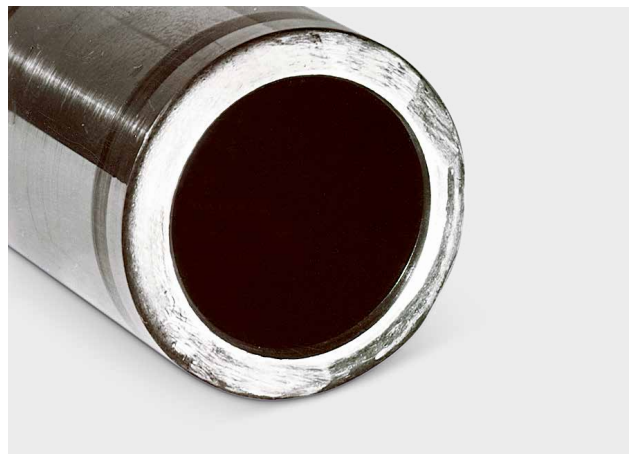
- End of the piston pin bore on both sides of the piston suffered serious damage, in some places as far as the ring zone (Fig. 1).
- Circlip jumped out of the retaining groove and broke into fragments.
- Second circlip damaged.
- Due to the lack of retention, the piston pin has wandered outwards towards the cylinder running surface.
- Front face of the piston pin worn to a convex shape due to prolonged contact with the cylinder running surface (Fig. 2).
- Asymmetrical running pattern of the piston.

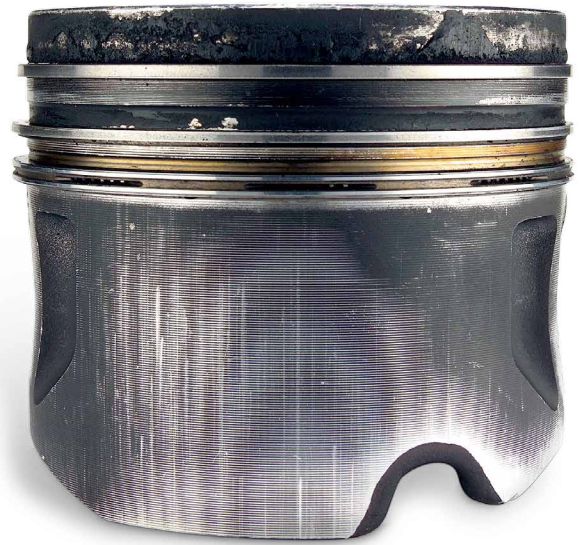
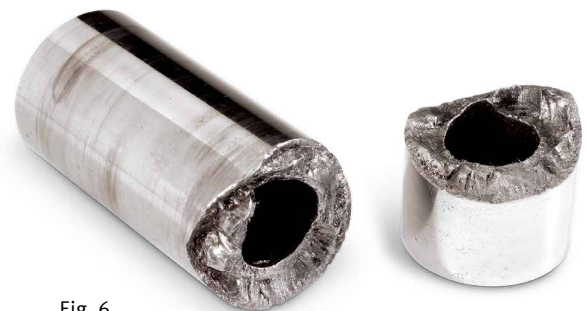
- Asymmetrical piston wear pattern (Fig. 4).
- Piston pin boss and piston pin broken (Fig. 5 and 6).
- Pin bore hammered out in the area of the circlips.

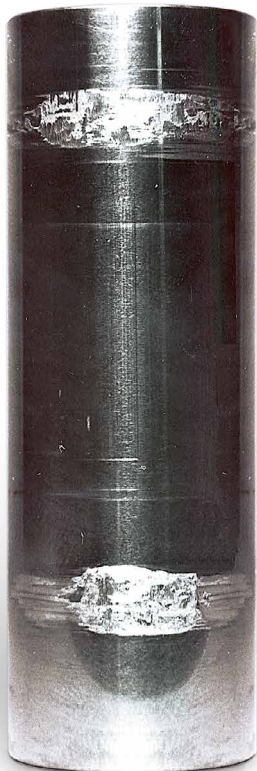
Fig. 1

- Piston pin has seized in the piston pin bores.
- Piston material has been welded onto the piston pin (Fig. 1).
- Piston pin displays a blue discolouration in the area of the connecting rod bush.

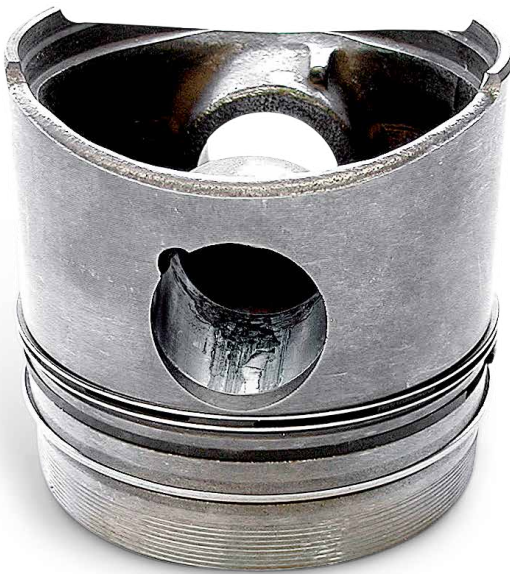
Fig. 1

- Piston has only run for a short length of time.
- No wear marks on the piston skirt.
- The piston pin bosses have seized on the upper side, i.e. the side under pressure load (Fig. 1).
- The surface at the seizures is clean bare metal; no traces of burned-in oil.

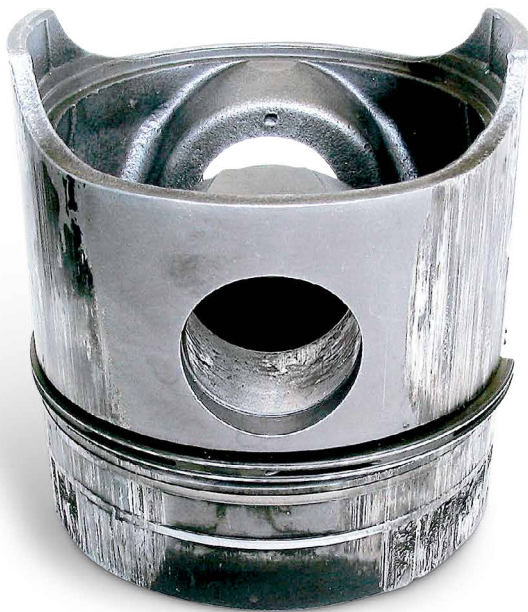
- Piston skirt has seized on both sides, starting at the piston head.
- Compression rings have become blocked in the ring grooves.
- Seizure marks are present in the piston pin bosses.

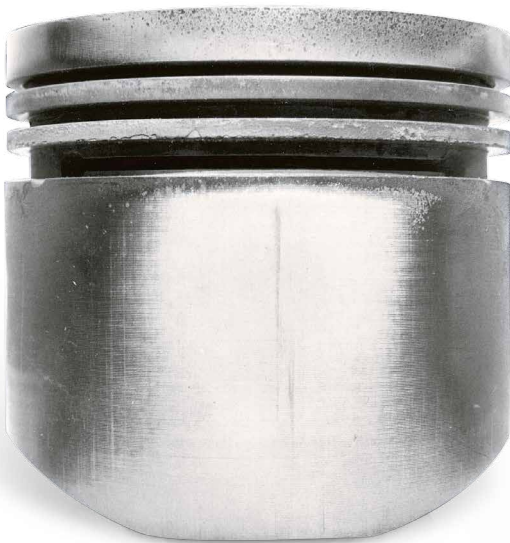
Fig. 1

- Piston top land has impact marks in the tilting direction (Fig. 1).
- The piston skirt displays a more pronounced running pattern to the top and bottom than in the middle of the skirt.

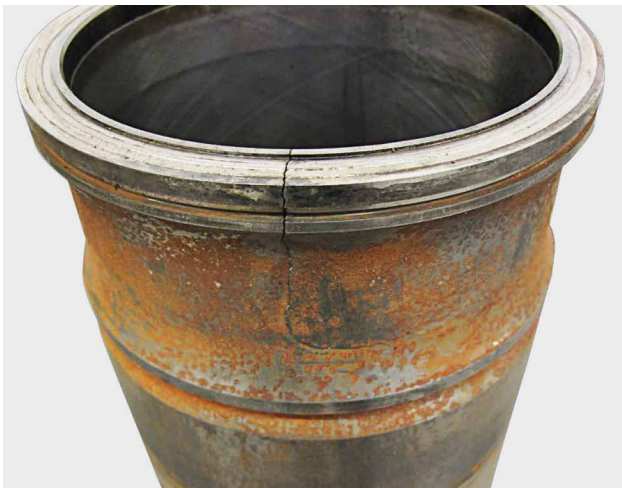
- Vertical crack, extending from the liner flange.
- Dry cylinder liners can also be affected because of their relatively thin cylinder wall thickness.

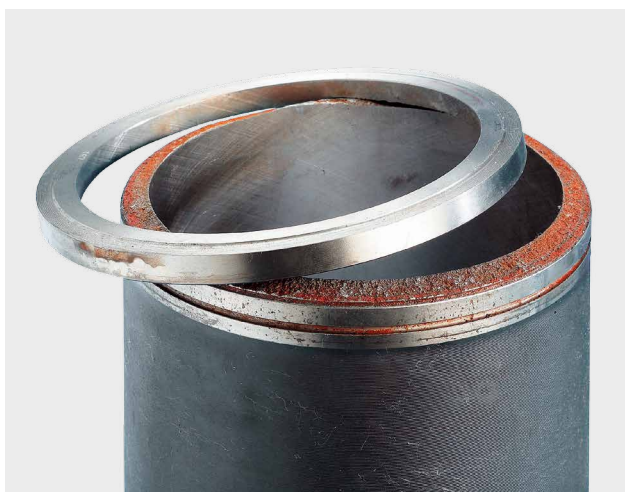
Fig. 1

- Liner flange has been torn off.
- The flange crack starts at the base of the bottom edge of the liner flange and extends upwards at an angle of approx. 30°.

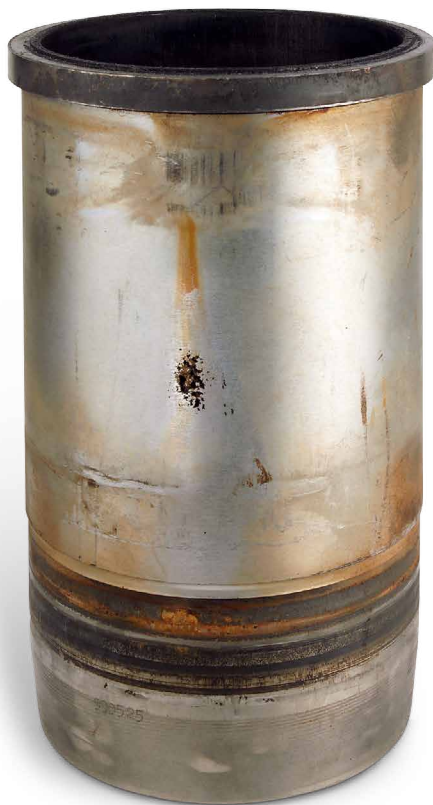
Fig. 1

- Severe cavitation on the water jacket of the wet cylinder liner (Fig. 1 and 2).
- Coolant has penetrated through into the combustion chamber.

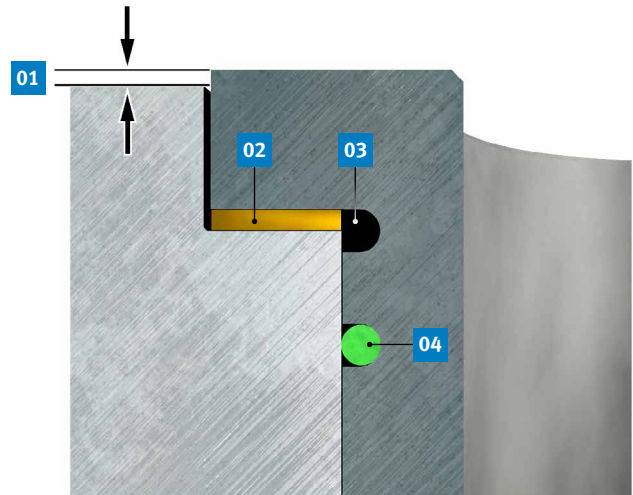
Fig. 4

- Installation of additional sealing rings in the undercut on the liner flange (Fig. 4): sealing rings may only be installed at this position if they are specifically required by the manufacturer.

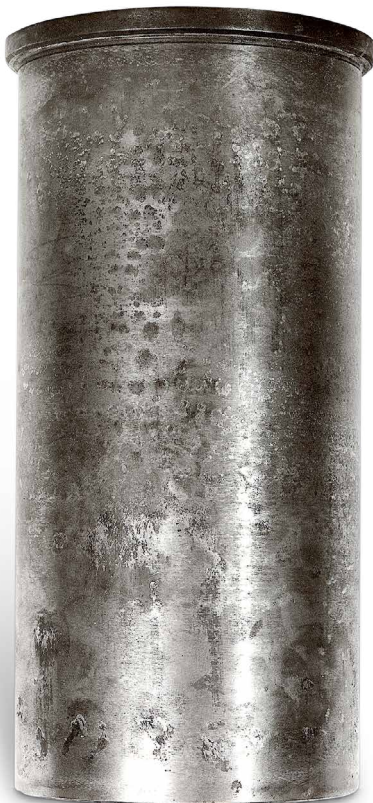
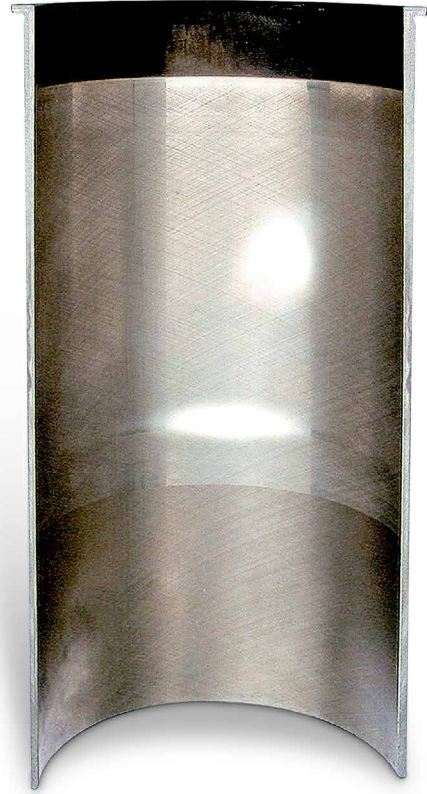
- Corrosion on the outside diameter of the cylinder liner (Fig. 1).
- Uneven wear pattern with individual bright areas on the cylinder surface (Fig. 2).
- Piston undamaged.
- Oil loss at the sealing points, in particular the radial oil seals.

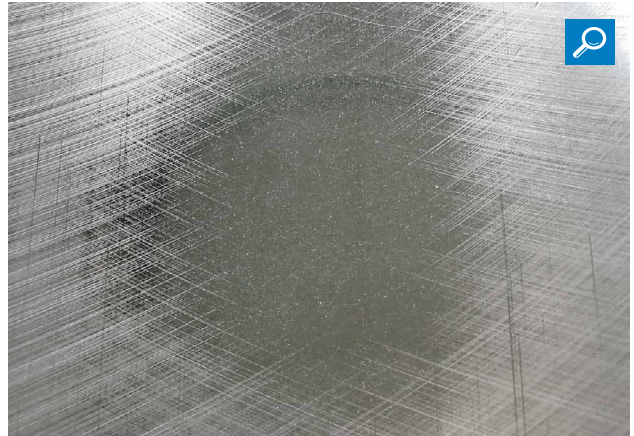
- Bright, bare areas with no honing structure on cylinder sliding surface (Fig. 1 and 2).
- No signs of wear on the piston.
- Oil carbon deposits on the piston top land.
- Increased oil consumption.

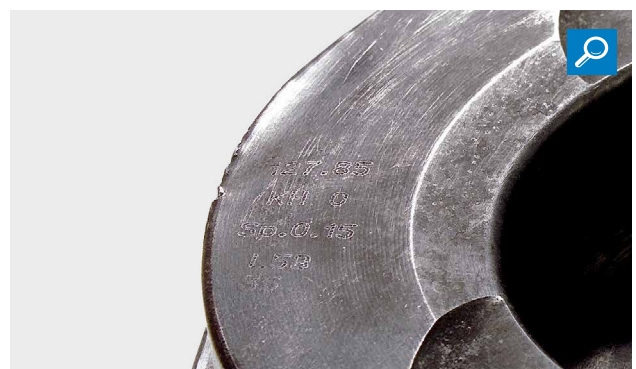
Fig. 4

- Upper area of cylinder liner displays severe damage due to a crack and seizure marks on the sliding surface (Fig. 2 and 3).
- Piston displays seizure marks on the pressure and anti-thrust sides.
- In the piston crown: bowl-shaped recess in the area of the seizure marks (Fig. 4).

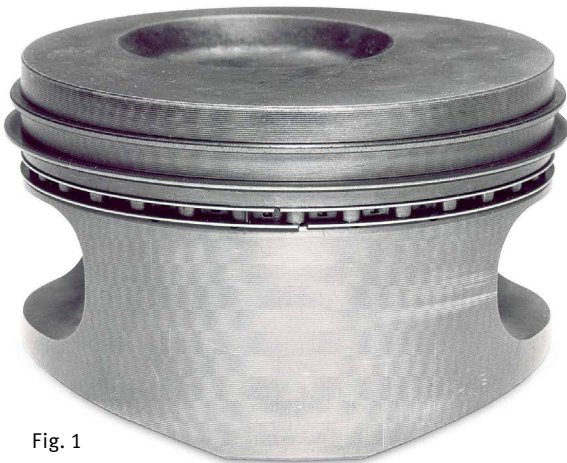
Fig. 1

- No signs of wear on piston rings or piston (Fig. 1).
- End of the expander spring of the 3-piece oil control ring broken off.
- Scratches in the groove base of the oil control ring.

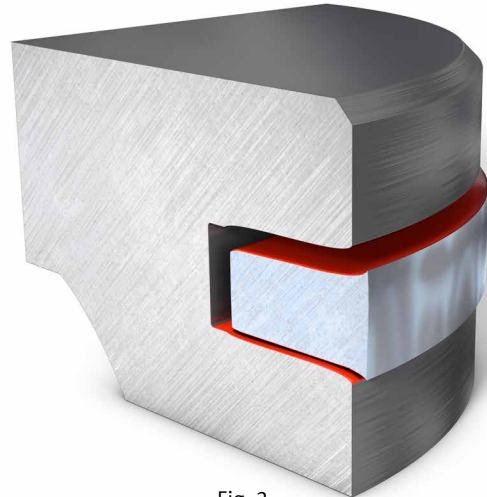
- Piston: matt, ground wear pattern on the skirt with fine, small longitudinal scratches on the piston top land and the piston skirt.
- Tool marks created during machining worn away.
- Worn compression ring edges, on the first piston ring in particular as well as ring groove edges (Fig. 2).
- Axial clearance of the compression rings substantially increased, in particular on the first piston ring.

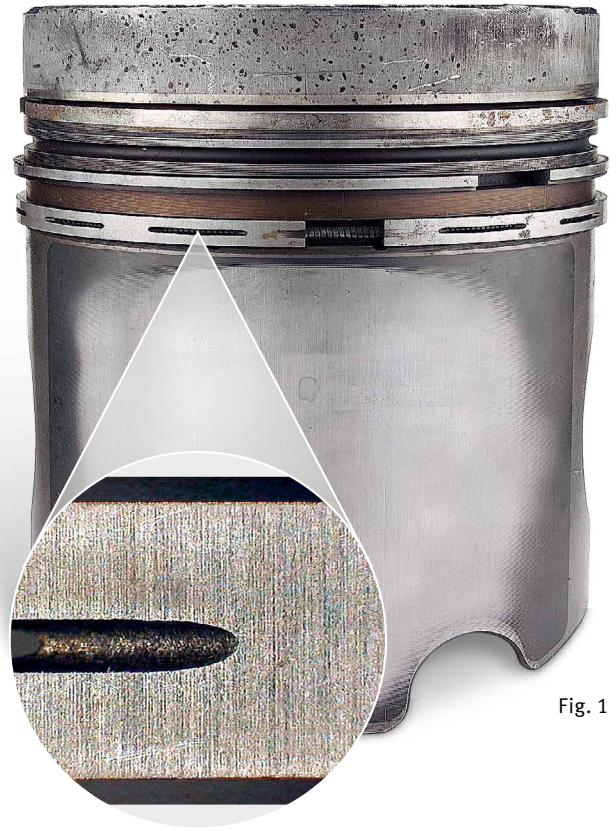
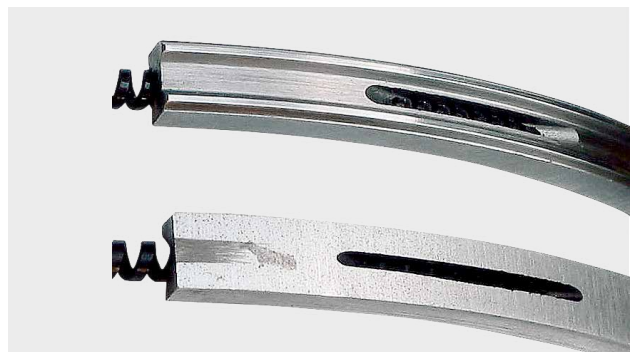
- Severe signs of wear on the piston top land and piston skirt.
- Friction marks on the piston skirt, characteristic of dry running due to fuel flooding.
- Piston rings display severe radial wear (Fig. 1). Both webs (support surfaces) on the oil control ring have been worn down (Fig. 2). By way of comparison in Fig. 3: profile of a new and worn oil control ring (double-bevelled spiral expander ring).
- Increased oil consumption.

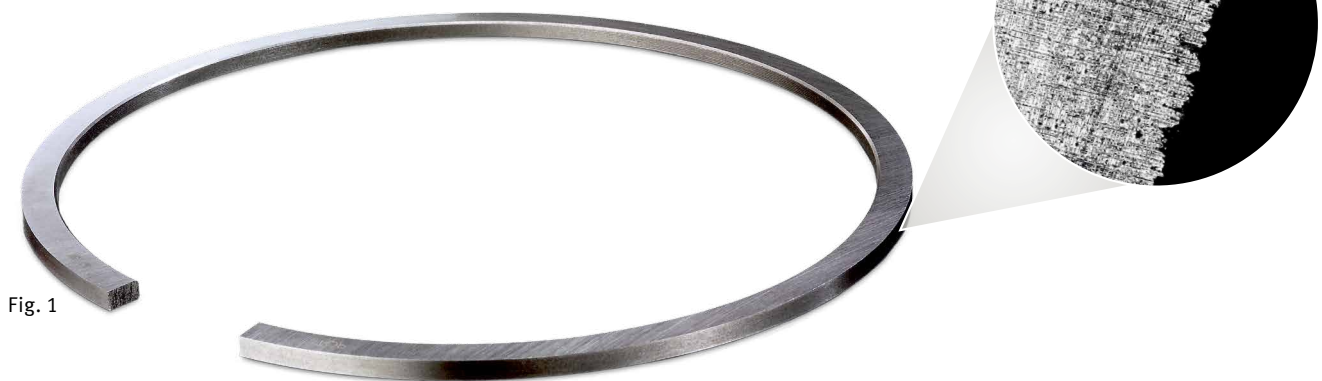
Fig. 1

- No damage or wear on piston.
- Superficial inspection of piston rings reveals no wear marks, however, closer inspection reveals abnormal wear on the oil-scraping ring edges, mostly on the bottom ring edges (see magnified image).
- Tangible burr on the bottom edge of the piston ring running surface.

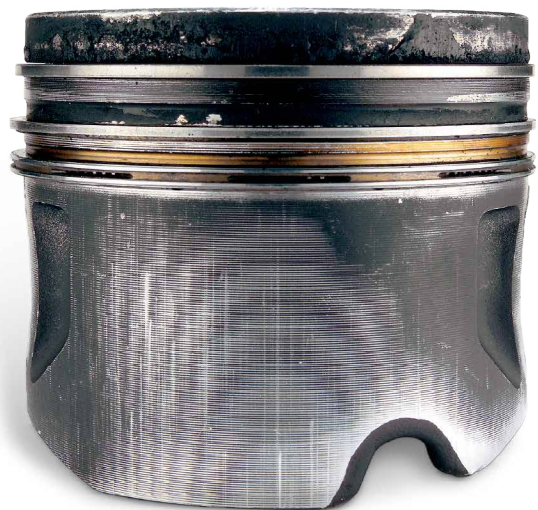
- Piston running skew, with the wear mainly on the lower, right-hand edge of the piston at the recess for the cooling-oil nozzle and under the piston pin bore.
