# KNOWLEDGE**POOL**

## DAMAGE TO ENGINE BEARINGS

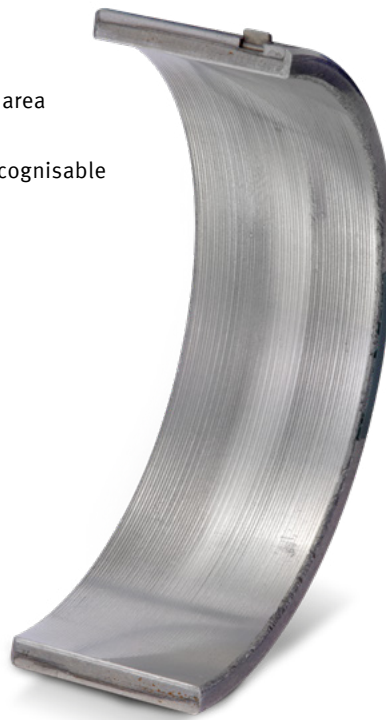
**Lower main bearing shell  
steel-aluminium composite  
(without coating)**

In the centre of the bearing, a bright stripe of wear can be seen. In the area of the relief and the edges of the bearing, no traces of operation are visible, however. Here, the machining structure of the bearing can still be recognised.

The adaptive run-in wear is desired and therefore does not represent damage to the bearing.

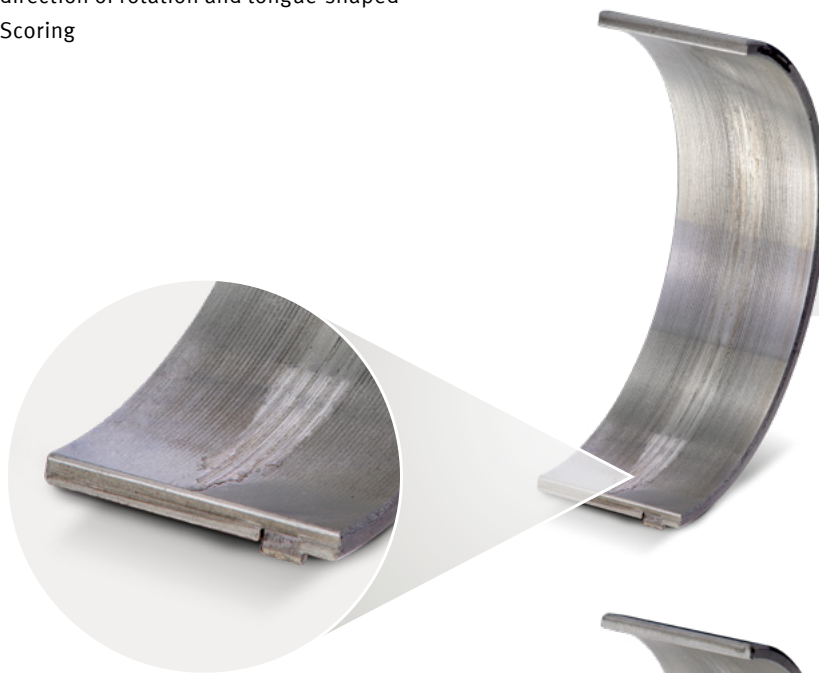
**Cap-side conrod bearing shell  
steel-aluminium composite**

In the centre of the bearing a clear bright mark of mixed friction, with associated scoring, is recognisable. The wear pattern is displaced out into the relief area.

- The lubrication gap is too small, meaning that a stable lubrication film cannot be formed – cause: form and geometry deviations of the shaft or journal, or bending of the crankshaft

- Blocked oil filter
- Defective oil pump
- Leak in the oil lines
- Overstressing of the bearings: the strain is higher than the bearing is designed for – causes are chip tuning or piston seizure, for example

Initial rubbing marks may continue to develop into seizure of the bearings. It is therefore important to replace the bearings and to rectify the cause:

- Check that all of the oil bores are free and that there is no blockage
- Check the actual bearing clearance: if it is not within the tolerance range, form and geometry errors are often the cause (see chapter: „2.5 Special cases“)
- Check the functioning of the oil filter and always change the oil filter and oil according to the manufacturer's instructions
- Check the oil level and oil pressure and readjust if necessary
- Check the oil pump is functioning
- Check the oil lines for any leaks
- Check the stress of individual bearings
- Check the entire bearing set for the embedding of particles or grooves. If present, the influence of particles may have caused the formation of the initial rubbing marks (see chapter: „3. Damage due to the influence of particles“)

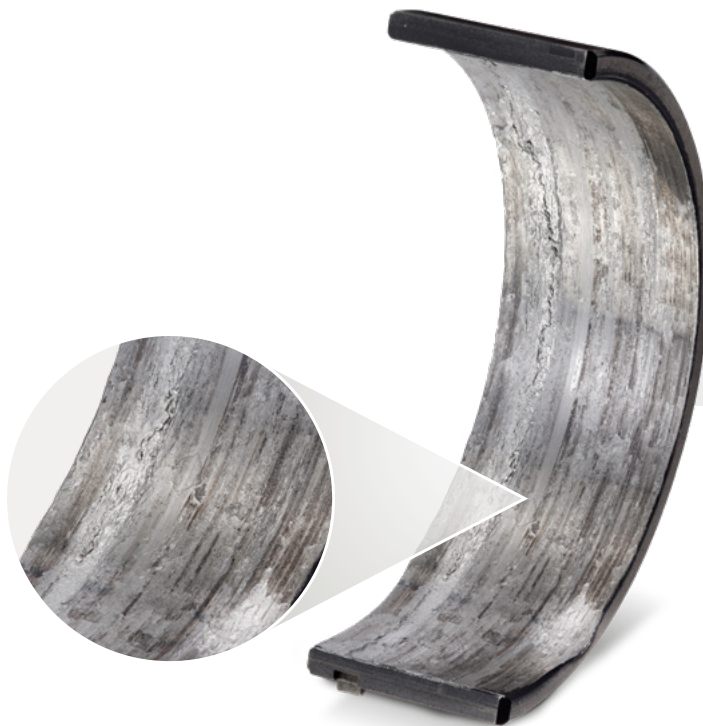
**Lower main bearing shell  
steel-aluminium composite**

High temperatures in the area of high mixed friction cause localised welding between the journal and bearing. These welded areas break up again, whereby the bearing material – which is softer compared to the crankshaft – is torn off. An acute lack of lubricant is the cause here. The temperature development caused by this causes overheating damage – a common side effect of bearing seizure.

- The lubrication gap is too small, meaning that a stable lubrication film cannot be formed – cause: form and geometry deviations of the shaft or journal, or bending of the crankshaft

- Blocked oil filter
- Defective oil pump
- Leak in the oil lines
- Overstressing of the bearings: the strain is higher than the bearing is designed for – causes are chip tuning or piston seizure, for example

Seizure is amongst the most serious types of bearing damage. The bearing is destroyed and has to be replaced. If use of the bearing is continued, other engine components may be damaged.

- Check that all of the oil bores are free and that there is no blockage
- Check the actual bearing clearance: if it is not within the tolerance range, form and geometry errors are often the cause (see chapter: „2.5 Special cases“)
- Check the functioning of the oil filter and always change the oil filter and oil according to the manufacturer's instructions
- Check the oil level and oil pressure and readjust if necessary
- Check the oil pump is functioning
- Check the oil lines for any leaks
- Check the stress of individual bearings
- Check the entire bearing set for the embedding of particles or grooves. If present, the influence of particles may have caused the formation of the initial rubbing marks (see chapter: „3. Damage due to the influence of particles“)

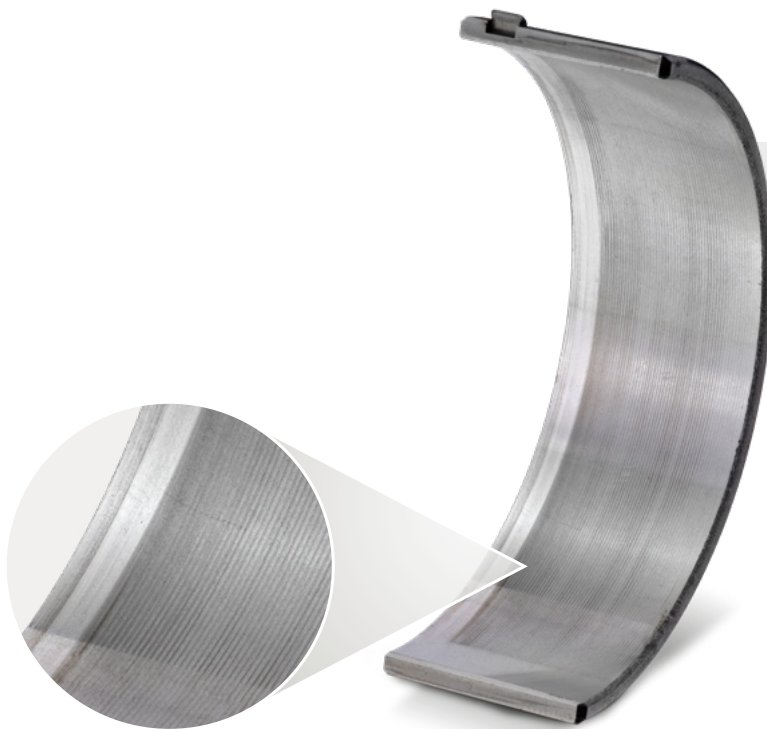
**Lower main bearing shell  
steel-aluminium composite**

- Bright, light stripes of wear on one side at the edge of the bearing
- Identifiable signs of material fatigue or initial rubbing marks possible in the area of the edge wear in severe cases
- Overheating phenomena such as discolouration due to thermal stress or carbon deposits in the area of the edge wear on the bearing back

- Tapered ground journal (Fig. 1)
- Tapered bearing bore (Fig. 2)
- Rounding radius too large on one side (Fig. 3)
- Bending of the crankshaft: during installation, the crankshaft was not balanced or is deformed due to mechanical strain during operation
- Bearing bore which is not aligned due to bolts with the incorrect tightening torque during the assembly of the engine or excessive distortion of the main bearing centre line due to temperature development during operation
- Axial shell misalignment

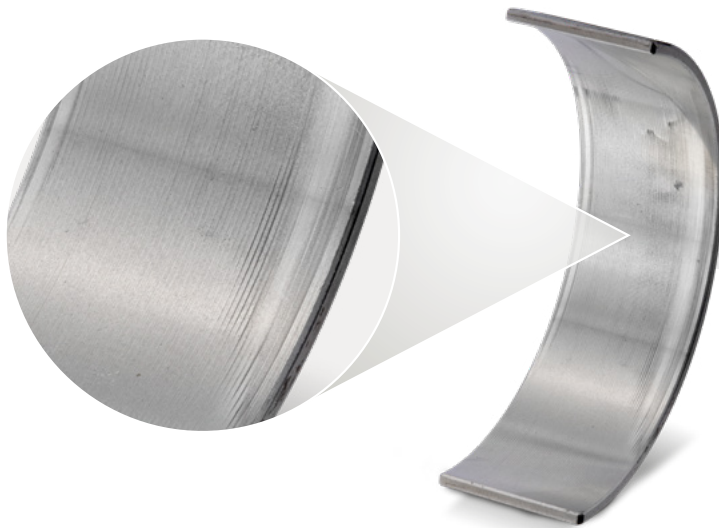
**Cap-side conrod bearing shell  
steel-aluminium composite**

Two-sided edge wear in the early stages – wear in the form of adaptive run-in wear.

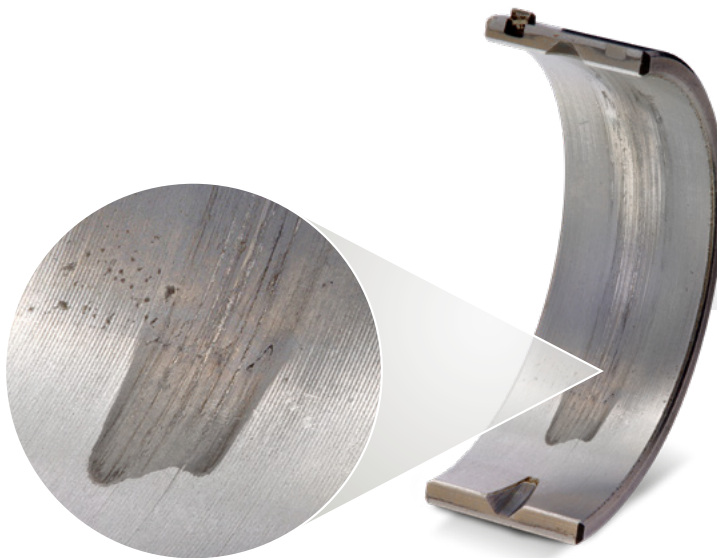
**Lower main bearing shell  
steel-aluminium composite**

Clear wear marks in the centre of the bearing which taper off towards the relief can be identified. They are already noticeable as initial rubbing marks in the sliding layer.

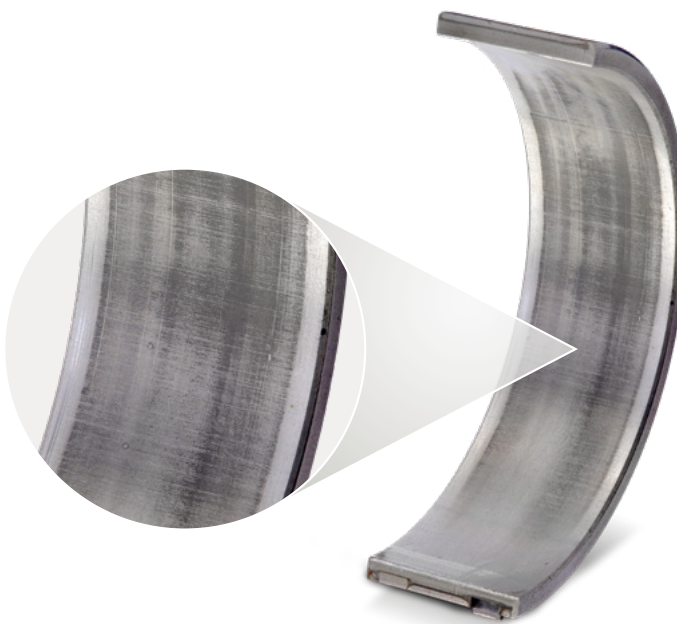
**Lower main bearing shell  
steel-aluminium composite**

Two wear-free strips are recognisable at the edges of the bearings without any visible wear marks. The remaining part of the bearing has a slight black discolouration, possibly due to corrosion or wear.

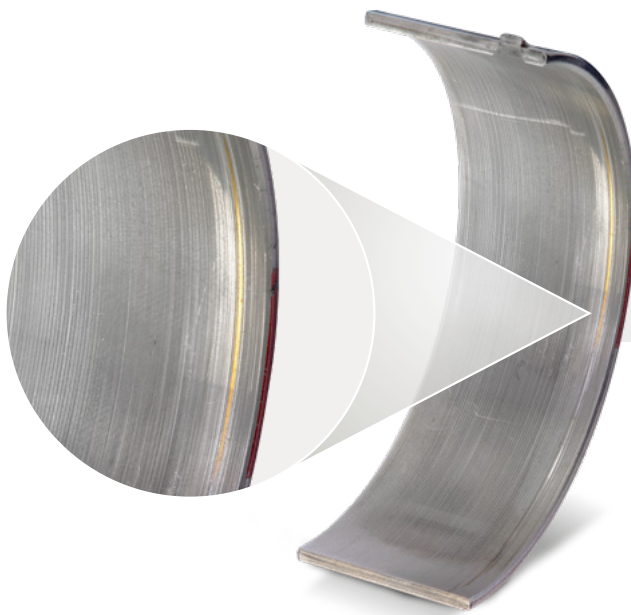
**Rod-side conrod bearing shell  
steel-brass composite with  
sputter coating**

The groove extends up to the brass layer.  
Light wear marks occur next to the scoring  
due to smoothed material accumulation.

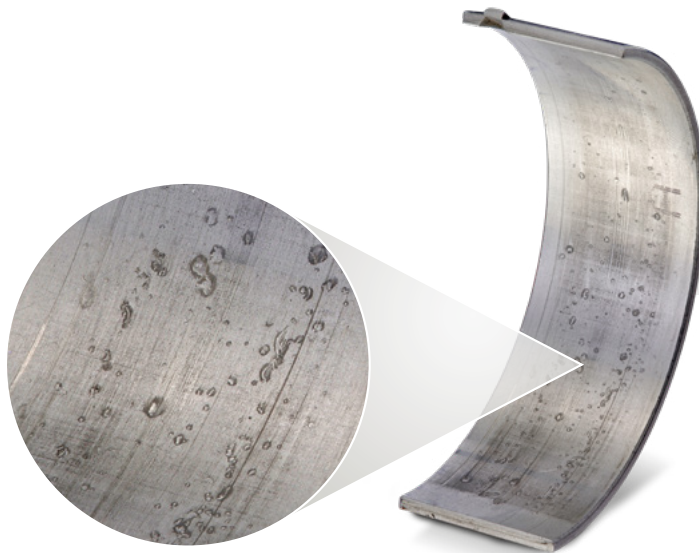
**Cap-side conrod bearing shell  
steel-aluminium composite**

Fine particle imprints and individual scoring marks are visible.

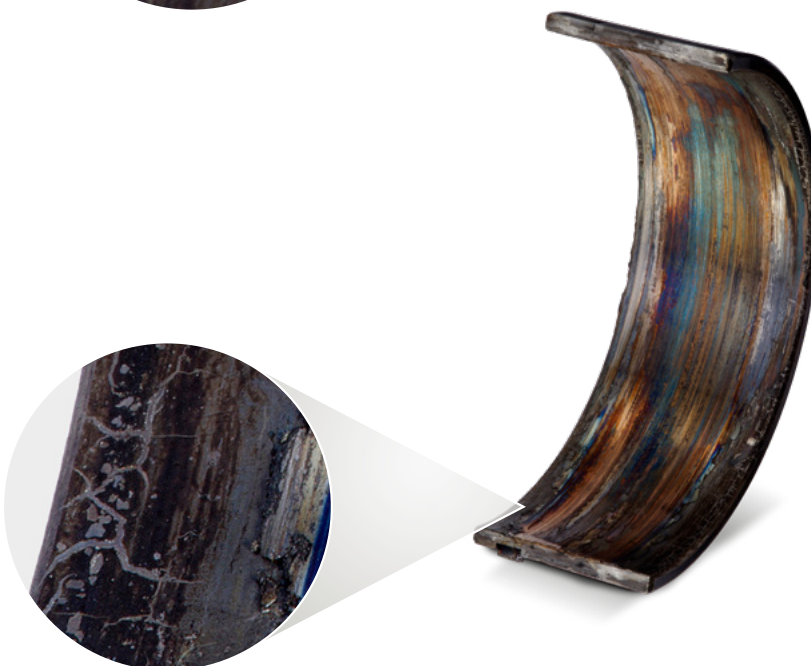
**For possible causes and remedy see chapter „6.1 Introduction“**

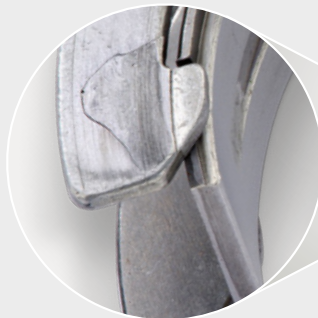
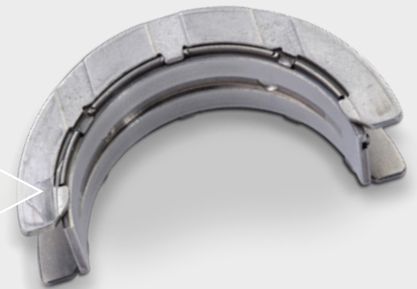
Large-scale material nick at the outer edge of the thrust washer
