SI 1947

SERVICE INFORMATION

INTAKE MANIFOLD SERVO MOTOR:

PROBLEMS AFTER INSTALLATION

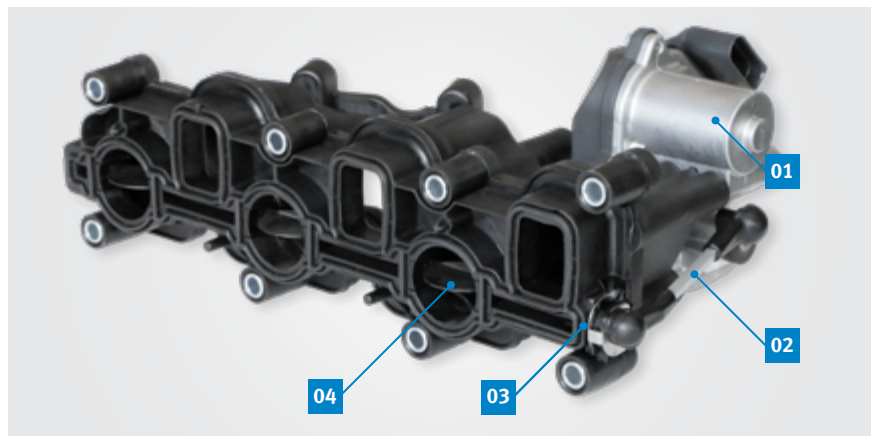
Intake manifold actuator

- Repeated malfunctions following installation of a new servo motor
- Fluctuations in speed and jerking
- Diagnostic trouble codes P1018, P208, P2011, P3135

Flaps are dirty or blocked

If the flaps (04) are carbonised or stuck, or blocked completely, then the mechanical resistance to move them increases.

This may be detected as a fault, but only the actuator is listed as the cause in the fault code memory.

Flap bearing faulty

The bearing positions of the shaft (03) on which the flaps turn may be worn out.

Condition of the link rod

The link rod (02) between the actuator (01) and the adjusting lever of the flaps may be faulty.

The following damage is possible:
Spherical head is worn out; rod has play; rod is bent.

In this case, too, it is only the actuator that is mentioned in the fault code memory.

DO NOT FORGET TEACHING-IN!

When such a component has been replaced, the control unit often has to be informed that a new part has been installed for which the old data no longer applies.

This teaching-in process generally occurs via the applicable program option in the menu of the engine tester. When this function is carried out, the actuator moves to the end stops and the control unit saves this data.

In all of these cases, the only thing that often helps is the additional replacement of the intake manifold.
