SI 0078
For technical personnel only!
1/2

SERVICE INFORMATION

VACUUM PUMP DAMAGE DUE TO INCORRECT ASSIGNMENT

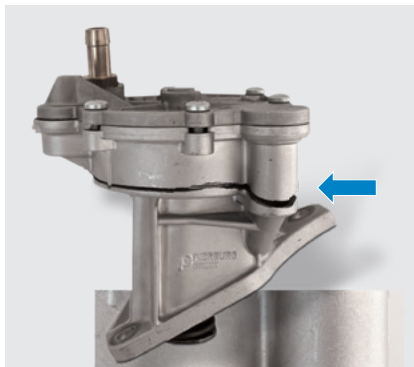
If an incorrect pump has been mounted, this will lead to breakage of the pump housing (see Fig. 1) during the initial engine start following installation, or even to breakage of the camshaft – and therefore to severe and expensive engine damage.

Fig. 1: Breakage in the pump housing

In order to prevent damage, it is essential to check the chassis number, registration date and/or the part number of the old pump!

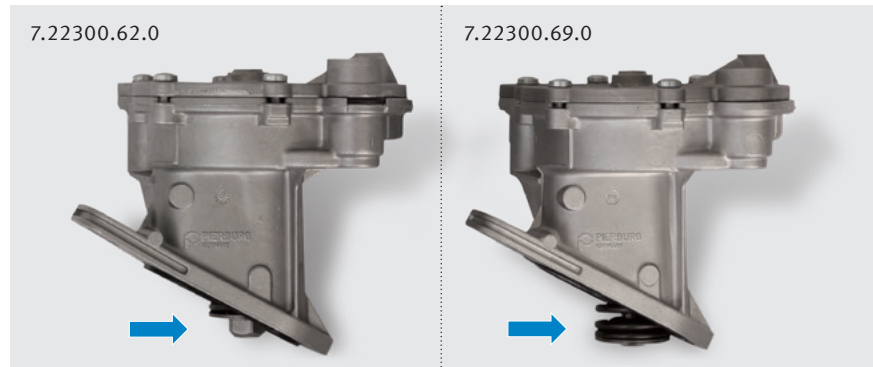
Fig. 2: Comparison of vacuum pumps

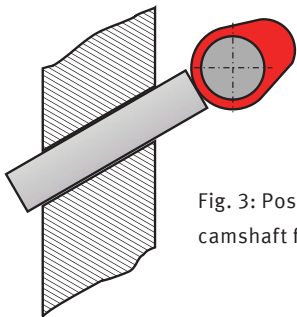
Fig. 3: Position of the camshaft for installation

In order to mount the pump with only a minimal amount of preload (max. 2 mm gap), the cam on the camshaft for driving the vacuum pump must be positioned on the opposite side of the connecting tappet (see Fig. 3) during mounting:

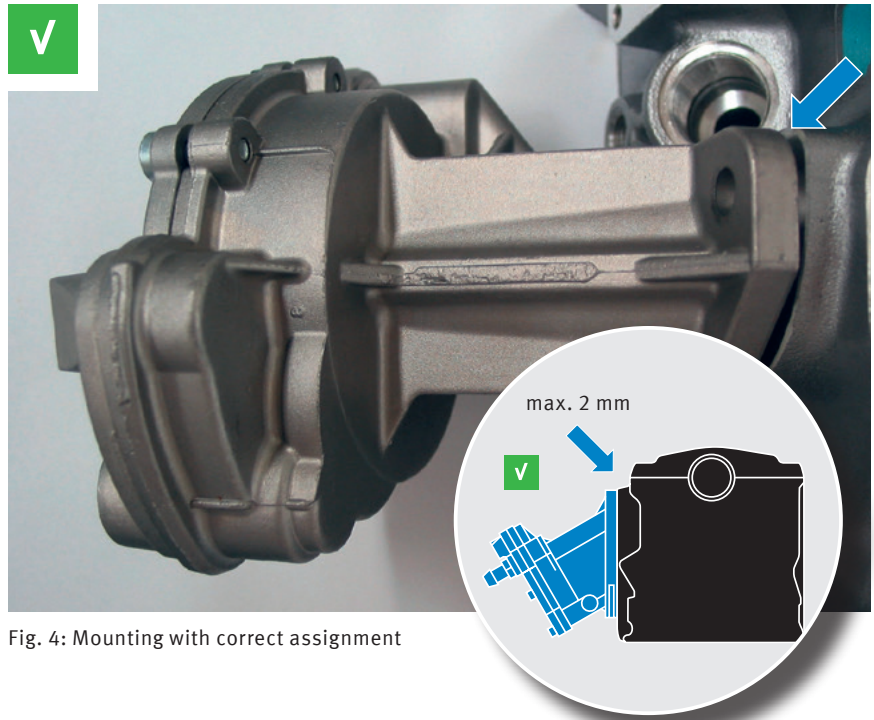
Fig. 4: Mounting with correct assignment

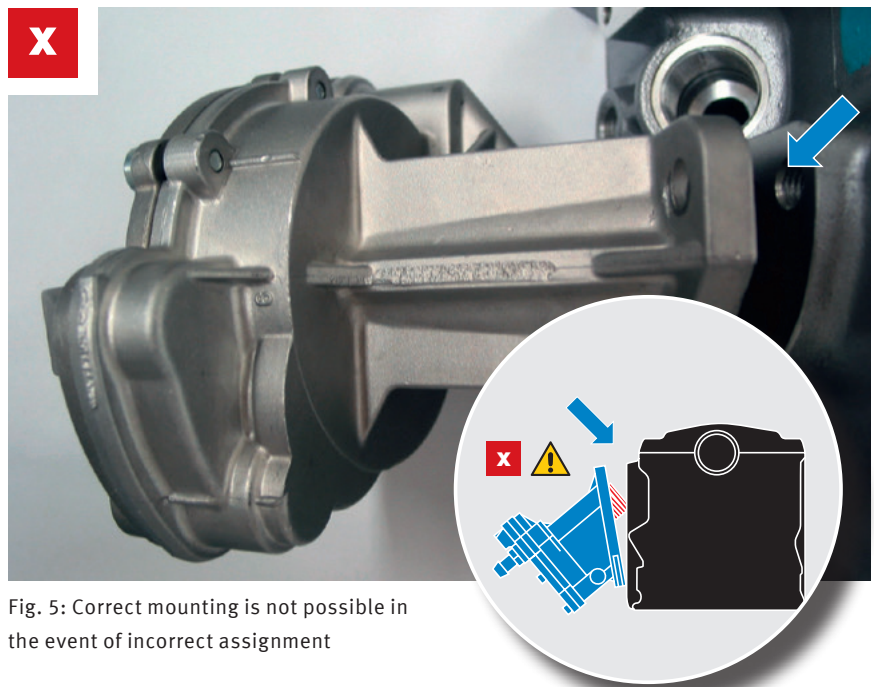
If it is not possible to press the vacuum pump to the flange (approx. 5 mm gap) without great effort, even with the cam on the opposite side of the connecting tappet, an incorrect assignment has very likely taken place.

Fig. 5: Correct mounting is not possible in the event of incorrect assignment

It is essential to check the chassis number, registration date and/or the part number of the old pump! Never attempt to solve this problem by modifying the connecting tappet (e.g. regrinding)!
