KNOWLEDGE POOL

PISTON DAMAGE – RECOGNISING AND RECTIFYING

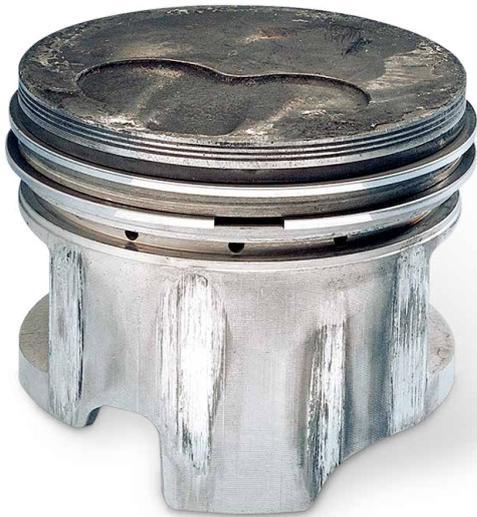
- Several similar areas of seizure marks around the piston skirt.
- Seizure marks on both the pressure and anti-thrust sides of the piston skirt, i.e. seizure marks on opposite sides.
- Surface changes from bright wear marks to smooth, darkly discoloured areas of wear caused by rubbing.
- Undamaged ring zone.

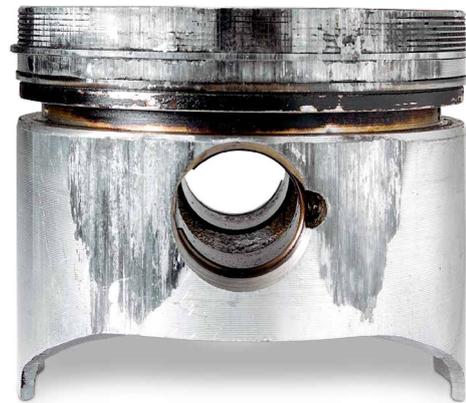
Fig. 1

- Seizure marks on both the pressure and anti-thrust sides, offset at approximately 45° to the piston pin axis.
- The seizure areas change from bright wear marks to relatively smooth, darkly discoloured areas of wear caused by rubbing (Fig. 1).
- Piston pin displays blue tempering colour (Fig. 3). Reason: piston pin bed has become hot due to insufficient clearance or a lack of oil.

- Mechanical overload of the connecting rod bearing, e.g. due to abnormal combustion.
- Malfunction/fracture in the oil injection jet.
- Insufficient or no oil pump pressure.
- Insufficient lubrication when the engine was first taken into operation. The piston pin was not or was insufficiently lubricated when it was assembled.
- Failure of the connecting rod bush (piston pin seizure) due to insufficient clearance or lubrication.
- Installation fault during the process of shrinking the piston pin (shrink-fit connecting rod).

During the shrinking process, care must be taken to ensure that, immediately after the piston pin has been inserted, the piston pin bed is not checked for freedom of movement by tilting the piston back and forth. The temperatures are equalized between the two components immediately after the cool piston pin is inserted into the hot connecting rod. The heat introduction increases the thermal expansion of the piston pin as is the case during engine operation. If the bed is moved in this state, it can cause initial rubbing marks or seizure marks. This may cause stiffness or failure of the piston pin bed during engine operation. For this reason, allow the assembled components to cool down before checking the freedom of movement.

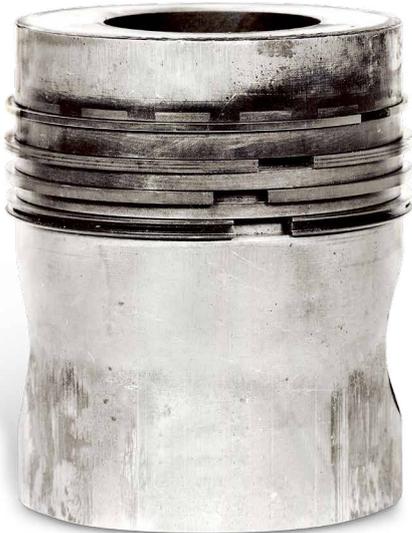
Fig. 1

- Seizure due to insufficient clearance at the bottom skirt ends, with wear marks and counter-wear marks.
- The marks change from bright wear marks to smooth, darkly discoloured areas of wear caused by rubbing (Fig. 1).
- There is nothing unusual about any of the remaining parts of the piston.
- Seizure marks in the cylinder liner in the area around the lower O-rings (Fig. 2).

The piston seizure at the bottom edge of the piston skirt was caused by distortion/restricted clearances in the lower area of the cylinder liner.

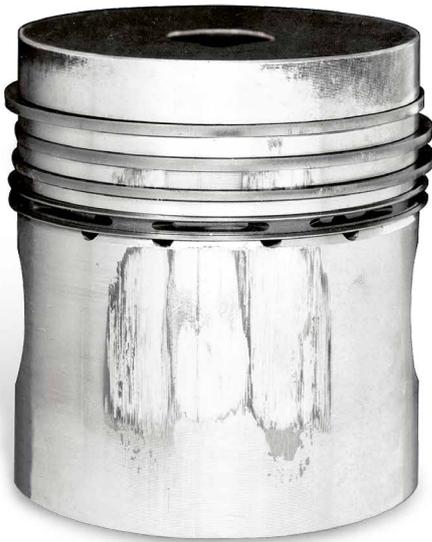
- Seizure marks on the piston skirt on the pressure side, which in some cases extend into the piston ring zone.
- Slight seizure marks on the anti-thrust side.
- Surface of the seizure areas is light-coloured and has an almost pure metallic finish.

There was an acute lack of lubricant between the piston and the cylinder bore. The fact that the surface of the seizure areas has an almost pure metallic finish indicates that the oil film was present but significantly weakened at the time of the seizure. Due to the limited extent of the damage, this concerns a temporary lack of oil or the early stages of damage. The damage would have been even more severe if engine had been operated further.

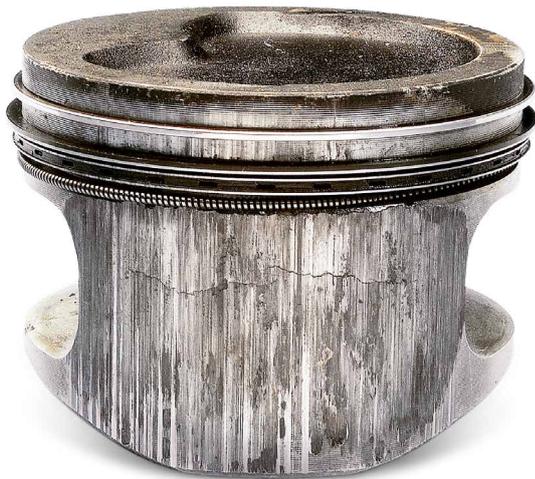
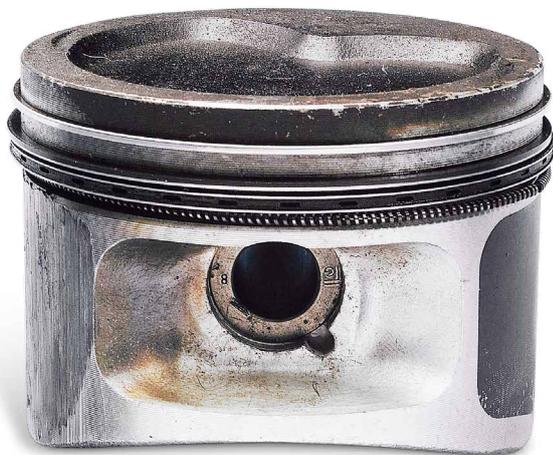
- Severe, darkly discoloured seizure areas with a heavily worn surface on the pressure side of the piston.
- Opposite side of the piston skirt free of damage.
- Piston ring zone usually undamaged in the early stages.

This is a typical example of seizure due to lack of lubrication. It usually occurs on the pressure side and is less common on the anti-thrust side. This damage is caused when the lubricating film breaks down on only one half of the cylinder. It is caused either by a lack of lubrication within a locally confined area or by the affected side of the cylinder overheating. Lack of clearance can be excluded as the potential cause here as, despite the severity of the seizure marks, there are no wear marks on the opposing counter-side.

- Partial collapse of the cooling mechanism due to lack of coolant, air bubbles, dirt deposits or other malfunctions in the cooling circuit.
- On ribbed cylinders, dirt deposits on the outside can lead to localised overheating and, consequently, a breakdown of the oil film.
- On air-cooled engines: defective, missing or incorrectly installed air baffles.
- Failure of the oil injection jet for cooling the piston.
- Insufficient oil pressure: insufficient lubrication on the cylinder pressure side for connecting rods with oil injection jets.
- Insufficient lubrication on the cylinder pressure side (which is subjected to greater loads) as a result of oil dilution or oil grades that are not suited to the intended purpose.

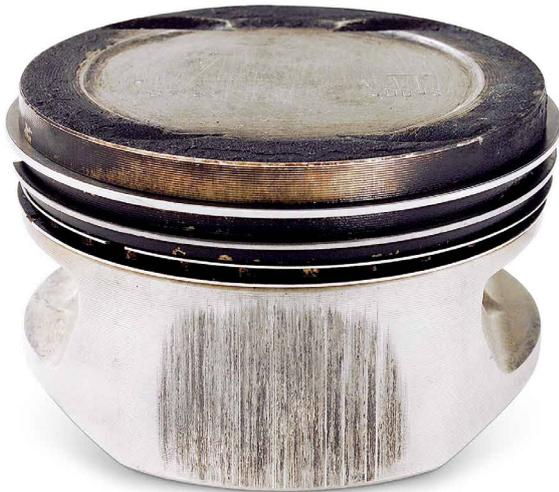
- Narrow, sharply defined longitudinal friction marks on the piston skirt instead of the normal piston wear pattern.

- Overrich engine operation and abnormal combustion caused by faults in the mixture preparation or in the ignition system.
- Insufficient compression and, as a result, incomplete combustion.
- Coldstart device defective or operated for too long (carburettor engines).
- Oil dilution caused by frequent shortdistance driving or an overly rich mixture.

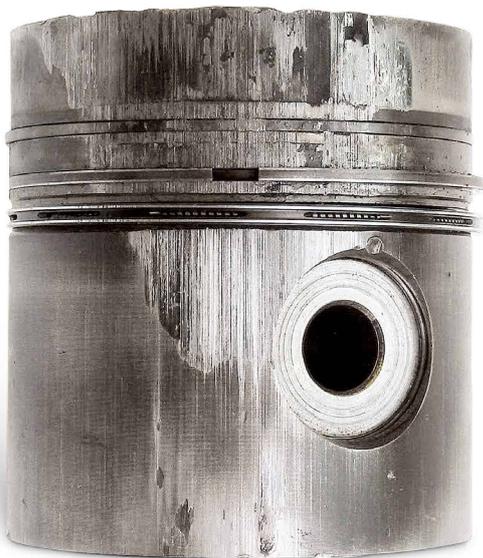
- Localised seizures that mainly occur on the piston top land.
- Surface of the seizure areas is rough and worn, in some cases larger pieces of material have been torn out.

Due to a fault on the injection nozzle, non-atomised fuel was able to reach the cylinder wall, where it weakened the oil film to the point where the piston was running dry without any lubrication at all. As a result, the piston top land seized so severely that it was temporarily welded to the cylinder wall. This caused chunks to be torn from the piston head.

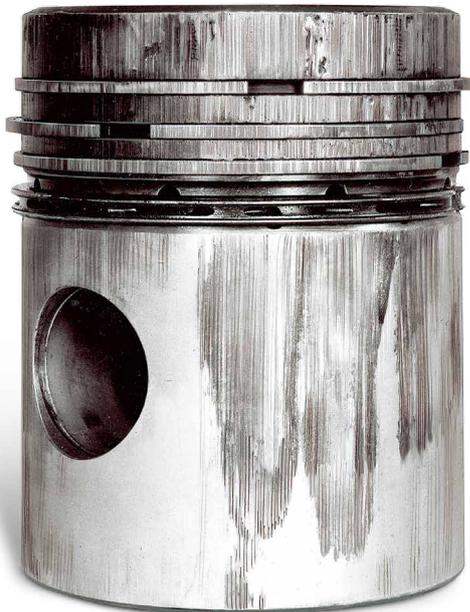
- Severe seizure starting from the piston head and lessening as it progresses towards the skirt end.
- Seizure marks are distributed around the entire circumference of the piston head.
- Surface of the seizure areas has a dark discolouration with severe scoring marks, and has broken up in places.
- Piston ring running surfaces show signs of seizure, which decrease in intensity towards the oil control ring.

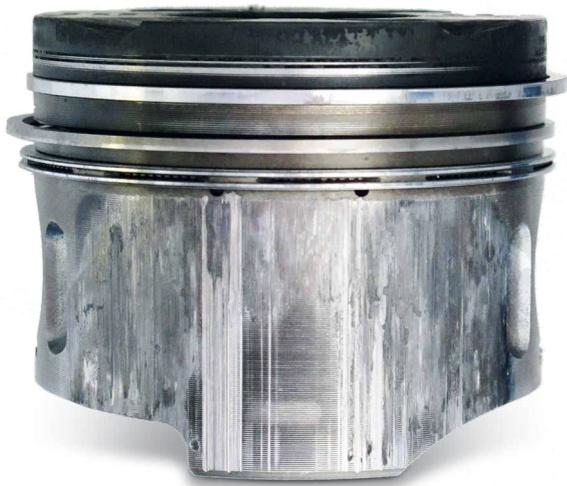
- The piston skirt has seized on both sides.
- The surface of the seizure marks has a dark discolouration and is rough and severely broken up.
- The piston ring zone is often only slightly damaged or not damaged at all.

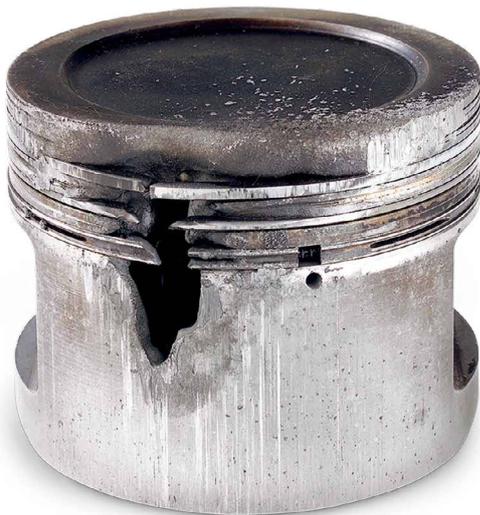
- The piston head has melted through behind the piston rings.
- The piston skirt has not seized; melted material has been worn away off the damaged area onto the piston skirt.

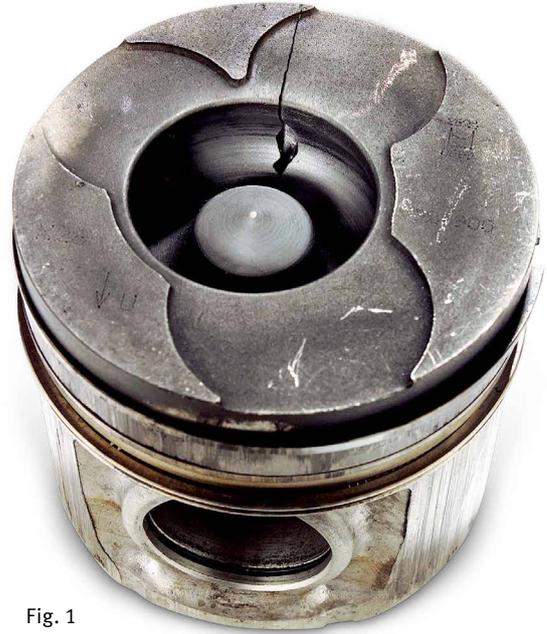
Fig. 1

- Stress cracks on the edge of the bowl.
- Major crack extends to the piston pin boss.
- Channel burned from the bowl to below the oil control ring by combustion gases streaming through the major crack.

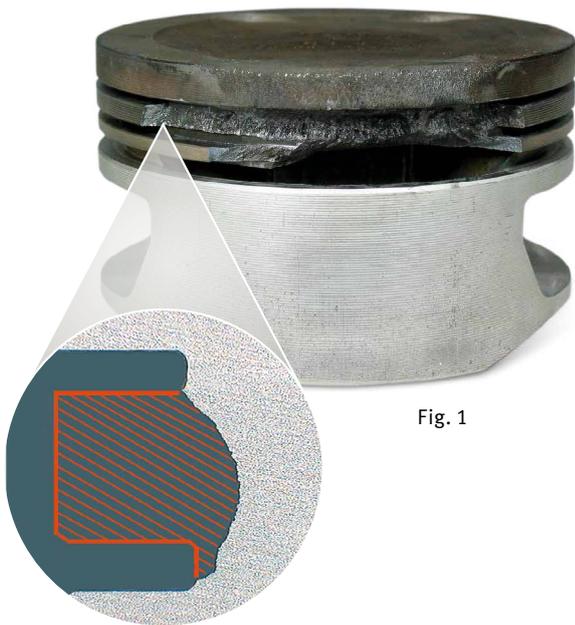
Fig. 1

- Ring land fracture on one side of the piston between the first and second compression ring (Fig. 1).
- Fracture, starting at the groove base at the top and running at a diagonal angle into the piston material, emerging at the groove base underneath (Fig. 2).
- Fracture is extended downwards.
- No piston seizure marks or signs of overheating.

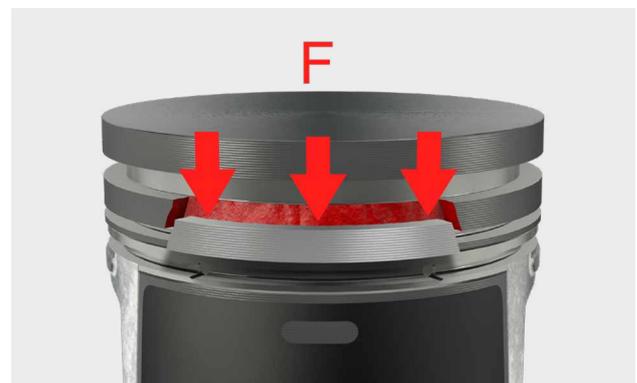
Fig. 3 shows the course of a fracture that occurs with knocking combustion and hydraulic locks: the force causing the fracture and acting from above on the ring land causes the fracture surfaces to extend downwards.

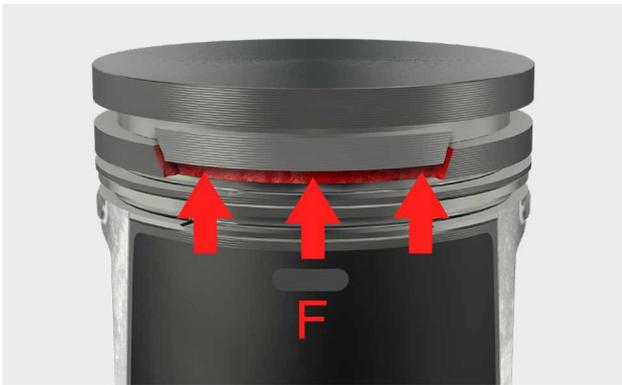
Fig. 4

If the piston rings are incorrectly compressed, more force is required when installing the piston. Forcibly pressing in or knocking in the piston causes pre-damage to the ring lands in the form of fine hairline cracks. The ring lands fracture in the reverse direction as the pressure comes from below in this case (Fig. 4).

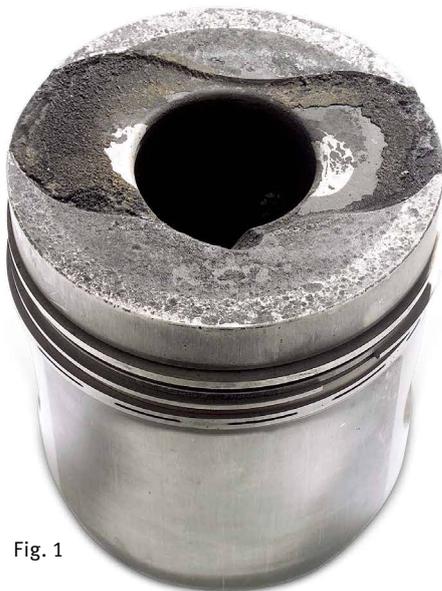
Fig. 1

- Severe impact marks on the piston head (Fig. 1). Nearly all oil carbon deposits removed.
- Scarring and oil carbon deposits pressed into the piston crown.
- Severe wear on the piston rings, particularly on the oil control ring.
- Imprint of the swirl chamber on the front edge of the piston crown (Fig. 2).
- Imprint of the valve on the right-hand side of the crown.
- First indicators of initial dry running damage due to lack of lubrication on the piston skirt (Fig. 4).

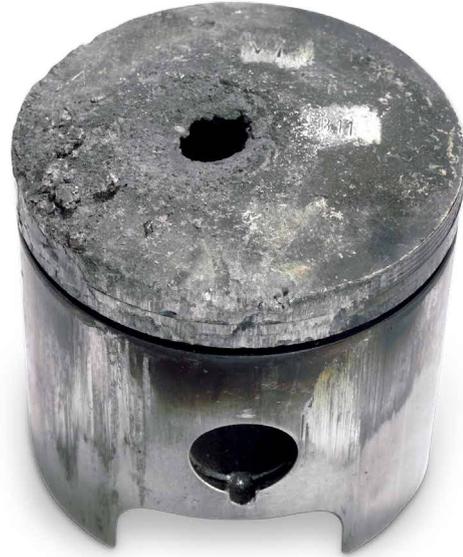
- Piston crown has a hole that penetrates all the way through, covered by the molten material.
- Skirt area displays seizure marks. Reason: the high temperatures and the piston material that has been ground down.

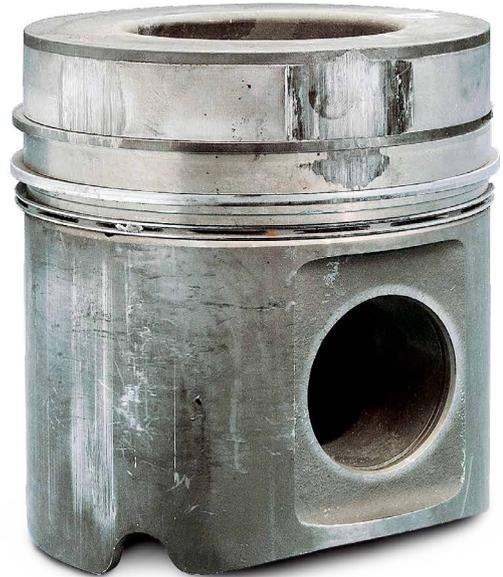
- Localised score marks can be seen on the piston head, going all around the circumference of the piston.
- Score marks start at the piston crown and end at the second compression ring.
- Score marks are centred around the piston top land.

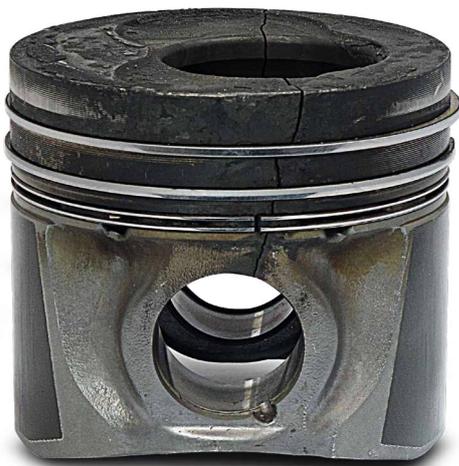
Fig. 1

- Formation of a cleavage fracture that leads to the piston crown. This results in the piston being split into two parts (Fig. 1).
- Boss fatigue crack in the centre axis of the piston pin bore (Fig. 2 and 3).

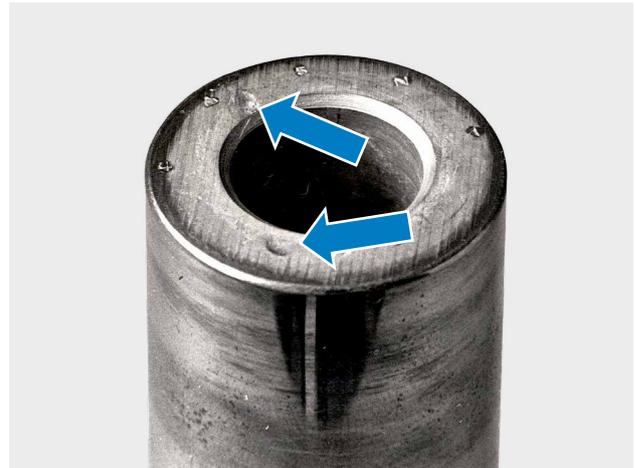
Fig. 2 shows that an incipient crack may not only be caused by overstressing, but also as a result of improper installation of the piston pin. The end face of the broken piston pin clearly shows that the incipient crack was caused by impact damage (hammer blow). An incipient crack can lead to breakage of the piston pin, even under normal load conditions.

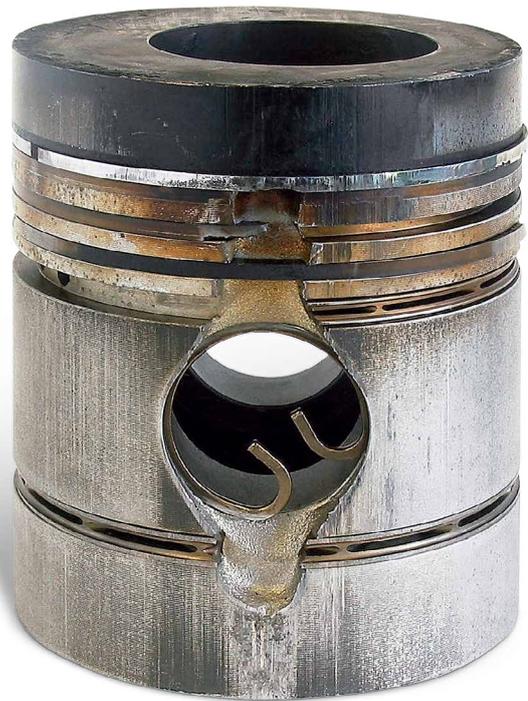
Fig. 1

- End of the piston pin bore on both sides of the piston suffered serious damage, in some places as far as the ring zone (Fig. 1).
- Circlip jumped out of the retaining groove and broke into fragments.
- Second circlip damaged.
- Due to the lack of retention, the piston pin has wandered outwards towards the cylinder running surface.
- Front face of the piston pin worn to a convex shape due to prolonged contact with the cylinder running surface (Fig. 2).
- Asymmetrical running pattern of the piston.

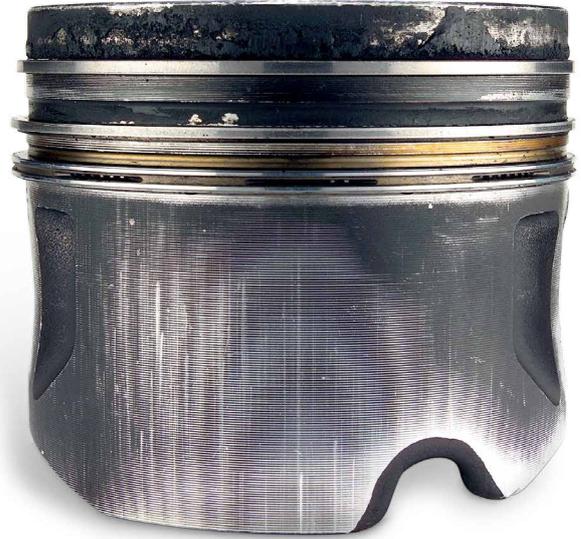
Fig. 4

- Asymmetrical piston wear pattern (Fig. 4).
- Piston pin boss and piston pin broken (Fig. 5 and 6).
- Pin bore hammered out in the area of the circlips.

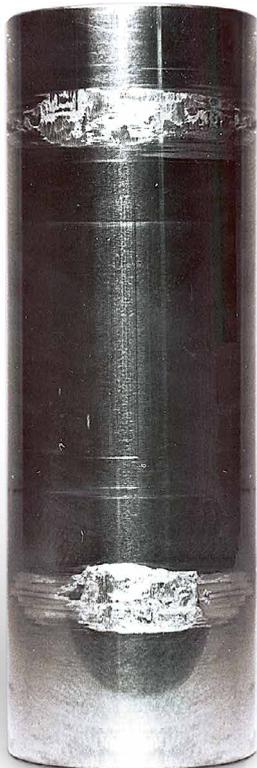
Fig. 1

- Piston pin has seized in the piston pin bores.
- Piston material has been welded onto the piston pin (Fig. 1).
- Piston pin displays a blue discolouration in the area of the connecting rod bush.

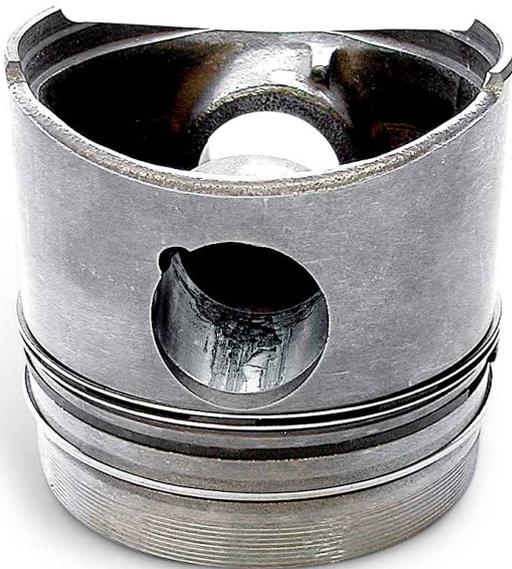
Fig. 1

- Piston has only run for a short length of time.
- No wear marks on the piston skirt.
- The piston pin bosses have seized on the upper side, i.e. the side under pressure load (Fig. 1).
- The surface at the seizures is clean bare metal; no traces of burned-in oil.

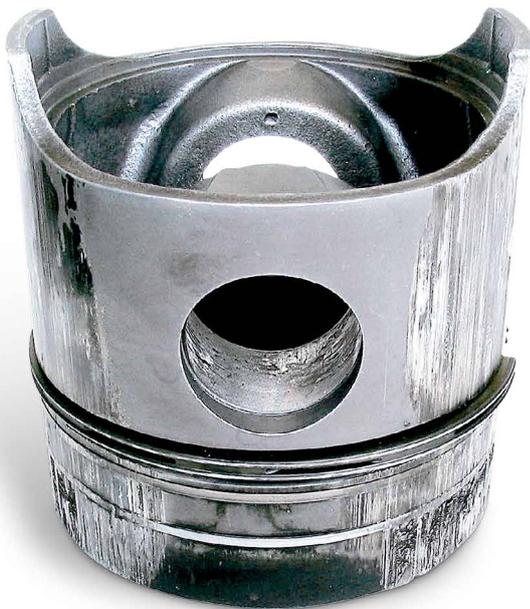
- Piston skirt has seized on both sides, starting at the piston head.
- Compression rings have become blocked in the ring grooves.
- Seizure marks are present in the piston pin bosses.

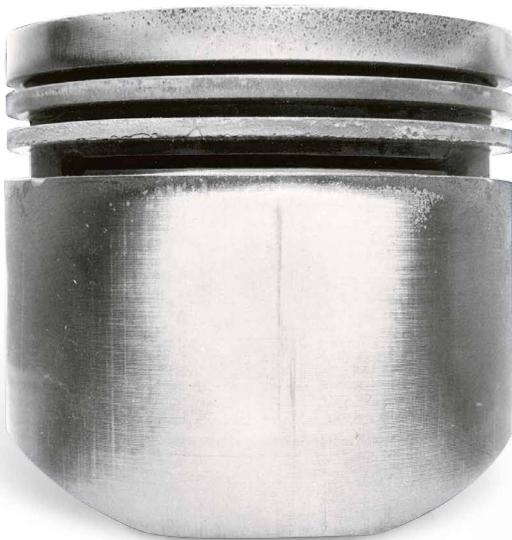
Fig. 1

- Piston top land has impact marks in the tilting direction (Fig. 1).
- The piston skirt displays a more pronounced running pattern to the top and bottom than in the middle of the skirt.

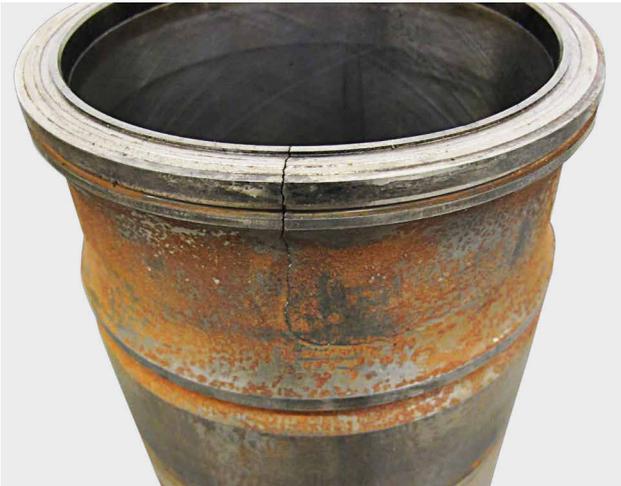
- Vertical crack, extending from the liner flange.
- Dry cylinder liners can also be affected because of their relatively thin cylinder wall thickness.

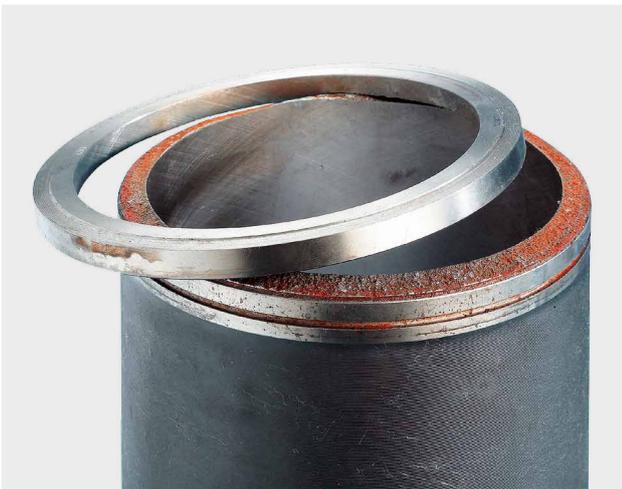
Fig. 1

- Liner flange has been torn off.
- The flange crack starts at the base of the bottom edge of the liner flange and extends upwards at an angle of approx. 30°.

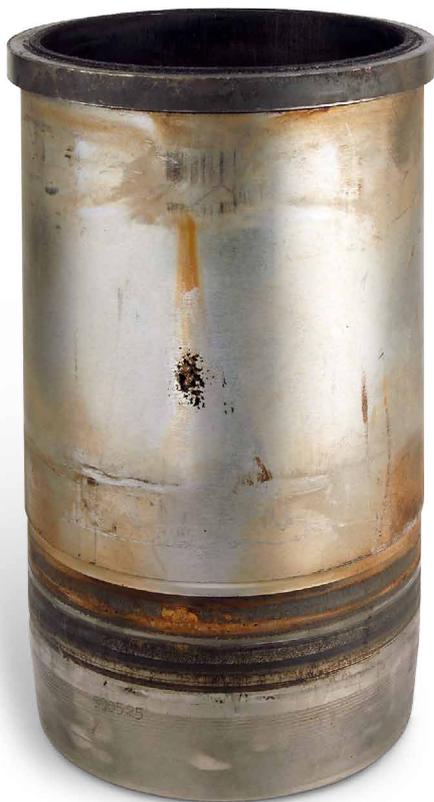
Fig. 1

- Severe cavitation on the water jacket of the wet cylinder liner (Fig. 1 and 2).
- Coolant has penetrated through into the combustion chamber.

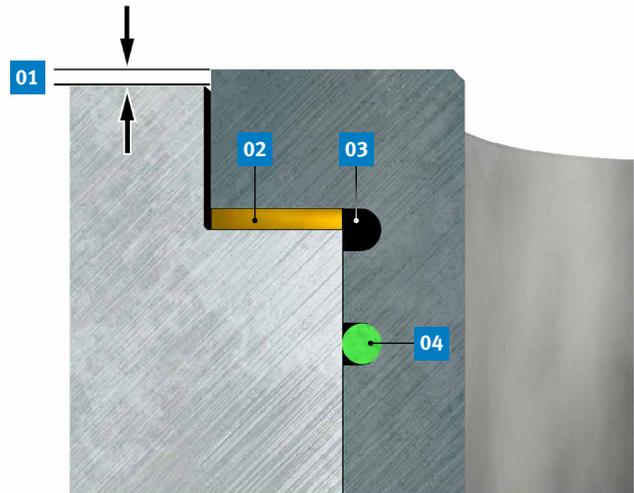
Fig. 4

- Installation of additional sealing rings in the undercut on the liner flange (Fig. 4): sealing rings may only be installed at this position if they are specifically required by the manufacturer.

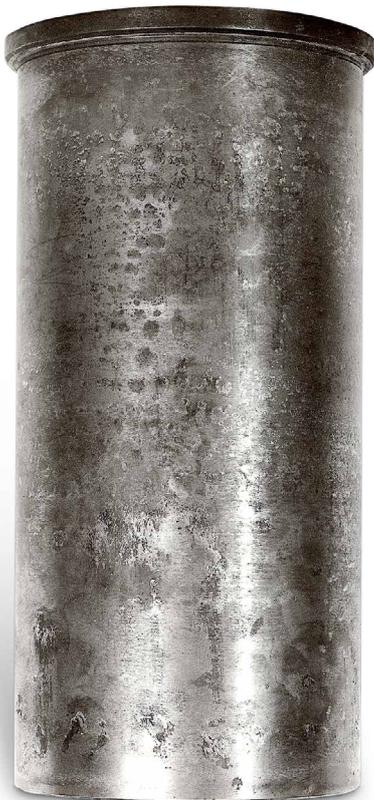
Fig. 1

- Corrosion on the outside diameter of the cylinder liner (Fig. 1).
- Uneven wear pattern with individual bright areas on the cylinder surface (Fig. 2).
- Piston undamaged.
- Oil loss at the sealing points, in particular the radial oil seals.

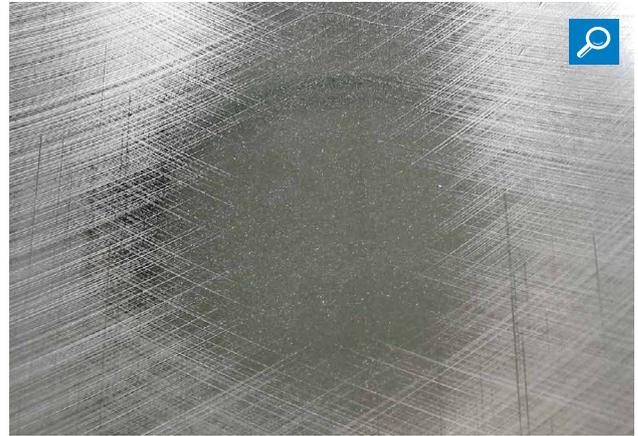
Fig. 2

- Bright, bare areas with no honing structure on cylinder sliding surface (Fig. 1 and 2).
- No signs of wear on the piston.
- Oil carbon deposits on the piston top land.
- Increased oil consumption.

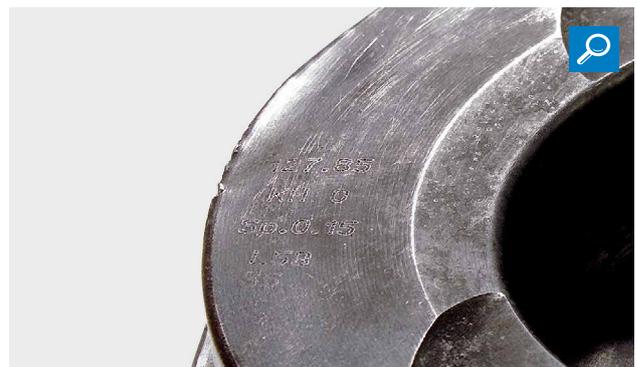
Fig. 4

- Upper area of cylinder liner displays severe damage due to a crack and seizure marks on the sliding surface (Fig. 2 and 3).
- Piston displays seizure marks on the pressure and anti-thrust sides.
- In the piston crown: bowl-shaped recess in the area of the seizure marks (Fig. 4).

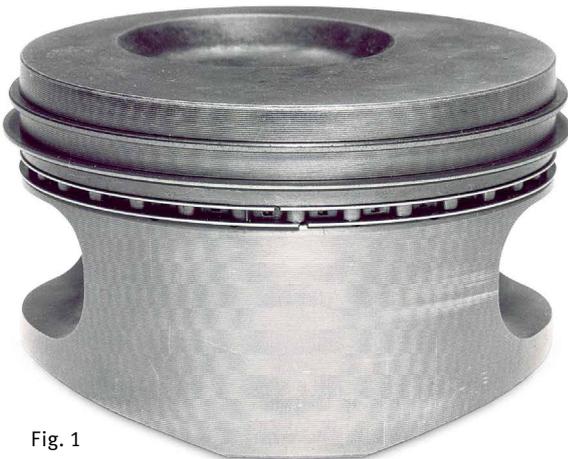
Fig. 1

- No signs of wear on piston rings or piston (Fig. 1).
- End of the expander spring of the 3-piece oil control ring broken off.
- Scratches in the groove base of the oil control ring.

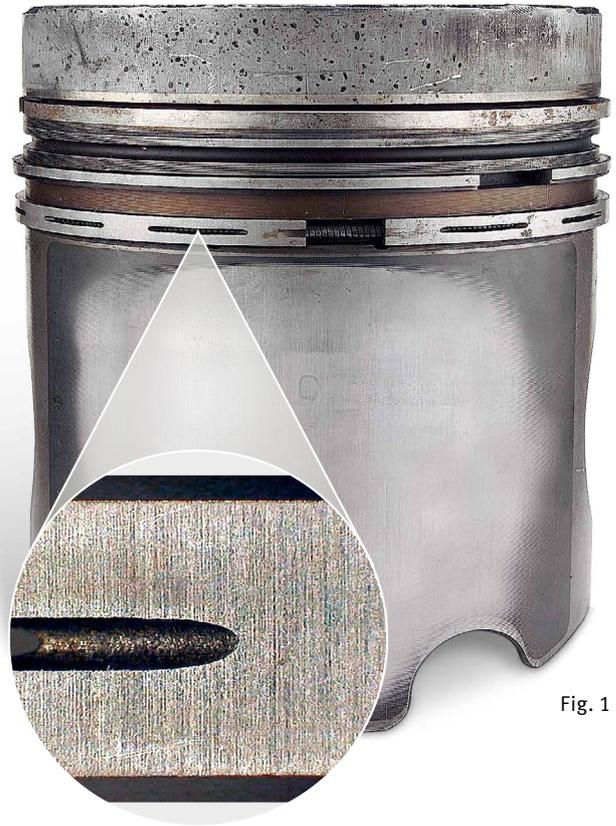
Fig. 1

- Severe signs of wear on the piston top land and piston skirt.
- Friction marks on the piston skirt, characteristic of dry running due to fuel flooding.
- Piston rings display severe radial wear (Fig. 1). Both webs (support surfaces) on the oil control ring have been worn down (Fig. 2). By way of comparison in Fig. 3: profile of a new and worn oil control ring (double-bevelled spiral expander ring).
- Increased oil consumption.

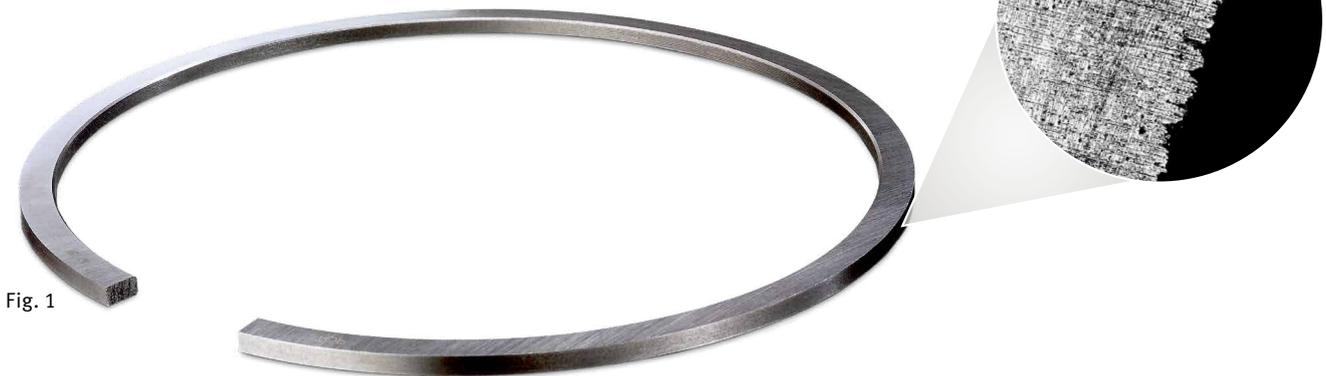
- No damage or wear on piston.
- Superficial inspection of piston rings reveals no wear marks, however, closer inspection reveals abnormal wear on the oil-scraping ring edges, mostly on the bottom ring edges (see magnified image).
- Tangible burr on the bottom edge of the piston ring running surface.

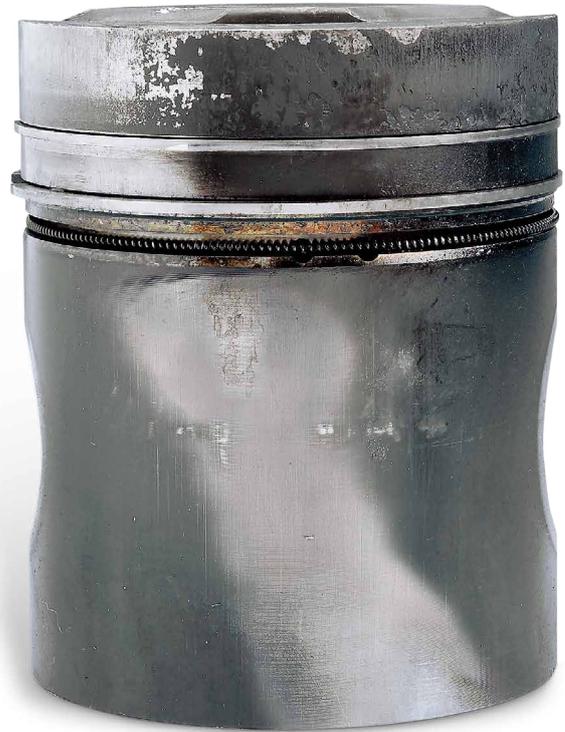
Fig. 1

- Piston running skew, with the wear mainly on the lower, right-hand edge of the piston at the recess for the cooling-oil nozzle and under the piston pin bore.
