**SI 1066**  
For technical personnel only!  
1/1

# SERVICE INFORMATION

## RATTLING NOISES

### DUE TO OIL SLUDGE IN THE VACUUM PUMP

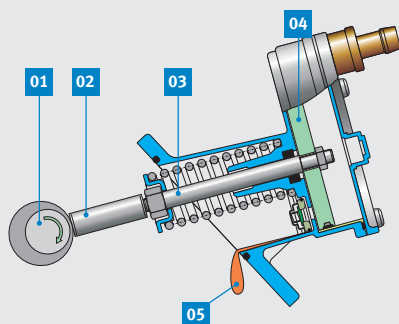
Fig. 1:

The piston vacuum pump is driven by the camshaft (01) through a connecting tappet (02). In the recommended installation position, the engine oil can flow back into the engine (Fig. 1). The installation position in the VW Transporter is as shown in Fig. 2.

Recommended installation position

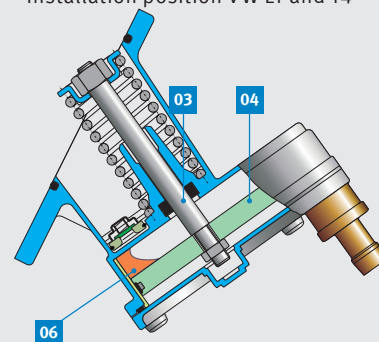
Fig. 2:

Installation position VW LT and T4

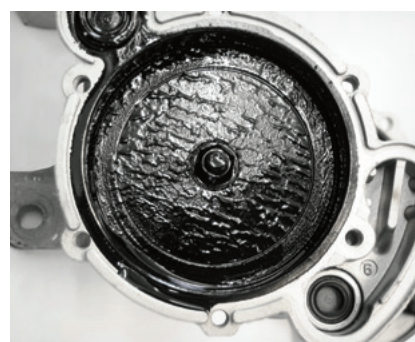
If oil is not changed regularly, the engine oil ages. Oil sludge with viscous consistency builds up between piston crown and housing. This prevents the piston from reaching its end position. There is leeway between tappet and connecting tappet. This results in rattling noises, which sound like bearing damage on the crankshaft.

- Intervals for changing oil not adhered to
- Insufficient quality of engine oil
- Soot formation due to unclean combustion
- Faulty exhaust gas recirculation

Fig. 3: Oil sludge in the vacuum pump of the VW Transporter results in rattling noises

In case of oil sludge deposits the vacuum pump must be replaced. It cannot be cleaned, as the vacuum pump cannot be opened with ordinary tools and there are no spare parts.
