SI 0088
For technical personnel only!
1/1

SERVICE INFORMATION

VACUUM PUMP DAMAGE

INSUFFICIENT LUBRICATION DUE TO INCORRECT ASSEMBLY

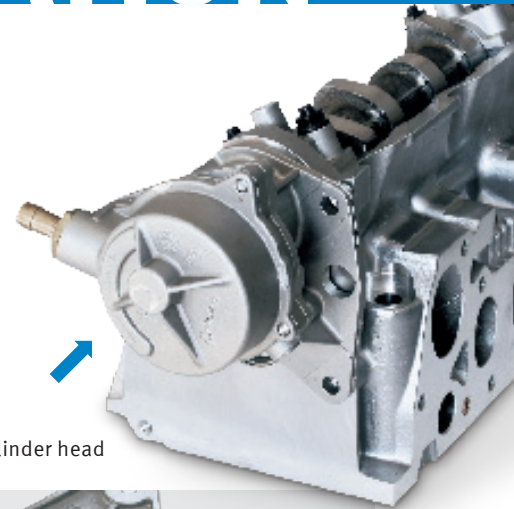
Vacuum pump
fitted to the cylinder head

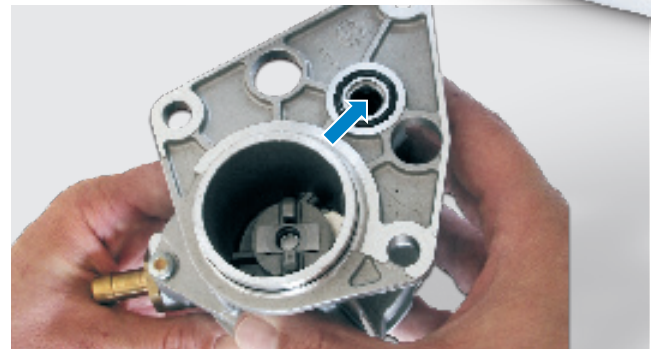
When replacing the cylinder head within the scope of an engine repair, the closure screw was not removed which seals off the opening of the lubricating oil supply to the vacuum pump.

Important: proper lubricating oil supply to the vacuum pump

If this is not done, the vacuum pump will suffer a total failure due to insufficient lubrication already when being operated for a short period of time.

In the case of vacuum pumps which are driven by the camshaft, this closure screw must be removed from the cylinder head.
