Damage to vacuum pumps through incorrect assignment

Vehicle	Product: Vacuum pump	
	PIERBURG No.	O.E. No.*
VW Transporter LT, T4 (pickup, window van, panel van, California) Engine code: AAB	7.22300.62.0	075 145 100 ; 075 145 101; 075 145 101 A
	7.22300.69.0	074 145 100 A

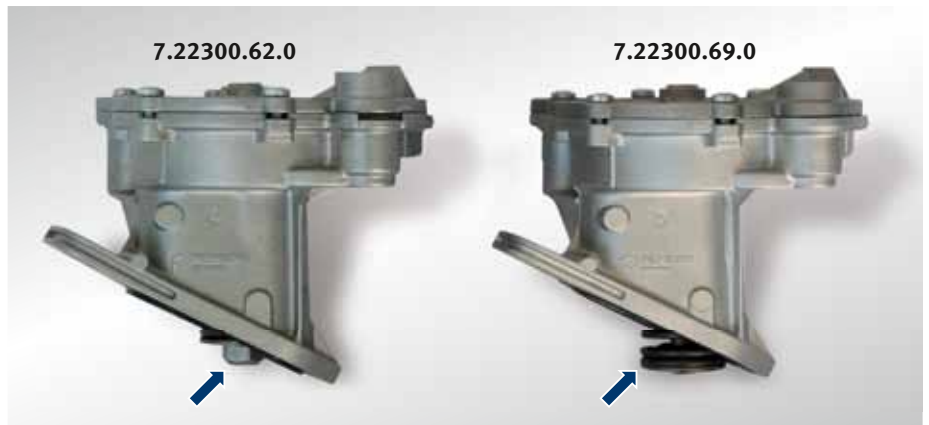
Fig. 2: Vacuum pump comparison

7.22300.62.0	7.22300.69.0
Replacement for	7.22300.12.0	7.22300.19.0
Year of manufacture	to 5/1994	from 5/1994
Vehicle identification number	to 70-R-180 000	from 70-R-180 001
VW part number	075 145 100, 075 145 101 075 145 101 A	074 145 100 A
VW cylinder head No.	074 103 351 A	074 103 351 D
MSI cylinder head No.	50 003 101	50 003 113
Cylinder head cover surface	11 bores; Ø 5mm	no bores
PIERBURG tappet rod number	3.52124.06.0	3.52124.05.0
VW tappet rod number	075 145 307	074 145 307 B
Tappet rod length	71,0 mm	67,5 mm

In order to prevent damage, a precise check of the vehicle data is essential. We recommend to check in any case the assignment through the vehicle identification number!

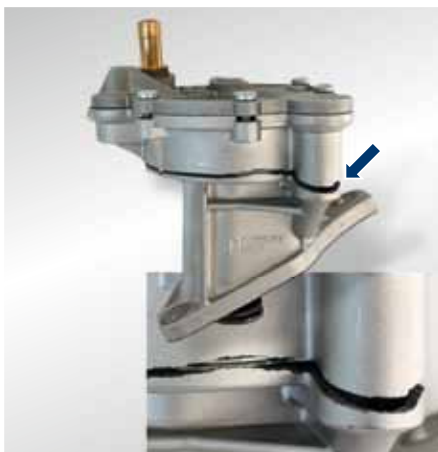
Fig. 1: Broken pump casing

! Mounting the wrong pump will “immediately”, upon starting the engine for the first time after installing the vacuum pump, cause the pump casing (see Fig. 1) to break or even the camshaft may break thereby resulting in severe and expensive engine damage.

- vehicle identification number
- registration date and/or
- part number of the old pump!
