Electric EGR Valves (e.g. Renault, Opel)

Stickiness at the valves

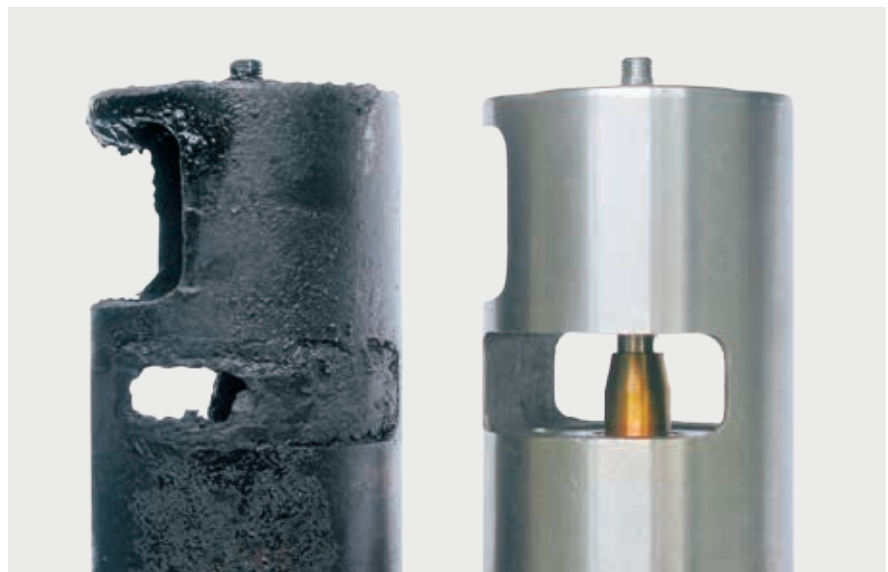
Through checks in the workshop the diagnosis "Malfunctioning EGR valve" was determined. The built-in electrical EGR valves suffer through oil-containing deposits.

- The valve is stiff.
- The valve is stuck and does not open.
- Due to the deposits the opening cross-section is reduced.
- The valve does not close fully.

EGR valve with sticky deposits and EGR valve as new

In the case of the EGR valves mentioned here, the most frequent causes of malfunctions are deposits at the valve disk or the valve seat. The EGR valve must be checked and replaced as required.

We do not recommend cleaning the EGR valve; when doing so, it might be damaged.

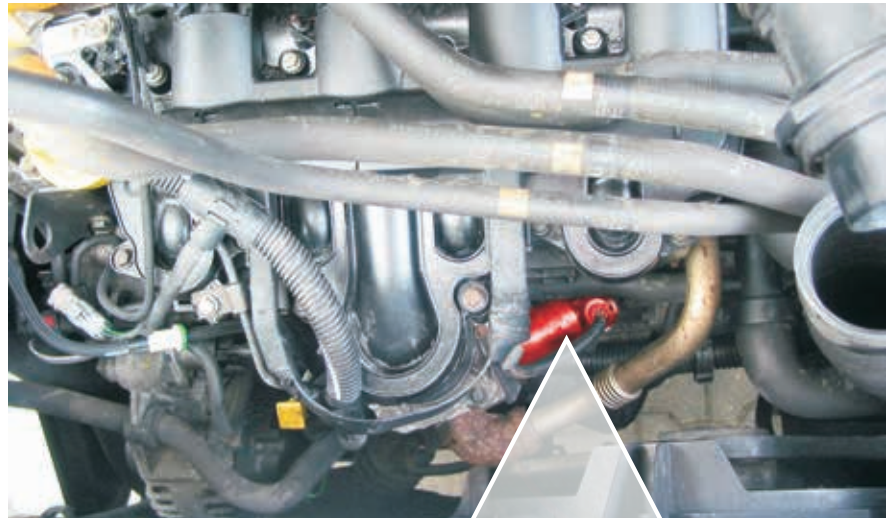
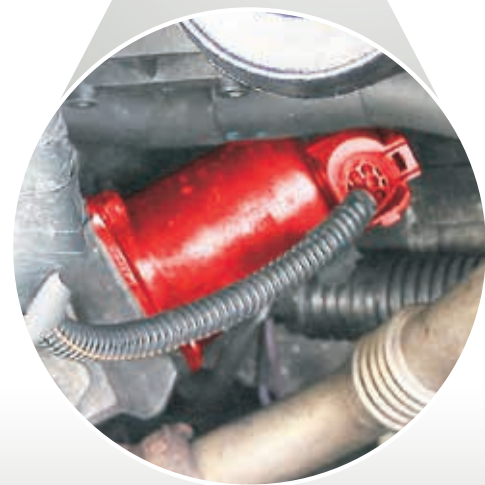
EGR valve in the Renault Master JD1M (highlighted)
