# Intake manifold/electric drive module

## Possible fault cause and replacement

Vehicle	Product	Intake manifold	Electric drive module
Opel Astra H, Vectra C, Signum with 1.9 l CDTi engine (Z19DTH) Zafira B Alfa Romeo: 147, 156, 159, GT (1.9 JTD) Fiat: Stilo (1.9 JTD)	<b>PIERBURG No.</b>	<b>7.00373.12.0</b>	<b>7.00521.14.0</b>
	Replacement for	7.00373.1 0.0/7.01860.00.0	7.00521.00.0/.11.0
	O.E. No.*	58 50 119/93179055	8 50 440/93183260
		58 50 158/55206459	58 50 574/93185801
58 50 180/55210201		8 50 444/55205127

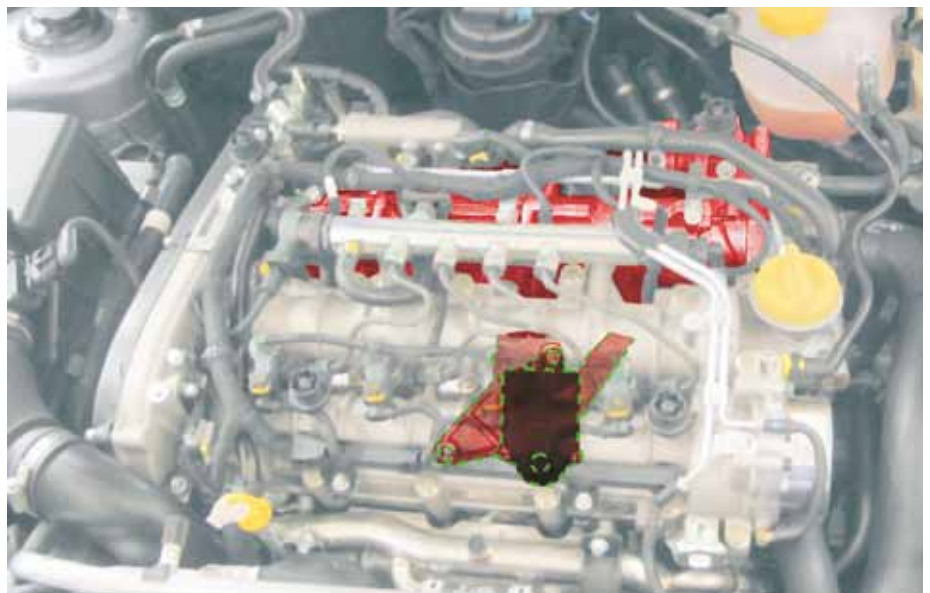
*Engine compartment of the Opel Vectra:  
The intake manifold with the EGR flap is emphasised in red. The drive module is located, not being visible, "behind the engine" and is only hinted (green dashed line).*

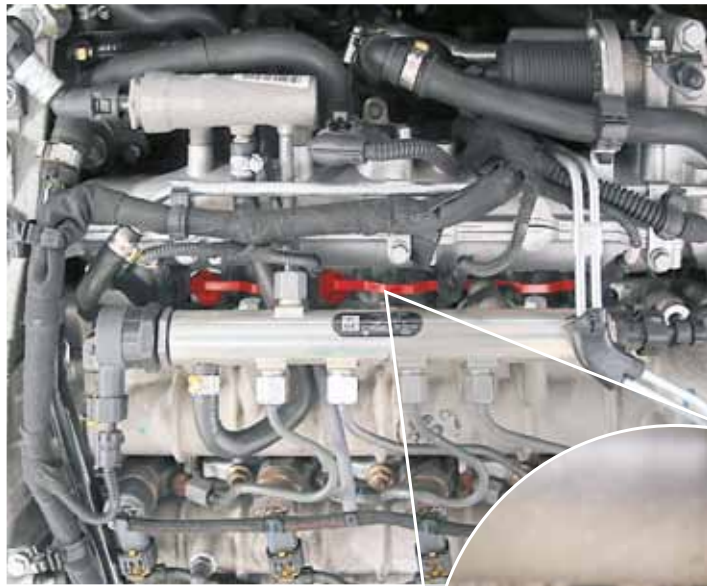
*Lever arrangement at the intake manifold in the Opel Vectra (top emphasised in red and detailed view)*

- Perform an actuator diagnosis (according to manufacturer’s information for the diagnosis unit) of the drive module: if the drive module switches, power supply and drive module are electrically in order.
- Check to ensure that there is a proper link (“lever arrangement”) between the drive module and the tumble flaps.
- Check to ensure that the tumble flaps can move freely. The actuating lever must, after being deflected, return to its initial position within a period of 1 to 2 seconds.
- It must not be possible to move the tumble flaps in the axial direction (see figure).

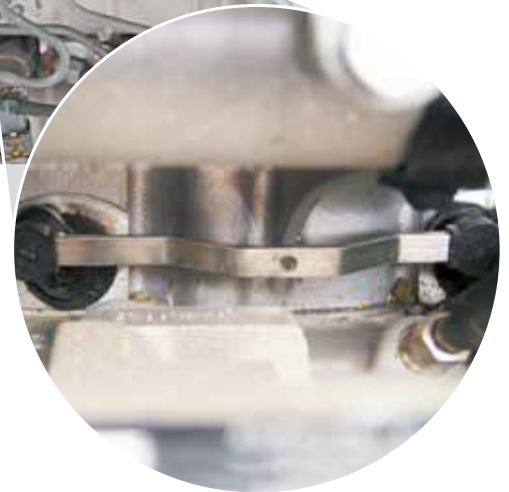
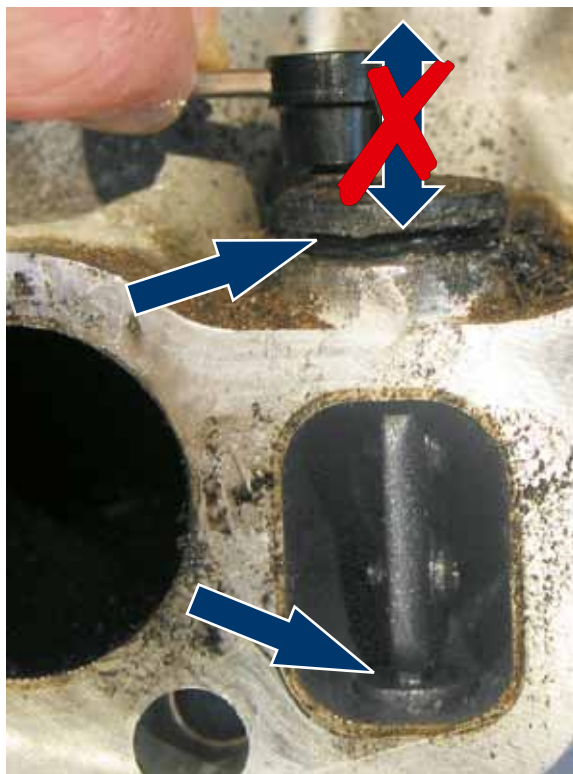
The true fault cause are often worn out, tight tumble flaps in the intake manifold. The drive module can no longer move the tight tumble flaps and indicates an error.

The cause for these malfunctions are often stiff or sticking tumble flaps. Deposits or sticking tumble flaps can be caused by very oily intake or charging air. There are many reasons for this.

*Worn out bearings at the tumble flaps*

For this reason when exchanging the intake manifold, also the electric drive module must be replaced by a new one. The "old" drive module can no longer be used.
