Piston damage – recognising and rectifying

Piston damage – recognising and rectifying!

3.4 | Damage due to abnormal combustion

Ring land fractures

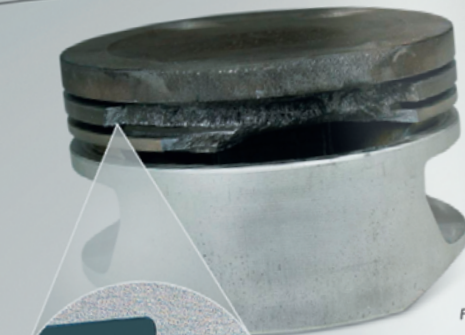
Fig. 1

- Ring land fracture on one side of the piston between the first and second compression ring (Fig. 1).
- Fracture, starting at the groove base at the top and running at a diagonal angle into the piston material, emerging at the groove base underneath (Fig. 2).
- Fracture is extended downwards.
- No piston seizure marks or signs of overheating.

Land fractures are not caused by material faults, but by material overload. A distinction can be made between 3 different causes:

1. Knocking combustion:

The octane rating of the fuel was not capable of covering the engine's needs under all operating and load conditions (refer to the chapter entitled "General information about piston damage due to abnormal combustion in petrol engines").

Ring land fractures caused by knocking combustion usually occur on the pressure side. On a diesel engine, knocking combustion is caused by an ignition delay.

2. Hydraulic locks:

Liquid (water, coolant, oil or fuel) accidentally enters the combustion chamber when the engine is stopped or running. As the liquid is incompressible, the piston and crankshaft drive are subjected to enormous stresses during the compression cycle. This results in ring land fractures, boss fractures or connecting rod/crankshaft damage.

3. Installation faults:

If the piston rings are incorrectly compressed, more force is required when installing the piston. Forcibly pressing in or knocking in the piston causes pre-damage to the ring lands in the form of fine hair-line cracks.

- Fuel without suitable anti-knock properties. The fuel quality must correspond to the compression ratio of the engine, i.e. the octane rating of the fuel must cover the octane requirements of the engine under all operating conditions.
- Petrol contaminated by diesel, which lowers the octane rating of the fuel.
- Excessively high compression ratio caused by excessive machining of the engine block surface and cylinder head mating surface, e.g. for engine reconditioning or tuning purposes.
- Ignition timing too advanced.
- Mixture too lean, resulting in higher combustion temperatures.
- Intake air temperatures too high, caused for example by inadequate ventilation of the engine compartment or incorrect switching of the intake air flap to summer operation (particularly on older carburettor engines).

- Injection nozzles worn or leaks.
- Injection pressure too low.
- Compression pressure too low, e.g. due to incorrect cylinder head or piston protrusion or damaged/worn rings.
- Defective cylinder head or piston.
- Damage to the piston or cylinder head.
- Improper or excessive starting (e.g. starting spray).
- Defective turbocharger.
