Rattling noises due to oil sludge in the vacuum pump

Vehicle	Product	Pierburg no.
VW Transporter LT, T4	Vacuum pump	7.22300.62.0/.69.0

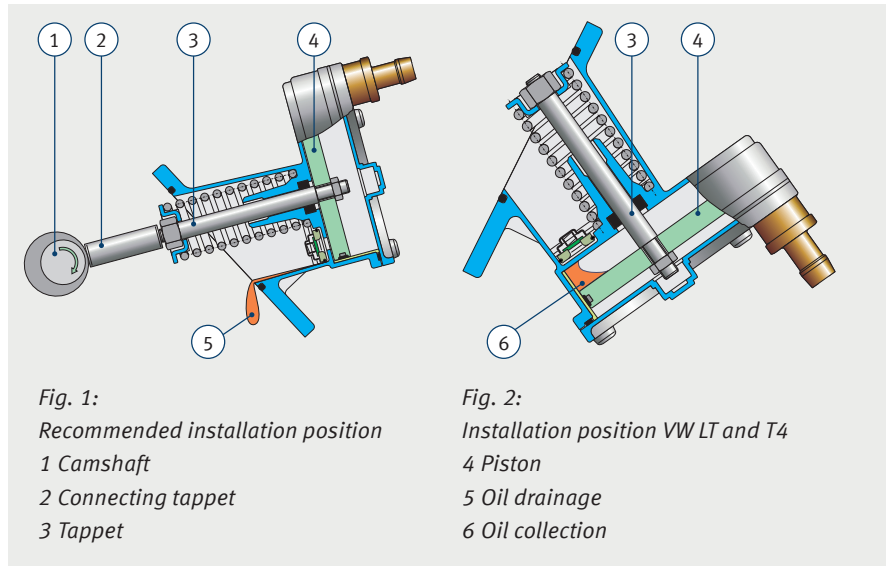
The piston vacuum pump is driven by the camshaft (1) through a connecting tappet (2). In the recommended installation position, the engine oil can flow back into the engine (Fig. 1). The installation position in the VW Transporter is as shown in Fig. 2.

Fig. 1:
Recommended installation position
1 Camshaft
2 Connecting tappet
3 Tappet

Fig. 2:
Installation position VW LT and T4
4 Piston
5 Oil drainage
6 Oil collection
