Turbocharger damage in PSA motors

1.6 HDi (9HX) and 1.6 HDi (9HY/9HZ)

An inadequate supply of oil often damages the turbocharger in 1.6 HDi-motors. This is caused by a high level of soiling to the engine lubricating system, i.e. when soot deposits and metal abrasion are carried there.

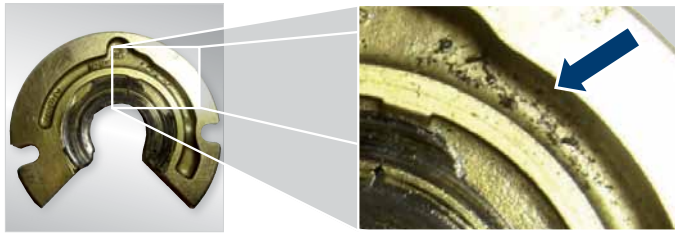
ill. 1: Oil deposits and dirt deposits on the axial bearing

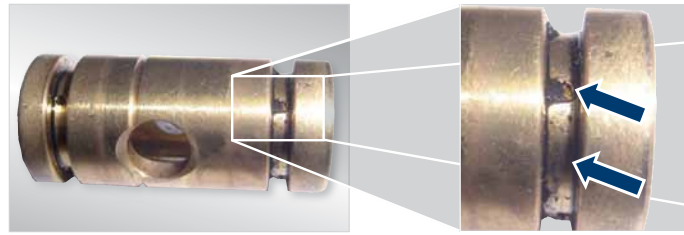
ill. 2: Soot and dirt deposits on the radial bearing

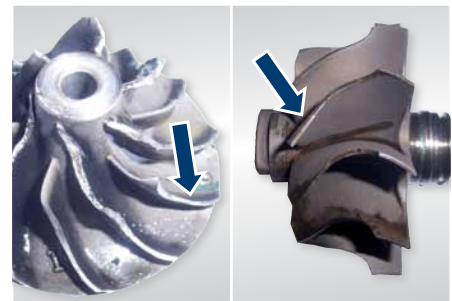
- **Turbine casing and compressor wheel are damaged symmetrically (ill.4).**

Cause: Greatly increased level of bearing clearance leads to friction on the casing of both the compressor impeller and the turbine wheel. High level of wear & tear to the bearing components from impure lubricating oil. In extreme cases, the maximum level of admissible bearing clearance may be exceeded.

ill. 4: Casing of compressor wheel (left) and turbine wheel (right) damaged symmetrically as a result of friction on the casings
