Valve damage and causes

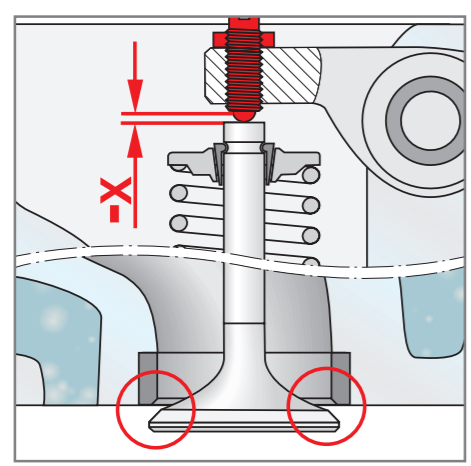
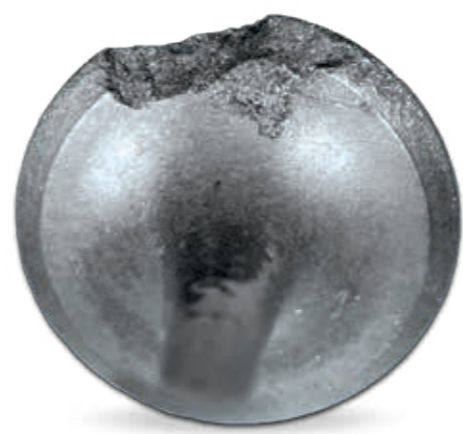
Incorrect valve clearance settings

Cause:
The valve clearance has been set too tight or the maintenance intervals have been exceeded.

Consequence:
The valve no longer closes properly. Combustion gases flow past the valve seat and heat up the valve head. This causes the valve head to overheat and burns through in the seat area.

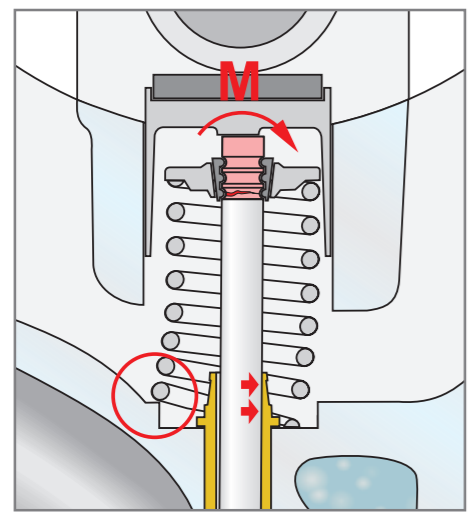
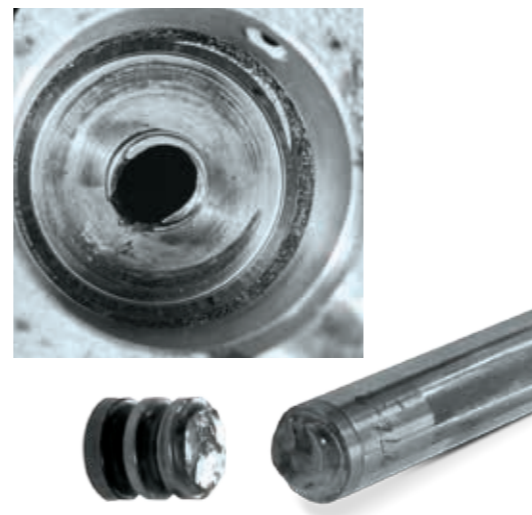
Incorrectly installed valve springs

Cause:
The spring was not inserted correctly during installation. The tilted spring has caused a lateral bending moment (M) on the valve stem.

Consequence:
The resultant alternating bending stress ultimately caused a fracture of the valve stem face and destroyed the valve guide.

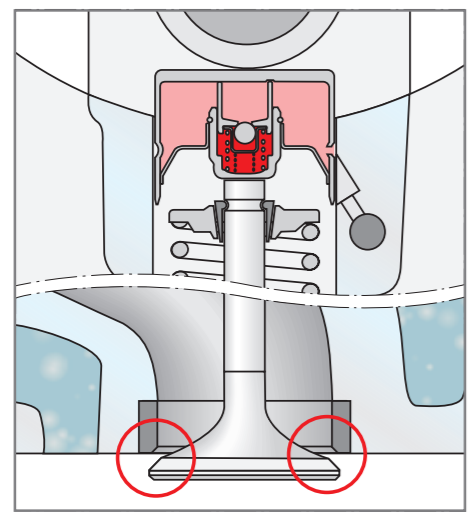
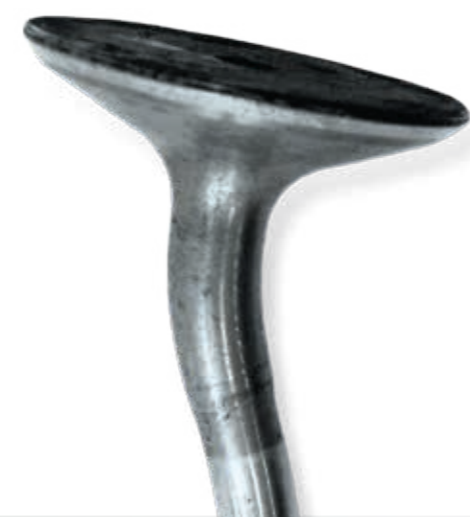
Incorrectly installed hydraulic tappets

Cause:
After installation of the tappets, the minimum required waiting time before starting the engine (at least 30 mins) was not observed. As a result, the excess oil in the working area of the tappets did not have enough time to escape.

Consequence:
If the engine is started prematurely, the valves strike against the piston and can bend or break.

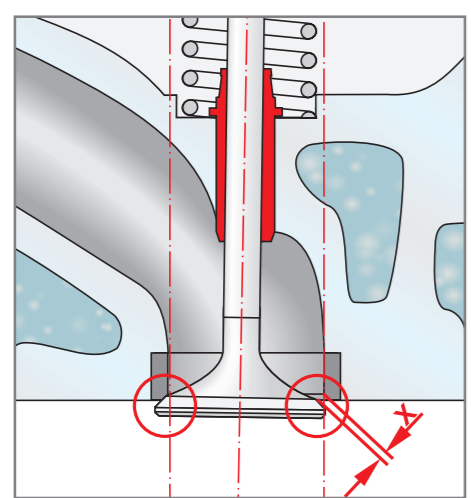
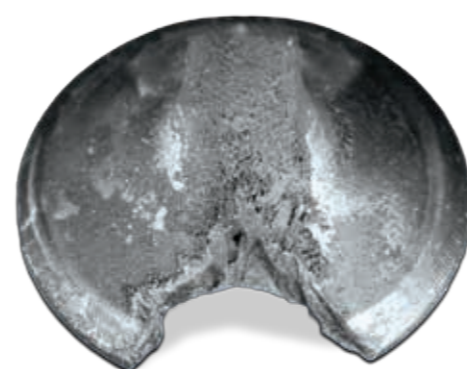
Misalignment at the valve seat insert or valve guide

Cause:
Non-centric remachining of the valve seat or guide.

Consequence:
The valve fails to close properly, overheats and burns through in the seat area. Fatigue fractures in the area of the fillet may also occur as a result of the unilateral stress of the valve head.

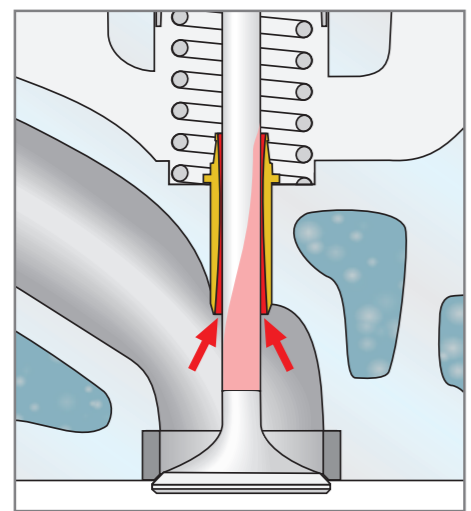
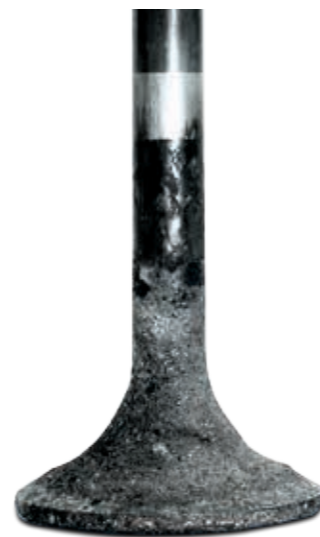
Excessive valve guide clearance

Cause:
The valve guide clearance is too large due to excessive wear of the valve guides or due to excessive reaming during repair.

Consequence:
The influx of hot gases can cause significant carbon deposits in the area of the stem guide. The valve becomes stiff and fails to close properly, with overheating of the seat occurring as a result (burns or shot channels).

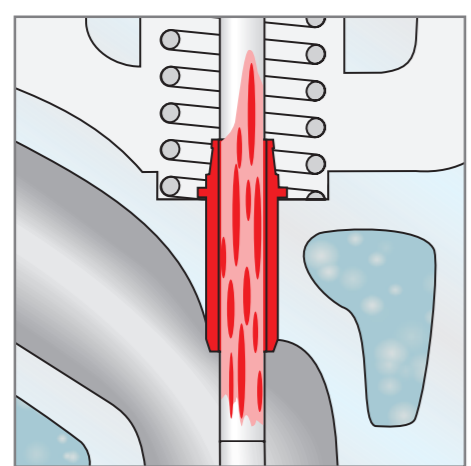
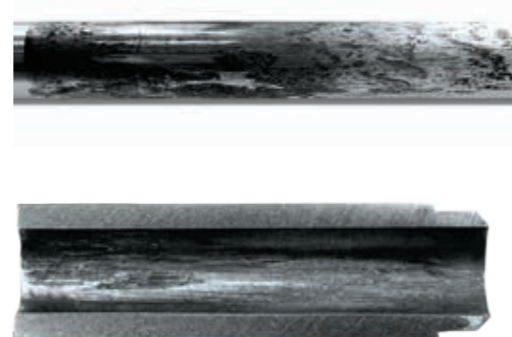
Insufficient valve guide clearance

Cause:
The guide diameter has been dimensioned too small during replacement of the valve guides.

Consequence:
Inadequate lubrication, stiffness and seizures of the valve stem in the guide. Consequential damage such as overheating of the valve head or seat area can occur.

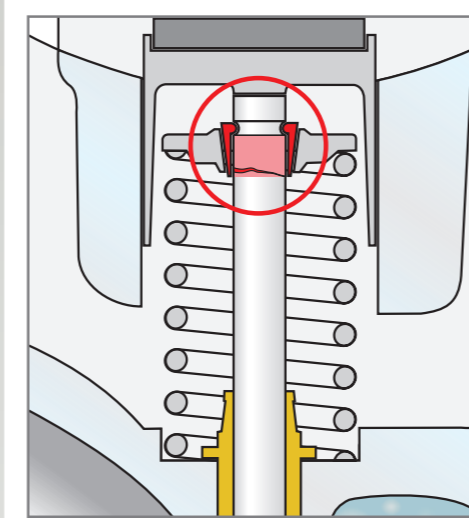
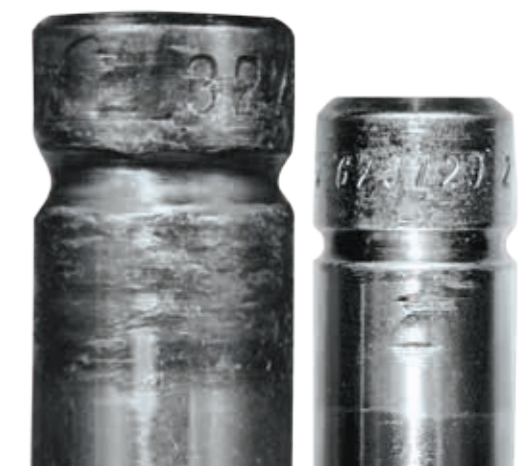
Use of worn valve crotters

Cause:
Old, worn valve crotters were used during replacement of the valves.

Consequence:
If worn valve crotters are reused, the clamping system can become loose during operation. This results in frictional corrosion on the stem and weakening of the valve in this area. This can cause vibration fatigue failure.

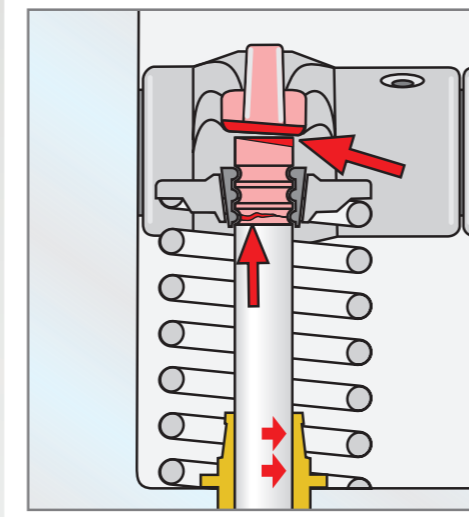
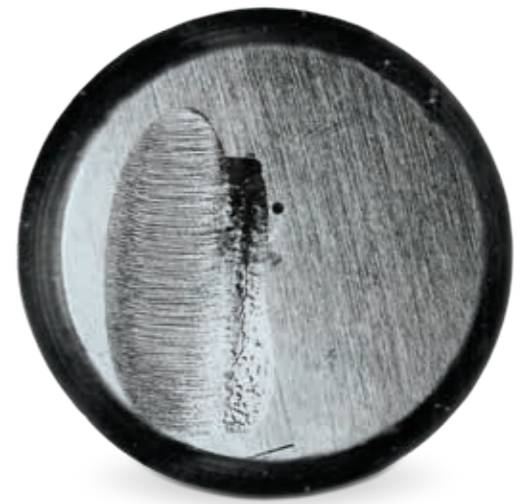
Installing damaged rocker arms/finger type rockers

Cause:
Forces are applied eccentrically from the rocker arm to the skirt end face of the valve.

Consequence:
Unilateral wear occurs on the stem and the skirt end. The lateral force on the valve stem caused by the eccentric application of force causes fatigue fractures in the area of the clamping system.

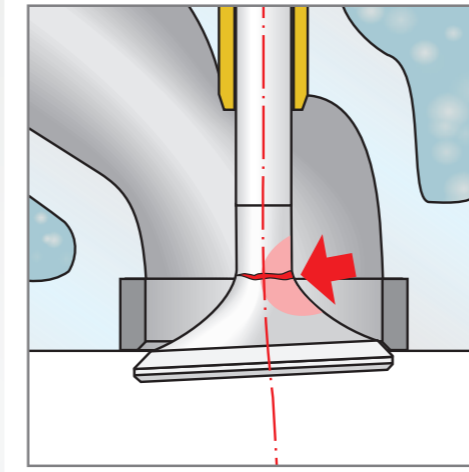
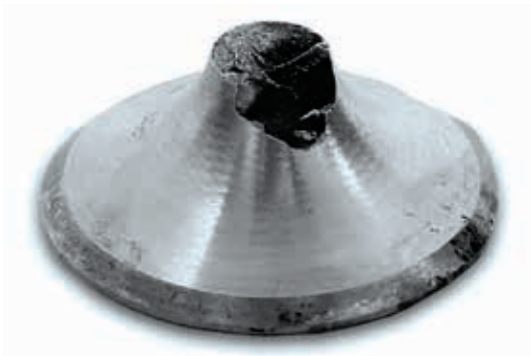
Installing bent valves

Cause:
A bent valve stem will cause unilateral support of the valve seat on the seating ring.

Consequence:
The unilateral stress causes alternating bending stresses and fatigue fractures in the fillet radius at the transition to the stem.

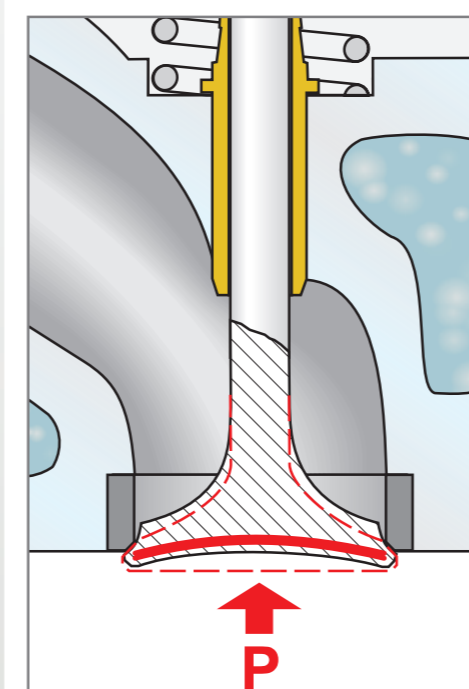
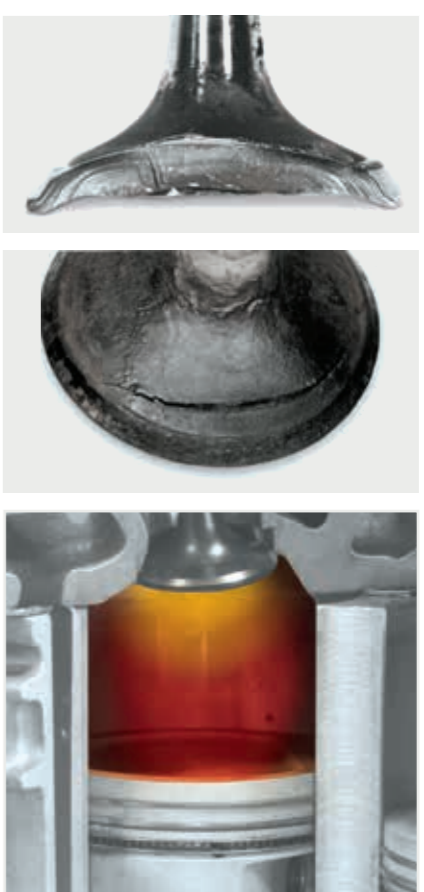
Valve overstressing due to combustion defaults

Cause:
Significant increased pressure and temperature loads occur in the combustion chamber as a result of combustion defaults.

Consequence:
The valve head cannot withstand the high thermo-mechanical loads and bends inwards. This results in so-called tulip formation and causes fractures in the area of the valve head.
