Oversize cylinder liners

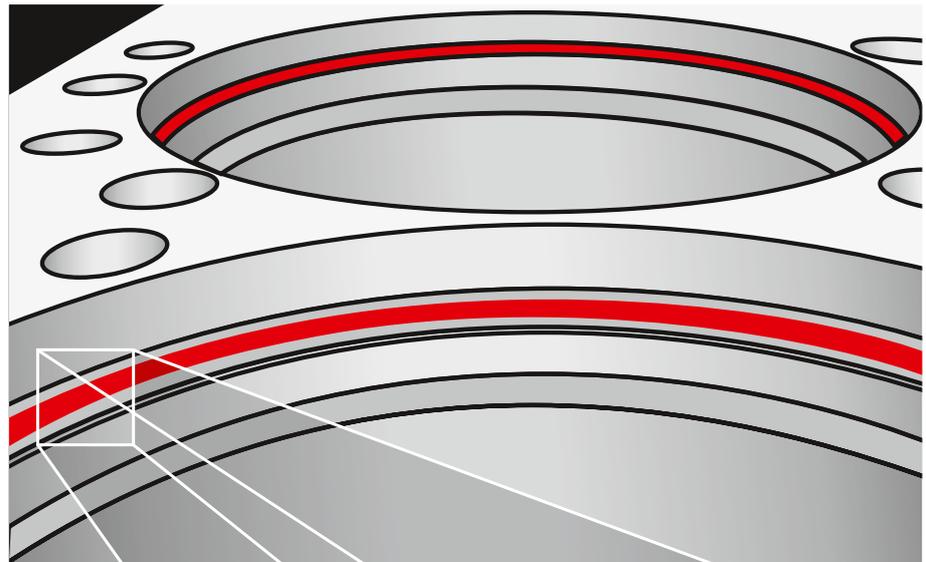
Fig. 1

In the course of an engine's service life, problems are caused on the engine blocks as a result of wear and corrosion that cannot be remedied by fitting new cylinder liners. Sealing surfaces may for instance have been corroded or liner flange seating surfaces (Fig. 1 and 2) affected by wear. If these deficiencies are not cleared, problems, or even damage, can be expected only shortly after new parts have been fitted. For the repair shop, and for the engine reconditioner as well, this means that they must remedy the damage to the sealing and functional surfaces to achieve clean, faultless surfaces again.

Generally, this is done by remachining the damaged surfaces. However, the removal of material as a result of grinding, turning or milling leads to dimensional changes that no longer permit the installation of components with standard sizes. If, for instance, the location hole of a cylinder liner is remachined in an engine block, i.e. the diameter of the bore in the engine block is enlarged, then the outside diameter of the cylinder liner must increase as well.

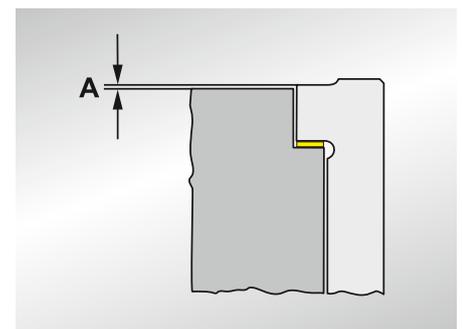
Fig. 4

The liner seat is often worn out. That means that the cylinder liner has worn itself into the liner seat during engine operation. A worn-out liner seat results in inaccuracies between engine block and cylinder liner when new liners are fitted. The consequences are that the liner does not fit properly, so leaks and damage (liner cracks) are caused by material distortion.

Remachining the liner flange seat and fitting a cylinder liner with an oversize flange height that the liner is correctly positioned in the engine block again, and guarantees the necessary ensures protrusion of the cylinder liner, dimension "A" (Fig. 4).
