Piston damage and causes

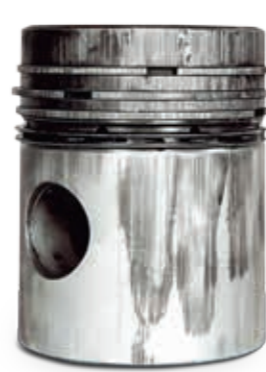
Seizure due to overheating (mainly piston crown)

- Overheating due to combustion defaults
- Bent/blocked oil injection jet
- Installation of incorrect pistons
- Malfunctions in the cooling system
- Clearance restriction in the upper sliding surface area

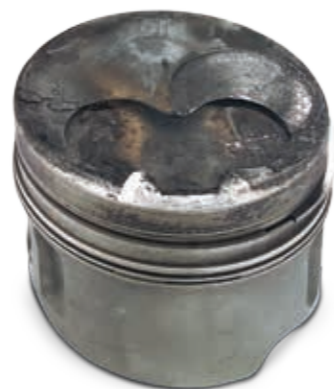
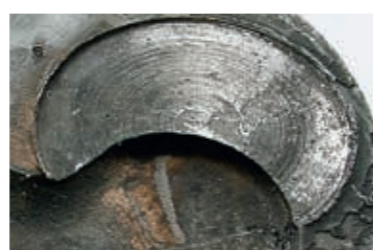
Impact marks

- Piston protrusion too great
- Excessive remachining of the cylinder head sealing surface
- Incorrect valve recess
- Incorrect cylinder head gasket
- Carbon deposits on the piston crown
- Insufficient valve clearance
- Incorrect valve timing caused by incorrect adjustment or a slipped toothed belt

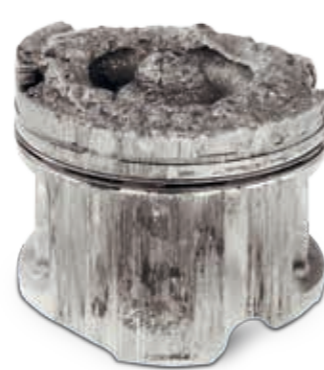
Fused/melted off material

- Faulty injection nozzles
- Incorrect quantity of injected fuel
- Incorrect injection point
- Insufficient compression
- Ignition delay
- Oscillating injection lines

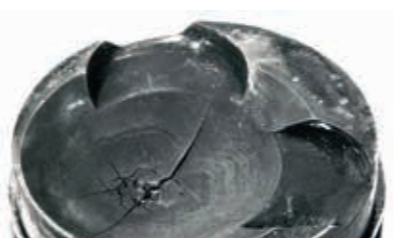
Cracks in the crown and crown bowl

- Faulty or incorrect injection nozzle
- Incorrect injection point
- Incorrect quantity of injected fuel
- Insufficient compression
- Lack of piston cooling
- Installation of pistons with incorrect bowl shape
- Improvement in performance (e.g. chip tuning)

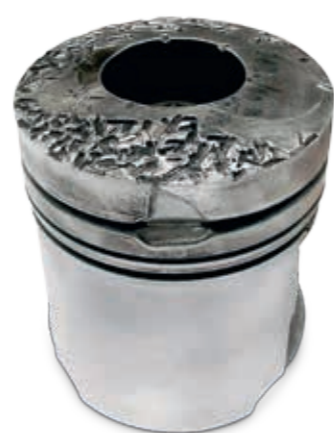
Material washout in the ring area

- Incorrectly installed pistons
- Fuel flooding
- Severe axial wear of the ring groove and piston rings
- Ring flutter

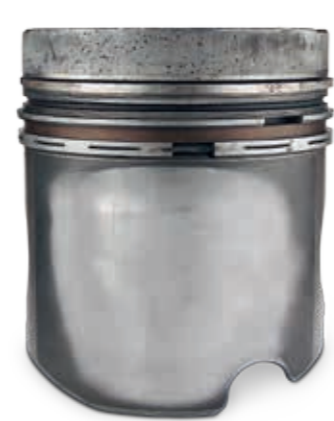
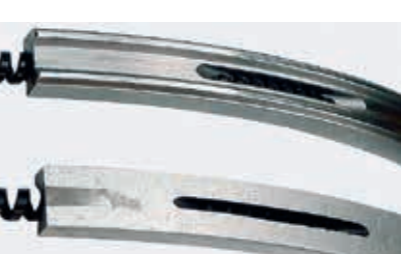
Radial wear due to fuel flooding

- Fault during mixture formation
- Combustion defaults
- Insufficient compression pressure
- Incorrect piston protrusion dimension

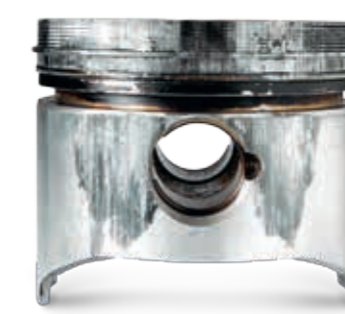
45° seizure

- Excessively narrow fit of the piston pin
- Seizure in connecting rod eye (inadequate lubrication at initial start-up)
- Incorrectly installed shrink-fit connecting rod

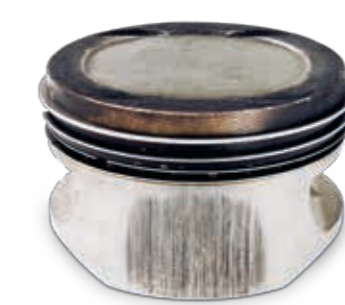
Dry running/Fuel damage

- Over-rich engine running
- Combustion defaults (misfiring)
- Insufficient compression
- Defective cold-start device
- Oil dilution with fuel

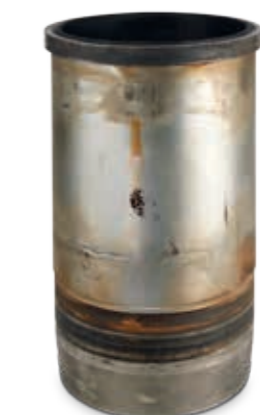
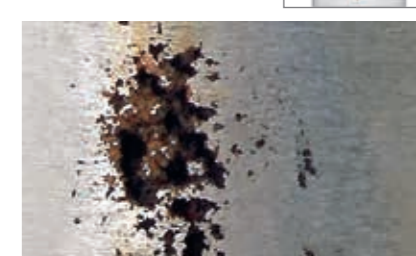
Cavitation

- Poor/inaccurate seating of the cylinder liner
- Use of incorrect O-ring seals
- Use of unsuitable coolant agent
- Increased prepressure in the cooling system
- Operating temperature too low/too high
- Restricted coolant flow

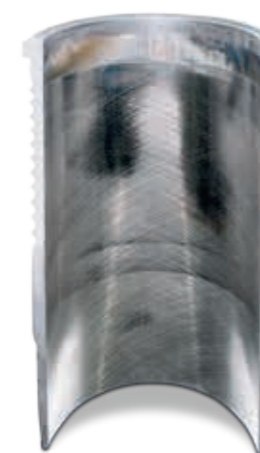
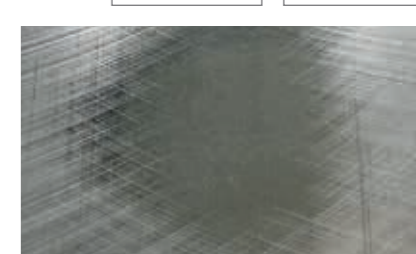
Bright spots in the upper cylinder area

- Carbon deposits on the piston top land due to:
- Excessive ingress of oil into the combustion chamber due to defective components
- Increased emissions of blow-by gases with oil entering the intake air system
- Insufficient separation of oil vapour from the blow-by gases
- Frequent idling or short-distance drives
