**SI 0083**  
For technical personnel only!  
1/2

# SERVICE INFORMATION

## QUICK INSPECTION OF SECONDARY AIR VALVES

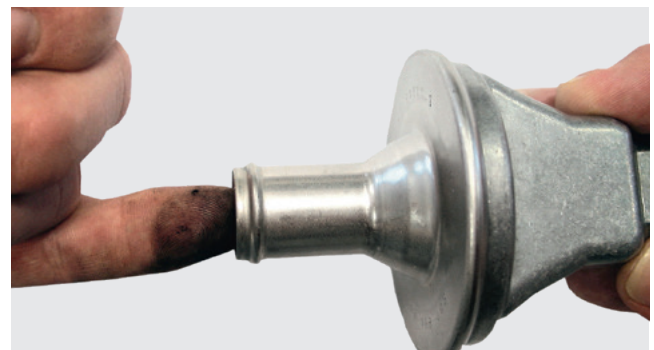
Fig. 1: Simple inspection of the non-return valve

- Loosen the connecting hose on the secondary air non-return valve leading to the secondary air pump.  
→ See inspection point "P" on the graphic overleaf
- If there are deposits on this side of the valve (finger test, see Fig. 1), the nonreturn valve is leaky and must be replaced.  
In that case the secondary air pump may already have been damaged.
- Inspect the secondary air pump and replace it if necessary.

Damage as a result of exhaust gas condensate

The new condition as a comparison

When replacing the secondary air pump, the electrical reversing valve and the secondary air valve must be inspected for leaks as a basic principle.

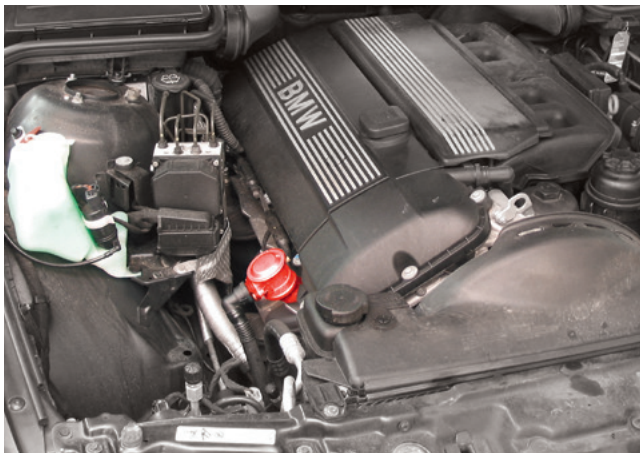
Two variants of the secondary air system

- 01 secondary air pump
- 02 electrical reversing valve (EUV)
- 03 switch-off non-return valve  
(approx. 1995 →)
- 04 secondary-air switch-off valve  
(approx. 1993 → 1997)
- 05 secondary-air non return valve  
(approx. 1993 → 1997)
- P inspection point for quick inspection

Secondary air valves are an integral part of the secondary air system. They are fitted between the secondary air pump (1) and exhaust manifold.

They prevent pressure peaks in the exhaust flow from damaging the secondary air system and exhaust gas or condensate from entering the secondary air pump. There are different designs of secondary air valves:

Switch-off non-return valves (3) are generally vacuum-operated valves. Later designs (from approx. 1998 →) are opened by the pressure of the secondary air.

This does away with pneumatic control by an electrical reversing valve (2).

Secondary-air non-return valves (5) open as a result of the pressure of the secondary airflow.

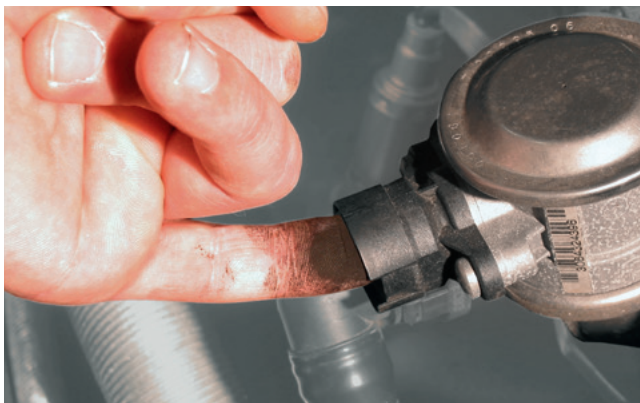
Quick inspection of the secondary air valve in the BMW 520i (highlighted)
