SI 0106
For technical personnel only!
1/4

SERVICE INFORMATION

SECONDARY AIR SYSTEM

DESIGN, COMPONENTS, TROUBLESHOOTING

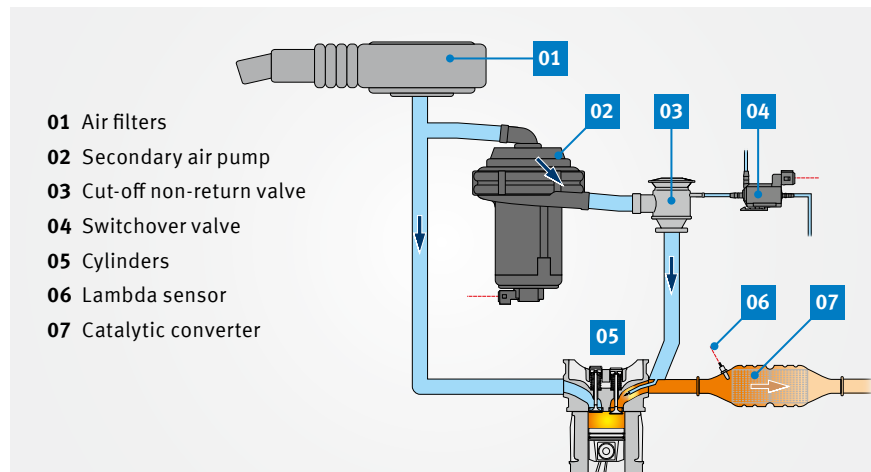
Block diagram of secondary air system (pneumatically actuated)

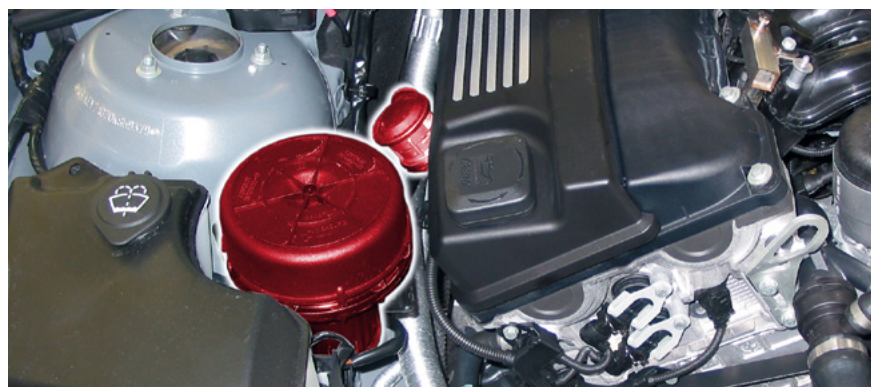
Secondary air valve and secondary air pump in BMW E46 (highlighted)

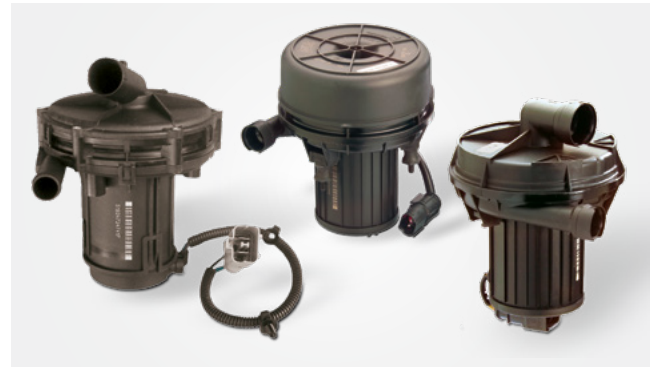
Various 1st and 2nd generation secondary-air pumps

The secondary-air pump draws in ambient air and injects it into the exhaust manifold downstream of the exhaust valves.

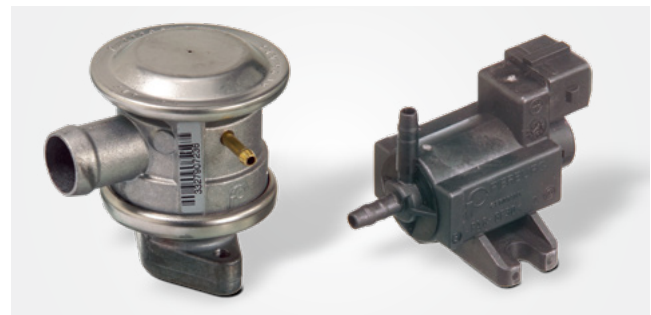
Vacuum-controlled valve with shut-off and non-return function (since approx. 1995) and solenoid switching valve

Secondary-air valves are fitted between the secondary-air pump and the exhaust manifold. Use is made of different versions. The secondary-air non-return valve stops exhaust gas, condensate or pressure peaks in the exhaust system (e.g. misfiring) causing damage to the secondary-air pump. The secondary-air shut-off valve ensures that secondary-air is only routed to the exhaust manifold in the cold starting phase. Secondary-air valves are either actuated by a vacuum controlled by a solenoid switching valve or open in response to the pressure of the secondary-air pump.

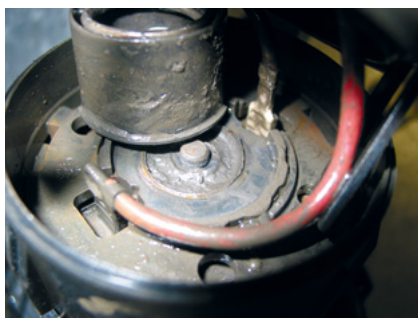
In most of these cases, a defective non-return valve or incorrect actuation of the secondary-air valve has led to exhaust gas condensate ingressing into and damaging the secondary-air pump. The standard remedy is then just to replace the secondary-air pump, which often leads to the same problem occurring again in a short space of time.

Corrosive exhaust gas condensate in the drive motor of a secondary-air pump

- The secondary-air pump must be replaced if it does not run or makes a scraping, whistling or scratching noise during operation.
- In such cases, the other secondary-air system components should also be checked.
- Check for contamination of the engine air filter.
- If the secondary-air is drawn in directly from the engine compartment rather than from the intake system, the separate air filter fitted upstream of the secondary-air pump may be clogged.

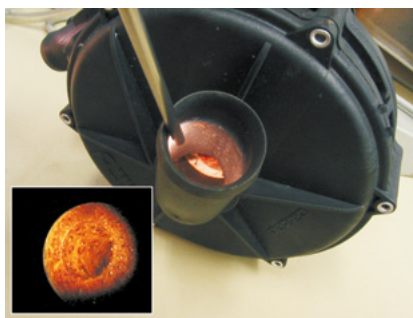
View of the corroded inlet of a secondary-air pump

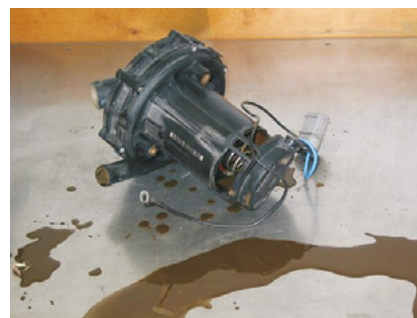
Liquid exhaust gas condensate from a secondary-air pump

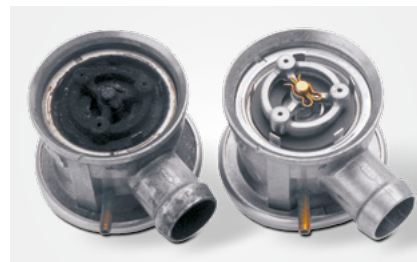
Open secondary air valve
Left: Damage caused by exhaust gas condensate
Right: New condition

- The secondary air valve must be replaced if it does not open on applying vacuum.
- If the secondary air valve opens on applying vacuum, the solenoid actuation valve (switchover valve) and the vacuum hoses must be checked.
- The secondary air valve diaphragm is leaking if the vacuum applied with the vacuum hand pump decreases.
- Deposits on the side facing the secondary air pump (finger test, Fig.) are an indication of non-return valve leakage.
- To check, unfasten the connection hose between the secondary air pump and secondary air valve.

In this case, the secondary air pump may already have suffered damage: Check and, if necessary, replace the secondary air pump.

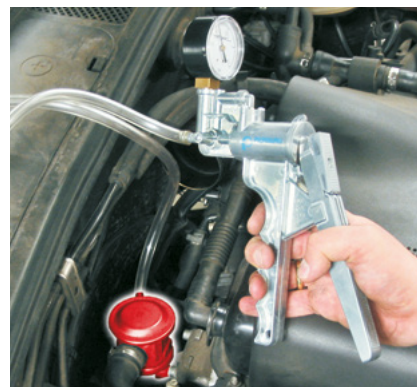
Following removal, operation of a vacuum-controlled secondary air valve can be checked using a vacuum hand pump:

Checking a secondary air valve with a vacuum hand pump

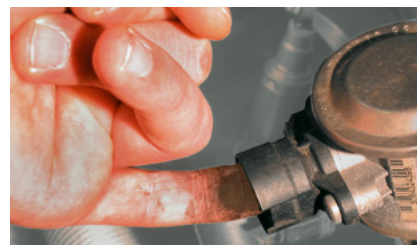
Finger test at secondary air valve in BMW 520i (highlighted)
If deposits are found on this end, the non-return valve is leaking and must be replaced.

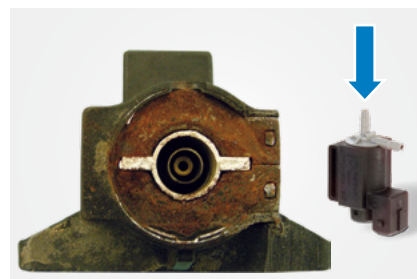
Corroded switchover valve (open)

- A vacuum hand pump can be used to check for opening and leakage.
- During blowing in of secondary air, the on-board voltage must be applied to the plug of the switchover valve. If not, an electrical fault has occurred and must be localised with the help of a circuit diagram.
