**SI 0096**  
For technical personnel only!  
1/1

# SERVICE INFORMATION

## SIMPLE FAULT CAUSES ARE OFTEN MISSED

### OBD ERROR DUE TO INADEQUATE VACUUM

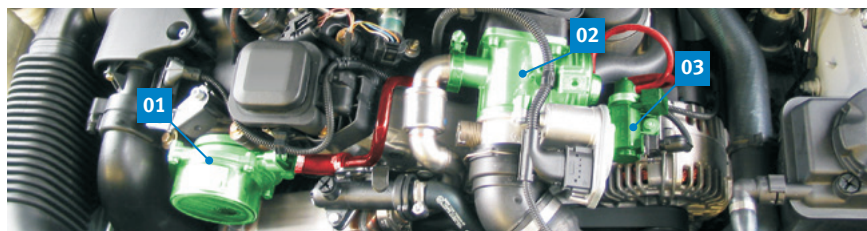
Example BMW 118d (E87):  
Components in the vacuum system (green), vacuum hoses (red)

- 01** vacuum pump
- 02** EGR valve
- 03** electro-pneumatic pressure transducer

**In the event of a malfunction, check the leak tightness of all components in the vacuum system and replace the failed part.**
