# Electric EGR valve (VAG 1.2 12 V)

## Possible thermal damage

Vehicle	Product		Electric EGR valve
	PIERBURG No.	Replacement for	
Seat Cordoba 1.2 12V Seat Ibiza 1.2 12V Skoda Fabia 1.2 12V VW Polo 1.2 12V	7.22785.16.0	7.22785.07.0/.12.0	03D 131 503 B/D

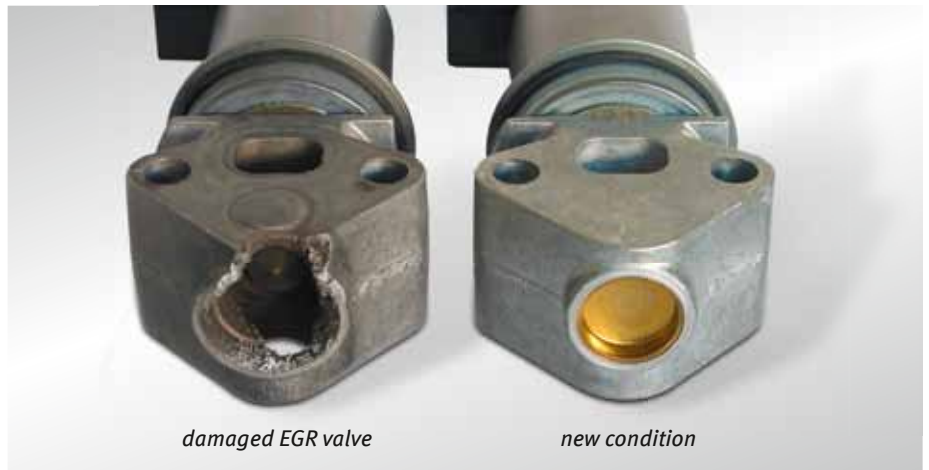
Through checks it has been found that the built-in electric EGR valves, in particular when travelling under full load, are exposed to increased thermal stress.

- The blind plug at the valve body develops a leak or is lost. Exhaust gas escapes.
- The valve is subject to deformation and will not fully close.
- In extreme cases the valve flange may be damaged by melting.

*damaged EGR valve*

*new condition*

**When replacing the EGR valve we urgently recommend to check the software revision of the engine controller:**

- **Engine Data revision level (minimum)**
- BME 7000/7001**
- AZQ 5323 - 5329**
