Frequent causes of damage:

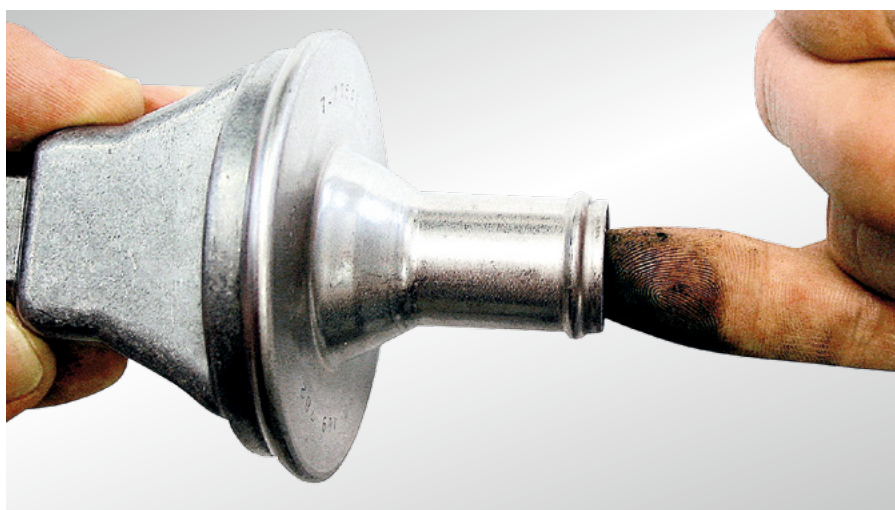
Fig. 32: simple check of the check valve

Non-return valves can be checked for leaks

very simply:

- Release the connection hose on the non-return valve that leads to the secondary air pump.
- If there are deposits on this side of the valve (for the finger test, see illustration), the non-return valve is leaking and must be replaced. In this case the secondary air pump may already be damaged. Check the secondary air pump and replace as well if necessary.
