Regulating Throttle Failure

in the VW Touran, Golf V, Audi A3 with 2.0 TDI engine

Vehicle	Product: Regulating throttle		
Audi A3 2.0 TDI	PIERBURG No. 7.14393.26.0	Replacement for 7.14393.11.0/.16.0/.20.0	O.E. No.* 038128063G
VW Touran 2,0 TDI			
VW Golf V 2.0 TDI

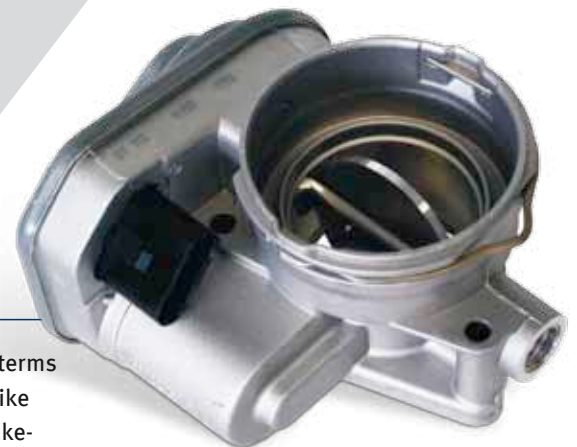
Product view of the regulating throttle

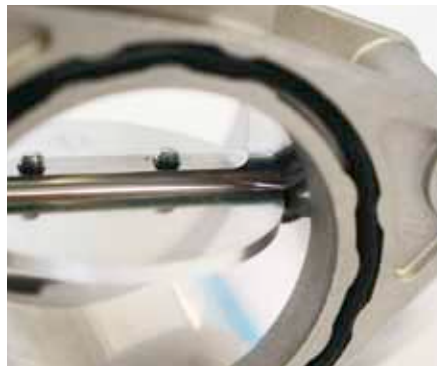
New regulating throttle

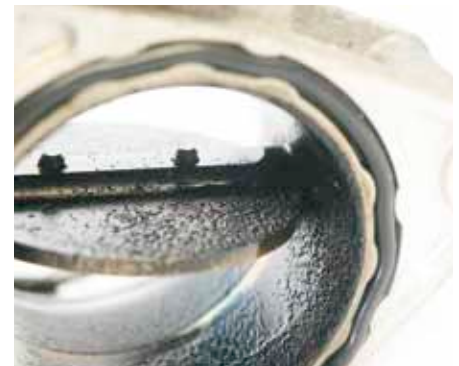
Regulating throttle suffering from oil contamination

We do not recommend cleaning of the regulating throttle:

- In the case of a defective regulating throttle suffering from the damage described overleaf, cleaning will not result in an improvement.
- A functional regulating throttle could be damaged by cleaning it.
