PISTON DAMAGE – RECOGNISING AND RECTIFYING

MOTORSERVICE GROUP

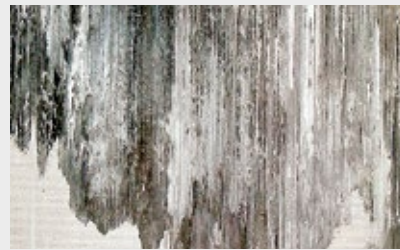
Seamless areas of narrow seizure marks, mainly on the piston skirt, showing a severely worn and darkly discoloured surface.

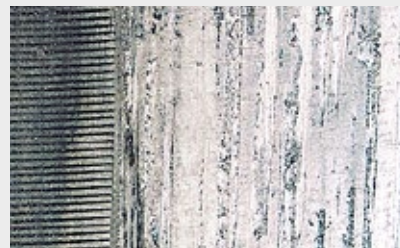
Identical to those described above, apart from the discolouration of the surface. The surface of the seizure areas has an almost pure metallic finish, with no dark discolouration. As the lack of oil affects the entire surface of the cylinder, there are often seizure marks on both the pressure side and the anti-thrust side in the piston, in many cases even in the early stages.

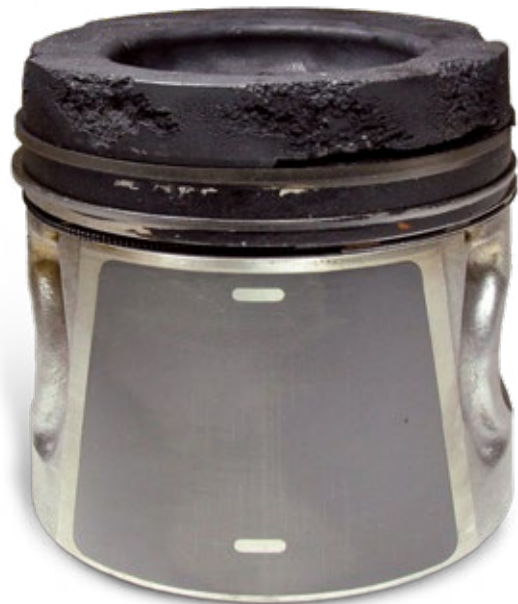
Fig. 2

- Erosive-type removal of material due to melting on the piston crown or the piston top land in the injection direction of the nozzle jets.
- No seizure marks on the piston skirt or the piston ring zone.

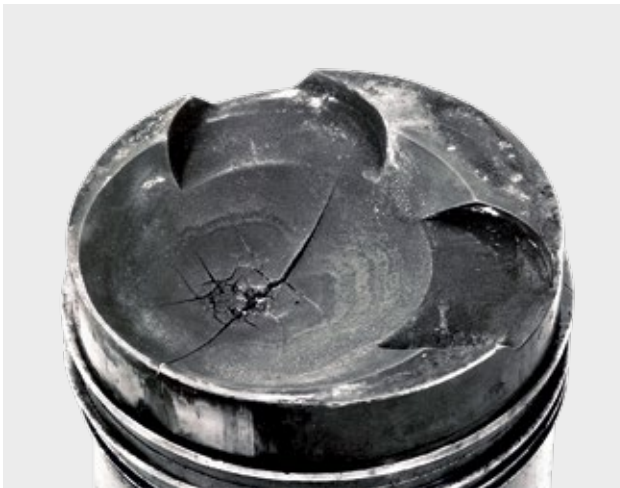
Fig. 3

The piston material is heated up significantly in localised areas – at the point where the prechamber jets make contact on prechamber engines (Fig. 3 and Fig. 4), and on the edge of the bowl on direct injection engines (Fig. 1). The material expands more than elsewhere in these areas. As the overheated areas are surrounded by colder materials, the material is plastically deformed here beyond its limit of elasticity. Exactly the opposite happens when it then cools down again: in the areas where before the material was previously buckled and forced away, there is now a shortage of material.

This results in tensile stresses, which ultimately cause stress cracks. If there are superimposed stresses caused by bending of the piston pin in addition to the thermal stresses, then the stress cracks turn into a much larger major crack, which causes complete breakage and failure of the piston.

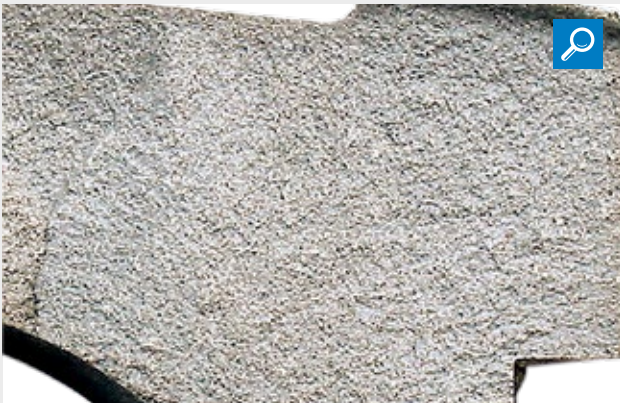
Fig. 1

A forced fracture (Fig. 1) is always caused by a foreign body that collides with the piston while the engine is running. These foreign bodies could be parts of the connecting rod, crankshaft or valves, etc. that have been torn off. A forced fracture of the piston can also occur if water or fuel gets into the cylinder.

The fracture surfaces of a forced fracture appear grey. They are not worn down and display no line markings. The piston breaks suddenly without any fracture development.

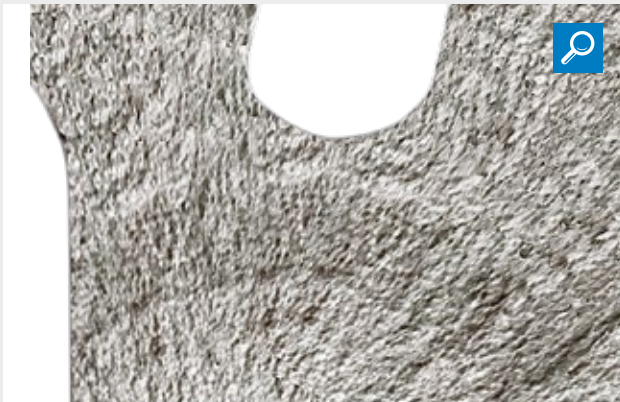
Fig. 2

In the case of a fatigue fracture (Fig. 2), line markings form on the fracture surface that reveal the starting point and the gradual progress of the fracture. The fracture surfaces are often worn to the point of being shiny. The cause for a fatigue fracture is overstressing of the piston material.

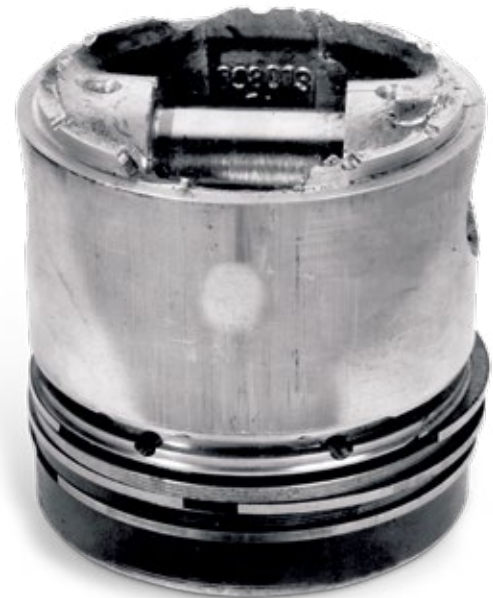
Fig. 2

The cause is an exceptionally fast sequence of hard impacts as the piston crown strikes the cylinder head, which subjects the piston to such violent shock vibrations that cracks are generated. The piston also no longer runs straight in the cylinder and subsequently strikes the cylinder wall with its skirt. On pistons with a lower oil control ring (Fig. 2) the skirt often breaks in the area of the lower oil ring groove.

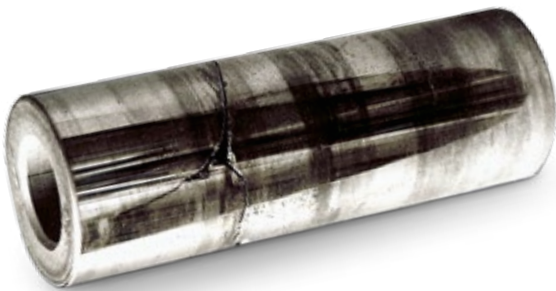
Fig. 1

- Lateral fracture on the piston pin (Fig. 1) at the transition between the connecting rod and the piston pin boss.
- Shorter fragment split along its length.
- Fracture surfaces display the characteristics of a fatigue fracture.

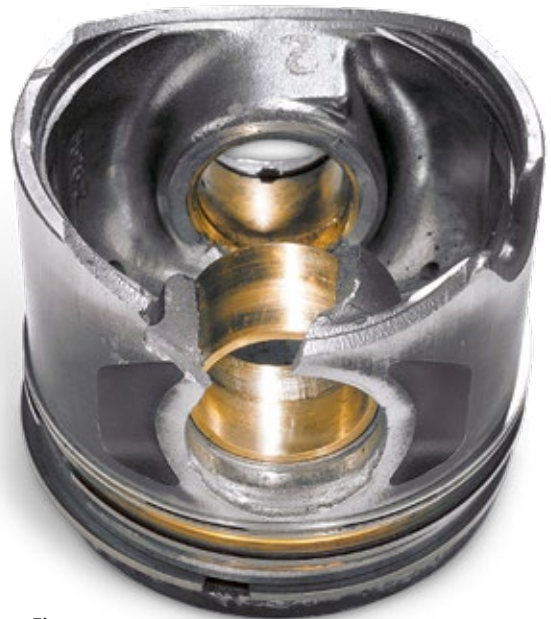
Fig. 5

- Asymmetrical piston wear pattern (Fig. 4).
- Piston pin boss and piston pin broken (Fig. 5 and 6).
- Pin bore hammered out in the area of the circlips.

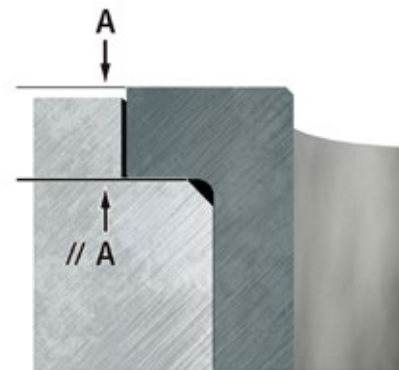
Fig. 2

The distortion of the seating surface cannot be detected by visual inspection alone unless the appropriate measuring aids are used. One simple way to check for this distortion is the use of bearing ink: thinly apply the ink around the seating surface of the liner flange on the engine block. Then insert the new liner without gaskets and press it onto the seat. Remove the cylinder liner again. The seating surface on the cylinder liner should now be evenly coated with ink around the entire circumference. If this is not the case, the liner seat needs to be reworked. This reworking is best performed on a stationary boring machine or with a mobile liner flange seat facing attachment. This ensures parallelism with respect to the housing surface (Fig. 2).

- Worn liner flange seating surfaces on the engine after an extended running period.
- Dirty or corroded liner flange seating surfaces.
- Failure to ensure that the flange seat is perfectly rectangular and/or parallel (Fig. 2 and Fig. 5).
- Incorrect cylinder head gaskets.
- Non-compliance with the engine manufacturer's prescribed tightening torques and tightening angles when installing the cylinder head.
- Wrong number of sealing rings.

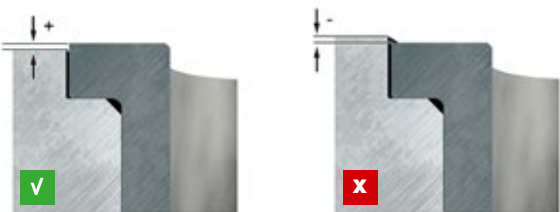
Fig. 6

- Prescribed liner protrusion not complied with (Fig. 6):
 - If the protrusion of the cylinder liner is too great, then the liner flange is pressed off when the cylinder head bolts are tightened.

When reworking the liner flange seating surface during engine reconditioning, the necessary protrusion of the cylinder liner over the cylinder surface must be ensured, either by inserting steel washers underneath or by using a cylinder liner with an oversized flange* (recommended).

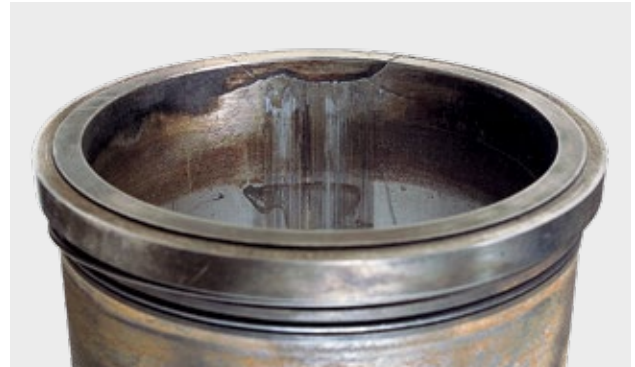
Fig. 2

- Upper area of cylinder liner displays severe damage due to a crack and seizure marks on the sliding surface (Fig. 2 and 3).
- Piston displays seizure marks on the pressure and anti-thrust sides.
- In the piston crown: bowl-shaped recess in the area of the seizure marks (Fig. 4).

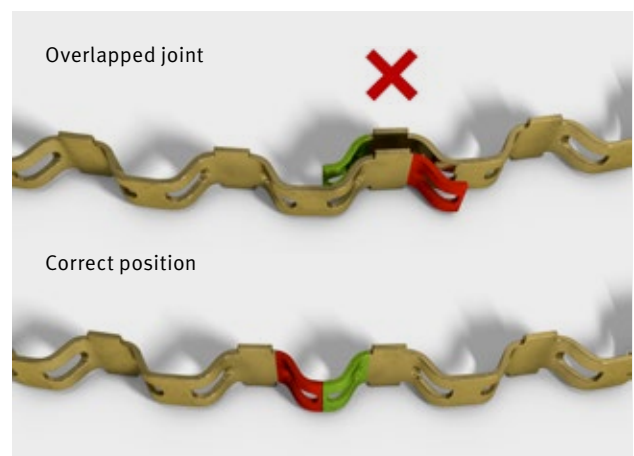
Fig. 2

- Incorrect oil control rings.
- Installation faults.

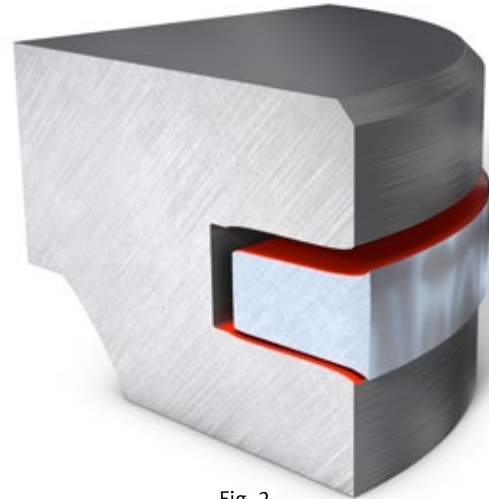
Fig. 2

- Piston: matt, ground wear pattern on the skirt with fine, small longitudinal scratches on the piston top land and the piston skirt.
- Tool marks created during machining worn away.
- Worn compression ring edges, on the first piston ring in particular as well as ring groove edges (Fig. 2).
- Axial clearance of the compression rings substantially increased, in particular on the first piston ring.

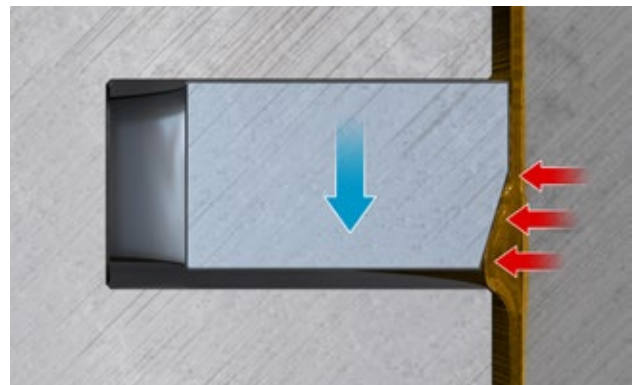
Fig. 2

The worn piston ring edges lead to high hydrodynamic forces (Fig. 2) between the running surfaces of the piston rings and the cylinder running surface as a result of the formation of an oil wedge.

The piston rings float on the oil film during the upward/downward motion of the piston and are lifted off slightly from the cylinder running surface. In this way, an increased quantity of lubricating oil reaches the combustion chamber where it is burned.

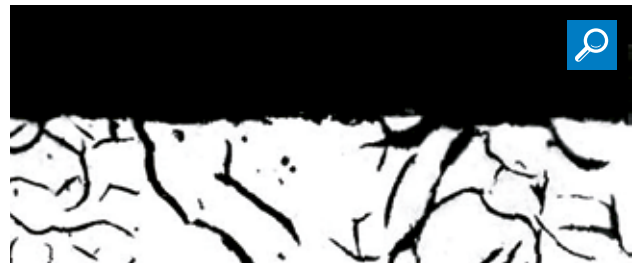
The microscopic enlargement in Fig. 4 shows the bent-over peaks through a section of the cylinder surface after the disadvantageous honing of the cylinder running surface (peak folding). Fig. 5 shows the surface after plateau honing. The burrs and peaks have been mostly removed, and the graphite veins have been exposed. The piston rings will encounter good conditions for running-in and should therefore provide a long service life. Hone-brushing the surface to create the plateau finish delivers particularly good results.

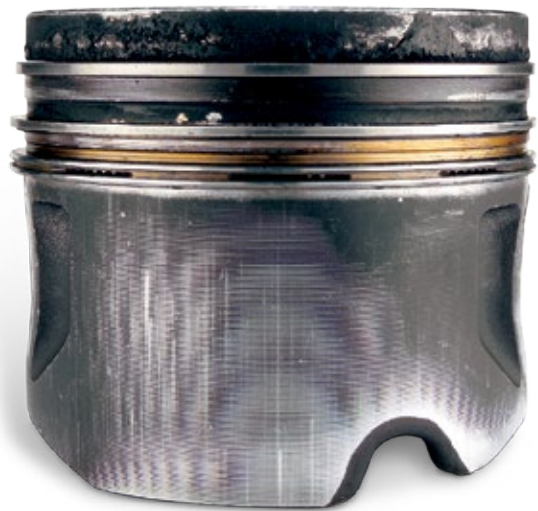
Fig. 2

Fig. 2:

- Piston running skew, with the wear mainly on the lower, right-hand edge of the piston at the recess for the cooling-oil nozzle and under the piston pin bore.
