# KNOWLEDGEPOOL

## DAMAGE TO ENGINE BEARINGS

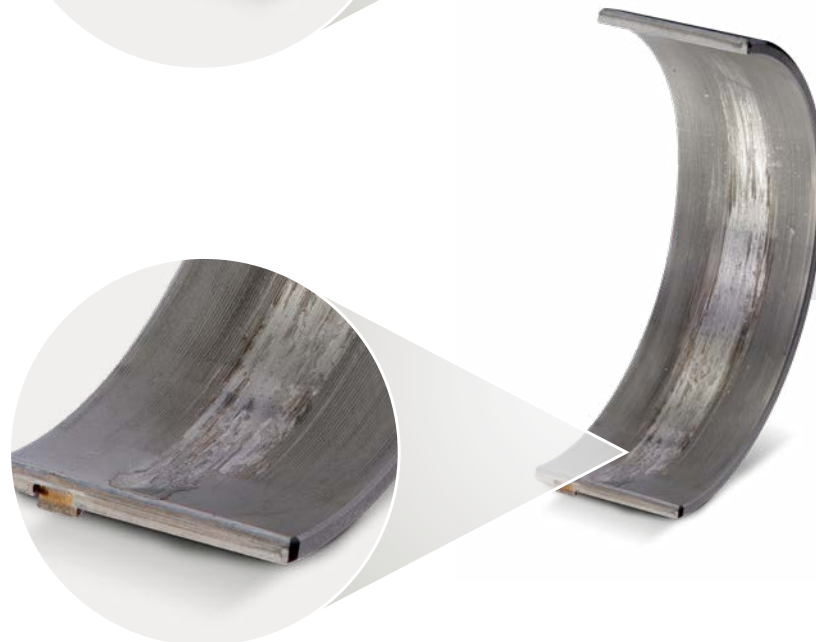
**Rod-side conrod bearing shell  
steel-brass composite with  
sputter coating**

A bright mark of mixed friction, with partial associated scoring, is recognisable. The sputter coating has been displaced out into the relief area. The area where the sputter coating has already seized has fused.

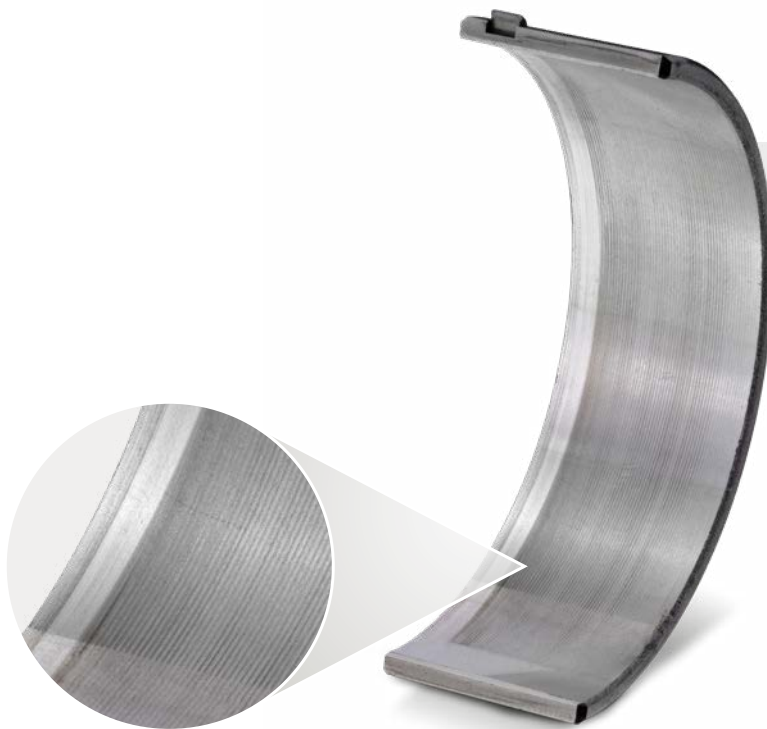
**Lower main bearing shell  
steel-aluminium composite**

One-sided worn bearing edge is visible. The wear occurs in the form of adaptive run-in wear. The function of the bearing is not impaired.

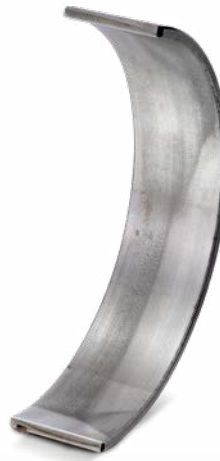
**Rod-side conrod bearing shell  
steel-brass composite with  
sputter coating**

The diagonally offset wear pattern can be recognised. At the edge of the bearing, the intensity of the wear is pronounced to differing degrees in different areas. The function of the bearing is not impaired.

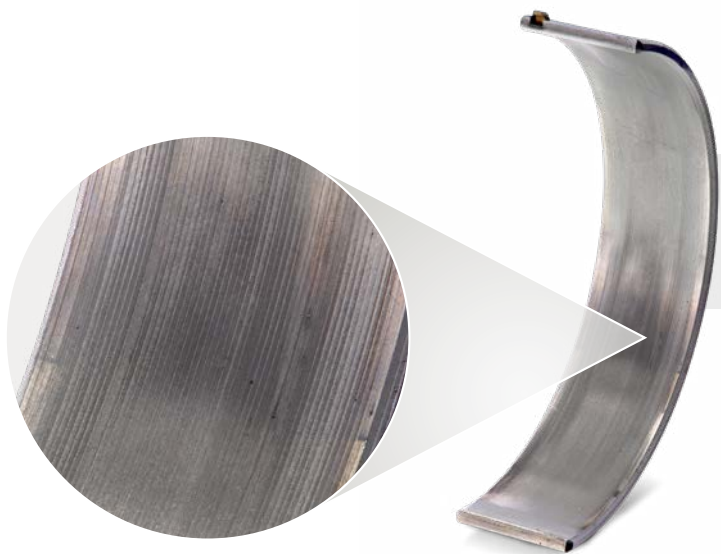
**Rod-side conrod bearing shell  
steel-brass composite with  
sputter coating**

Two-sided edge wear in the early stages – wear in the form of adaptive run-in wear.

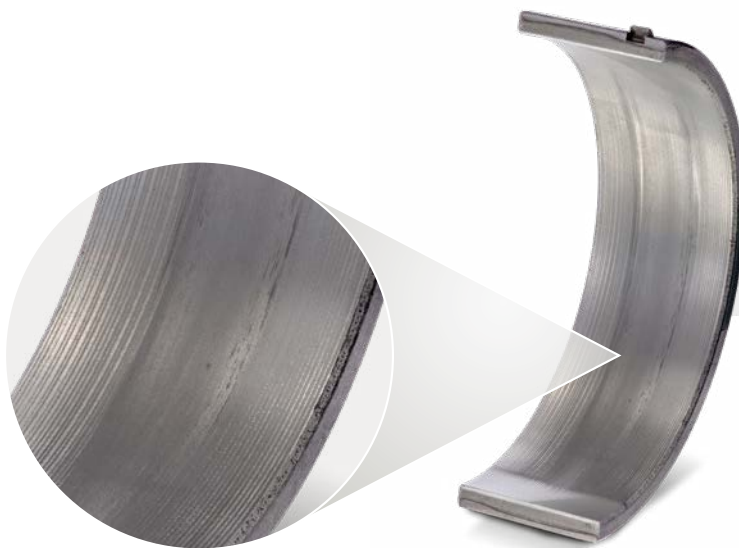
**Lower main bearing shell  
steel-aluminium composite**

Here, a strong wear pattern in the centre of the bearing which tapers off towards the relief can be identified. In terms of form, the wear pattern still corresponds to adaptive run-in wear.

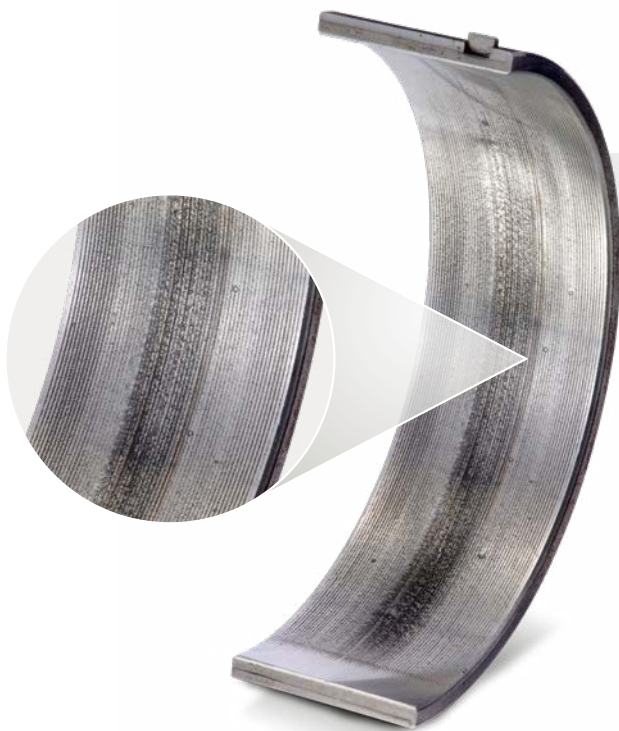
**Lower main bearing shell  
steel-aluminium composite**

Clearly delineated stripes can be seen in the centre of the bearing. This corresponds to the shape of the oil groove which is in the upper main bearing shell. The wear marks occur in the form of adaptive run-in wear.

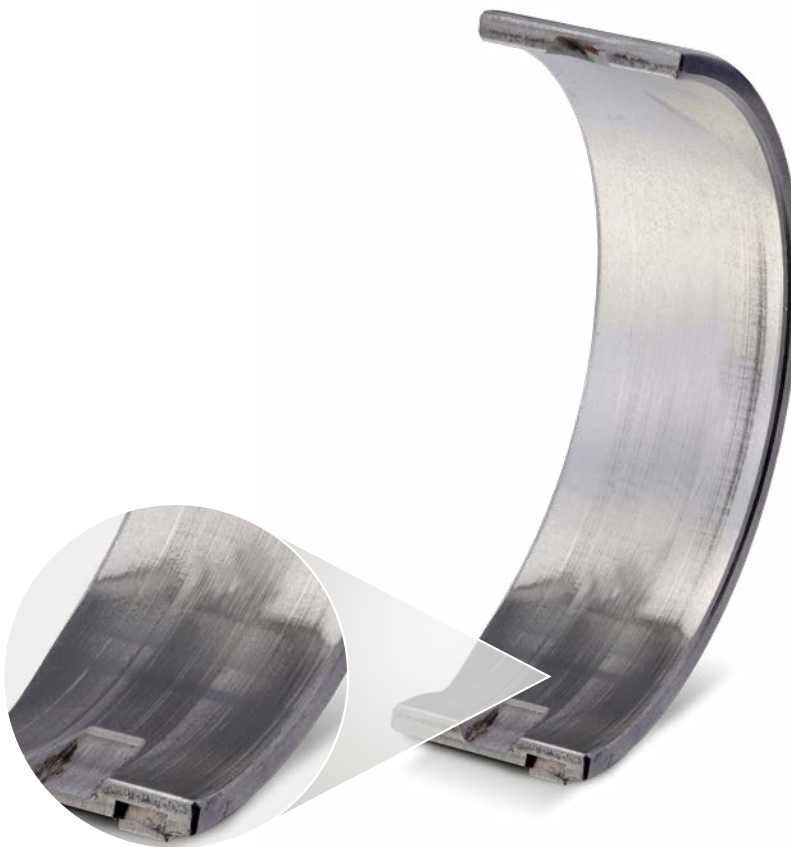
**Lower main bearing shell  
steel-aluminium composite**

Pronounced wear is visible in the relief, whilst the bearing crown is considerably less worn.

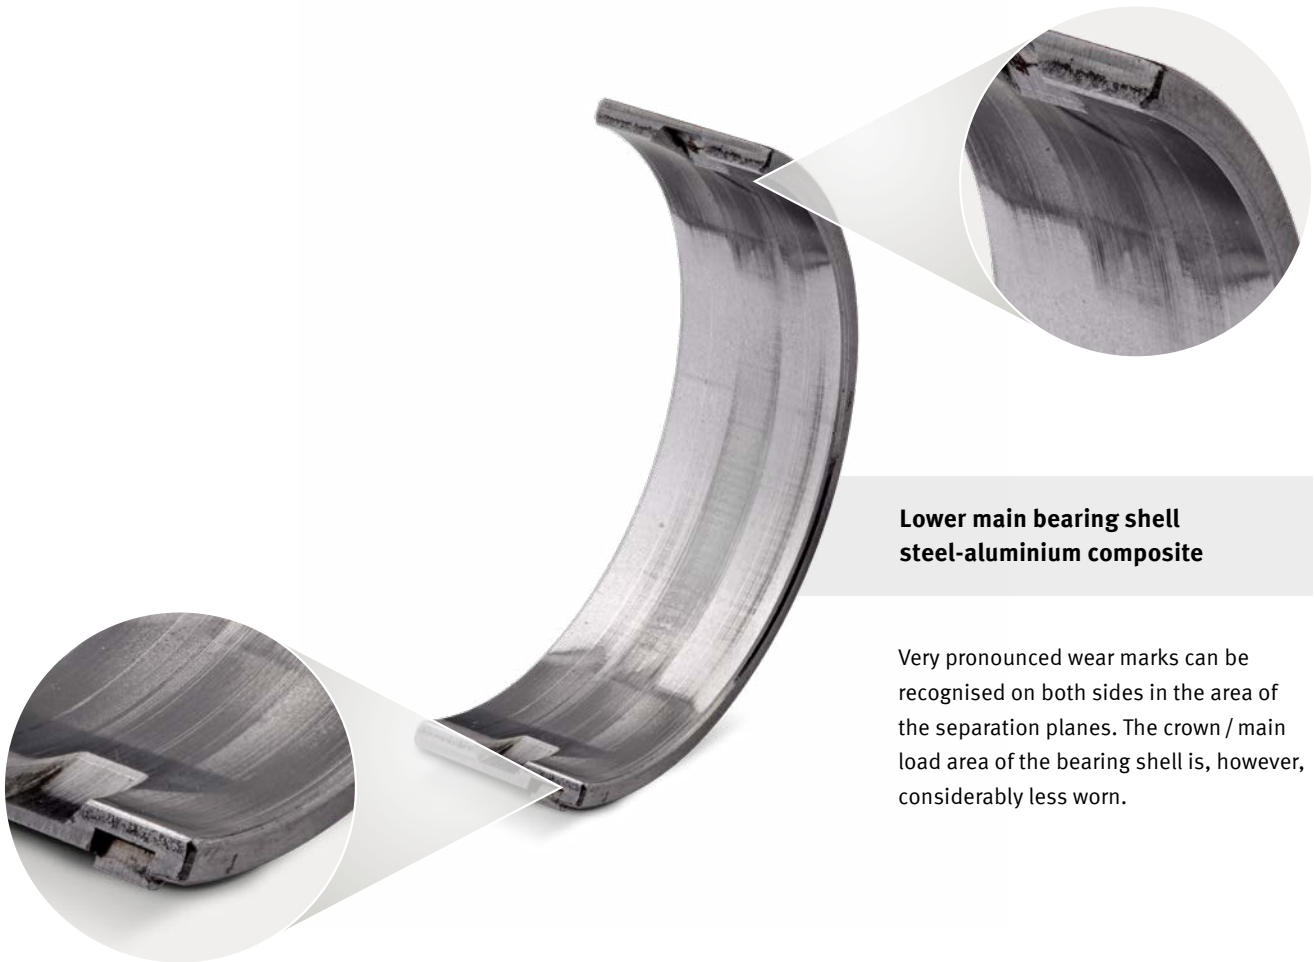
**Lower main bearing shell  
steel-aluminium composite**

Very pronounced wear marks can be recognised on both sides in the area of the separation planes. The crown / main load area of the bearing shell is, however, considerably less worn.

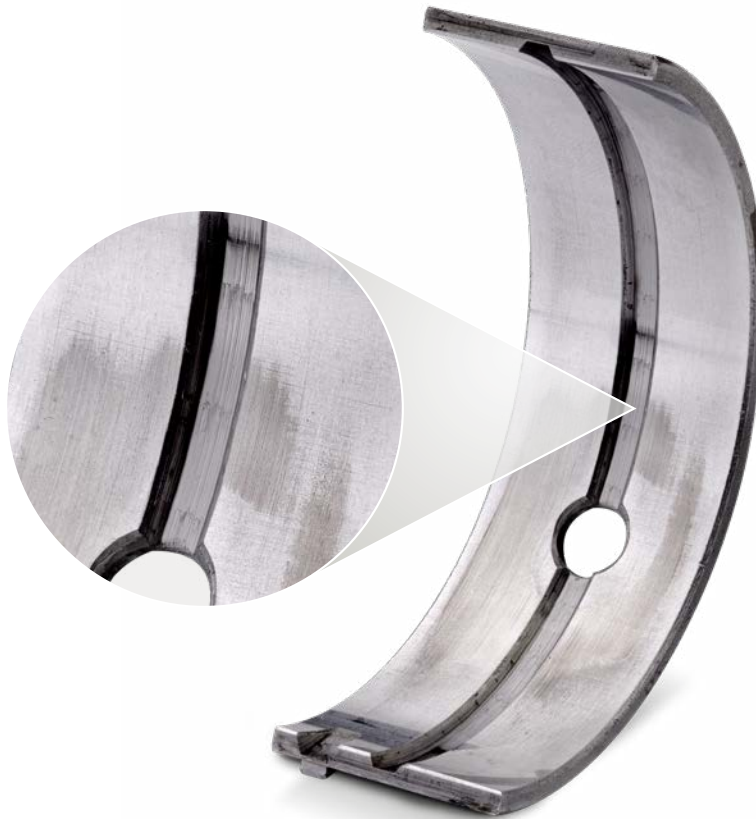
**Upper main bearing shell  
steel-aluminium composite**

Wear marks in the area of the crown in the form of adaptive run-in wear can be recognised. No other operating marks are visible in other parts of the bearing sliding surfaces.

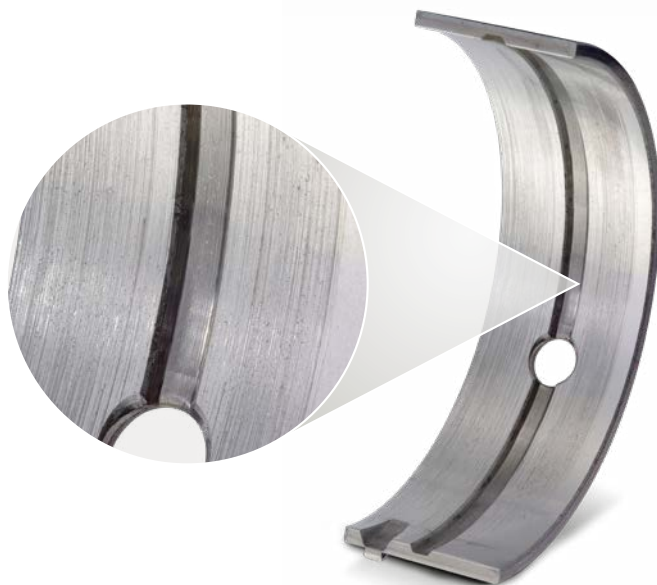
**Upper main bearing shell  
steel-aluminium composite**

Two wear-free strips are recognisable at the edges of the bearings without any visible wear marks. The remaining part of the bearing has a slight black discoloration, possibly due to corrosion or wear.

One wear-free strip is recognisable at the edges of the bearings without any visible wear marks. The remaining part of the bearing has pronounced scoring.

The bearings can continue to be used depending on their wear condition. They should be replaced as soon as initial rubbing marks develop or indicators of material fatigue become visible and measures to determine the cause should be taken:

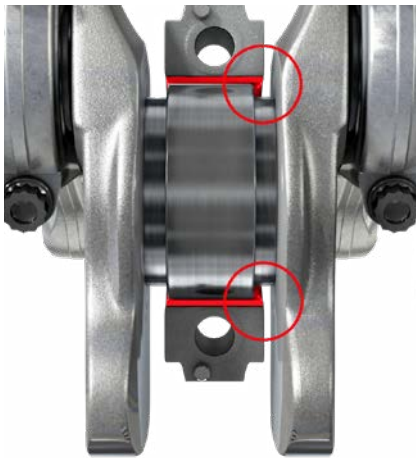
Fig. 1: One-sided axial protrusion

Due to one-sided (Fig. 1) or two-sided (Fig. 2) axial protrusion of the bearing shells, narrow, wear-free strips at the edges of the bearings are formed, which also do not demonstrate the typical adaptive run-in wear. Irrespective of the speed of the journal, there is never any metallic contact in these areas.

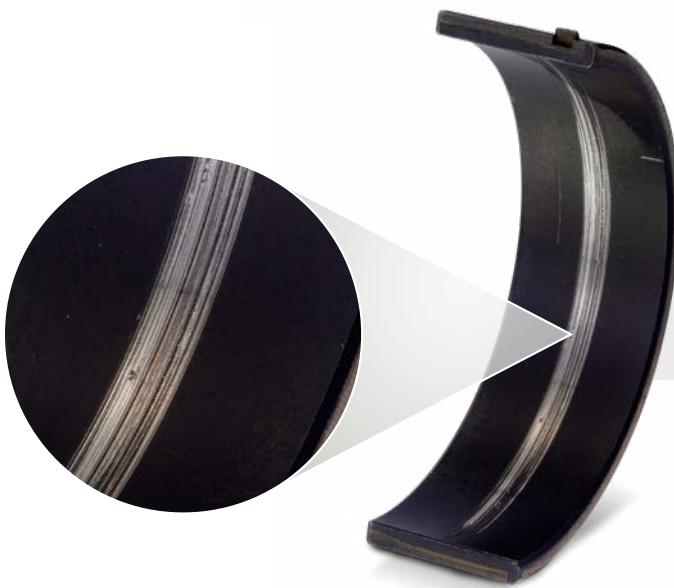
**Lower main bearing shell  
steel-aluminium composite  
with polymer coating**

The grooves are worn up to the aluminium  
alloy layer.

If grooves with pronounced material accumulation are present at the edges, the bearing must be replaced. If grooves are present with areas of material accumulation which have been flattened, and no further influence of particles can be expected, the bearings can still be used.

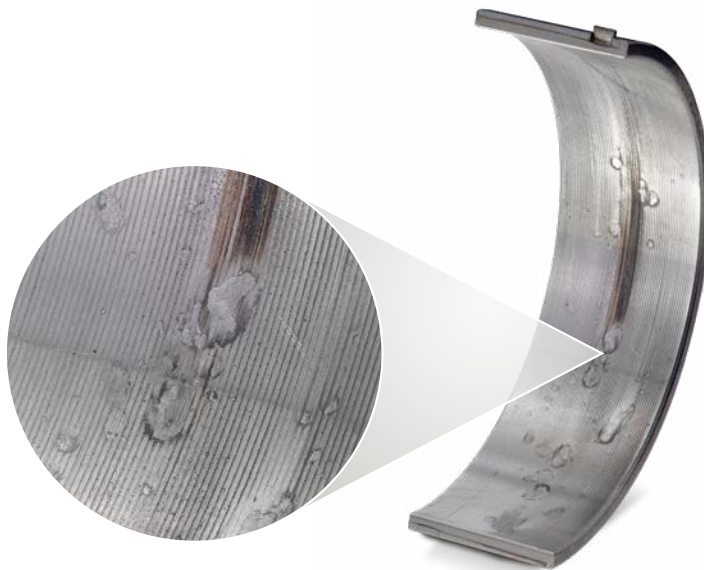
**Lower main bearing shell  
steel-aluminium composite**

Large particle imprints without embedded particles are visible. The particles have caused areas of material accumulation which have caused an initial rubbing mark in the centre of the bearing.

If large particle embedding in conjunction with initial wear of the journal and bearing is present, the bearing must be replaced.

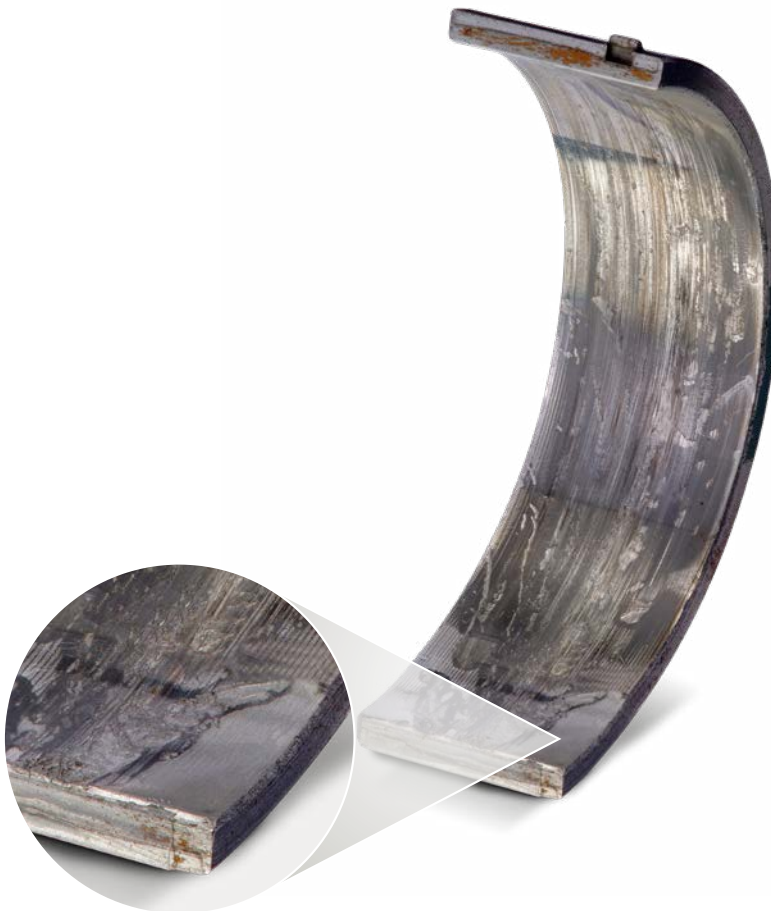
**Lower main bearing shell  
steel-aluminium composite**

A dirt progression mark, starting from the parting face, has occurred. Several large particle indents one after the other – running diagonally – are visible. Particles which are still embedded may be present in part.

Very large and hard particles which find their way into the lubricant gap cannot become embedded in the bearing material. They are forced through the lubricating gap, but then always become stuck again. Frequently, the pattern appears from oil grooves or oil bores as the particles were introduced here. Pronounced material accumulation along the progression track causes initial rubbing marks and seizure.

If there are pronounced areas of material accumulation along the progression track, or signs of an initial rubbing mark, the bearing must be replaced. The bearings can still be used, however, if the material accumulations have been flattened and there is no longer the risk of the influence of particles.

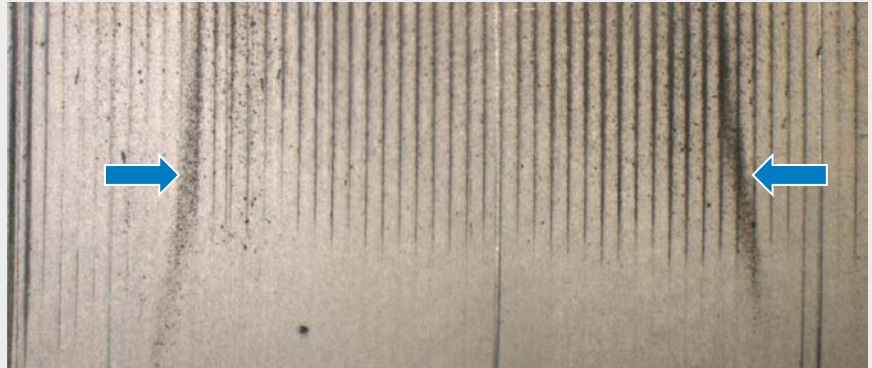
- Fine scoring in the direction of the oil flow
- Roughening and fissures of the sliding layer

Erosion is a form of abrasive material removal, caused by the flow forces of the oil. This effect is reinforced by the smallest particles in the oil, such as carbon deposits or deposits from abrasion. Erosion is also often the result of cavitation, as here particles from the material are broken off and enter into the lubrication system.

- Keep the temperature of the oil low through sufficient cooling
- Always replace the oil filter and oil according to the manufacturer's specifications: ensure that the inspection intervals are complied with and only oil and oil filters to the right standard are used

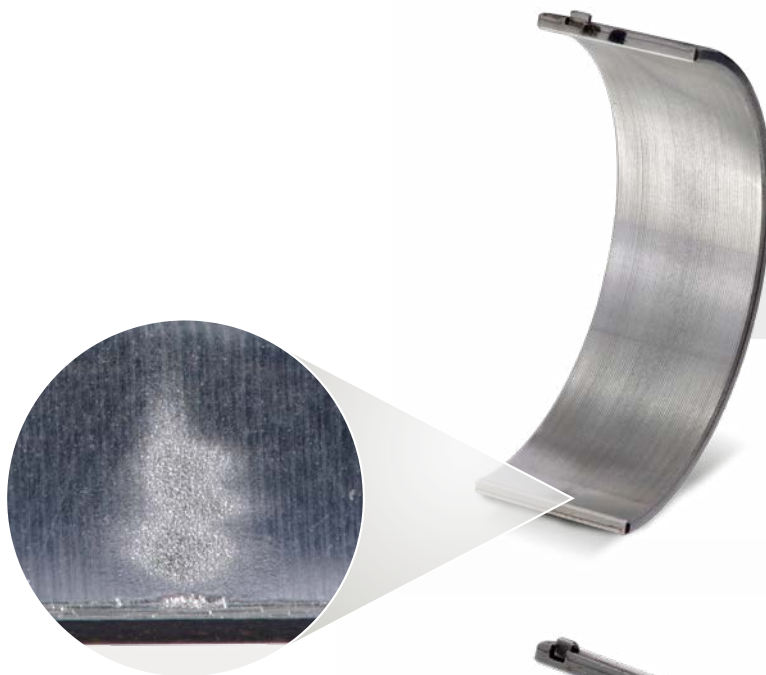
**Cap-side conrod bearing shell  
steel-aluminium composite**

Cavitation in the relief: material removal can clearly be seen – the area is matte compared to the surrounding material.

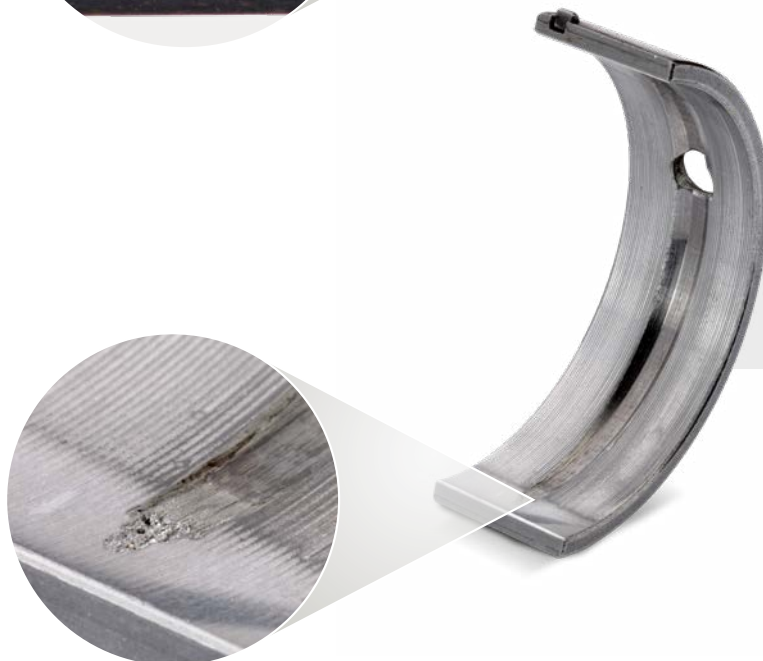
**Upper main bearing shells  
steel-aluminium composite**

Cavitation in the run-out of the oil groove: a mushroom-shaped nick in the bearing material can be seen. The area is much more matte and roughened compared to the surrounding material.

Pressure surges caused by the implosion of gas and vapour bubbles near to the surface of the bearing result in material nicks (see chapter: „4. Erosion and cavitation“). Cavitation often comes hand-in-hand with erosion and corrosion and can cause fine scoring in the same or adjacent bearings.

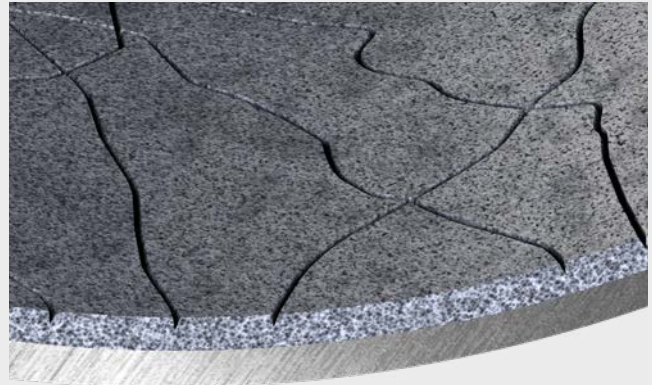
Fig. 1: First cracks

If the integrity of the material is exceeded locally, fatigue occurs. The first cracks form (Fig. 1), which continue to grow due to notch effect and a network of cracks develops (Fig. 2). In addition, nicks occur (Fig. 3) in the bearing metal. The network of cracks and the nicks reduce the strength of the bearing, meaning a fatigue fracture can be caused in the event of stress. The engine bearing has then lost its ability to function and complete failure occurs.

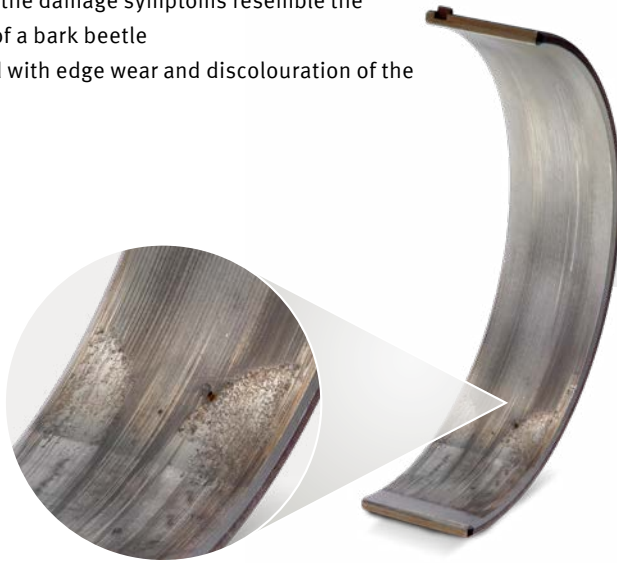
**Rod-side conrod bearing shell  
steel-brass composite with  
sputter coating**

The engine bearing demonstrates signs of fatigue towards the relief in the form of cracks and initial nicks up into the brass layer.

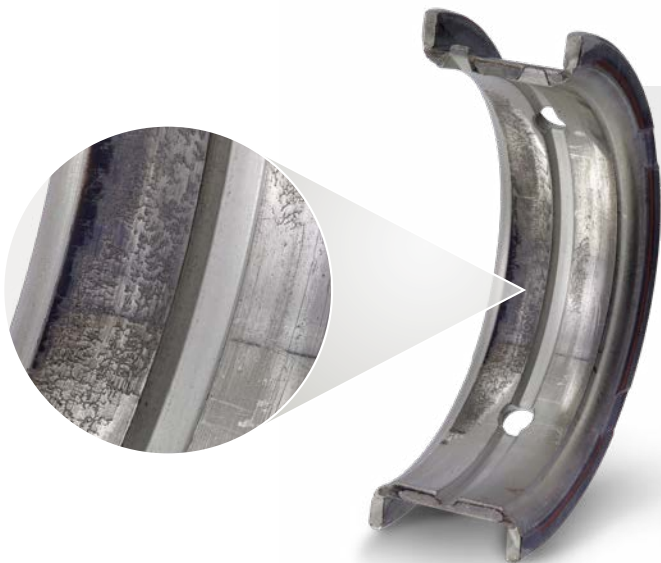
**Main bearing shell  
steel-bronze composite with  
galvanic coating**

One-sided edge wear on both bearing shells caused the fatigue of the galvanic layer and created the typical „bark beetle“ damage pattern.

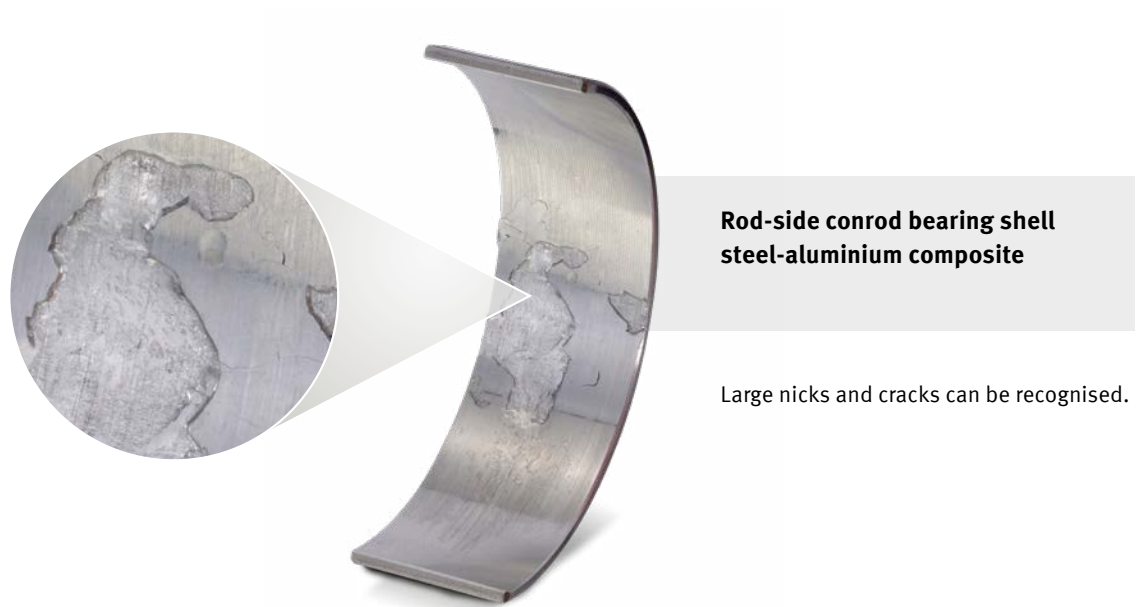
- Cracks and cobblestone-like nicks down to the bearing material
- Edges of the nick rounded off due to wear depending on further service life

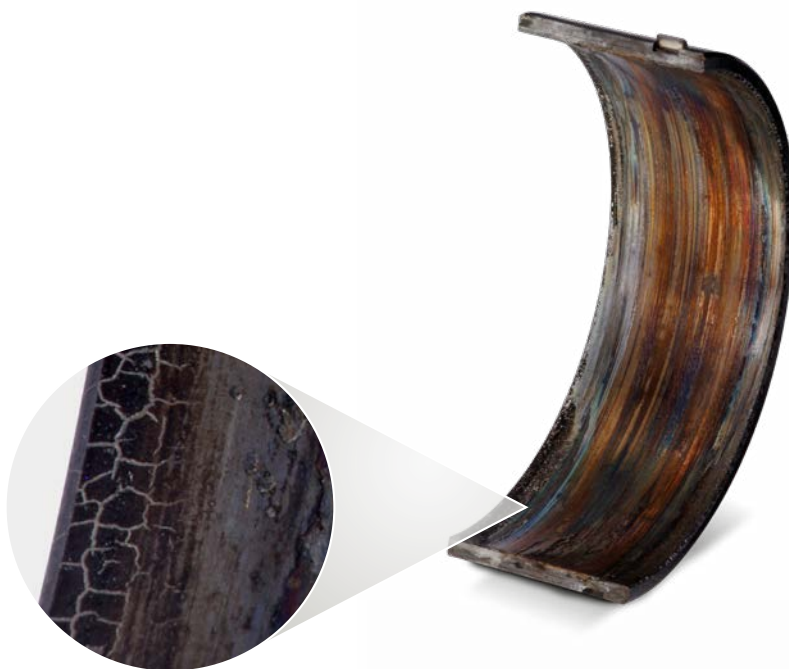
**Cap and rod-side conrod bearing shell steel-bronze composite with galvanic coating**

Clear discolouration and fusion is visible on the sliding layer of the seized bearing shells. The crack formation is above all recognisable in the area of the edge.

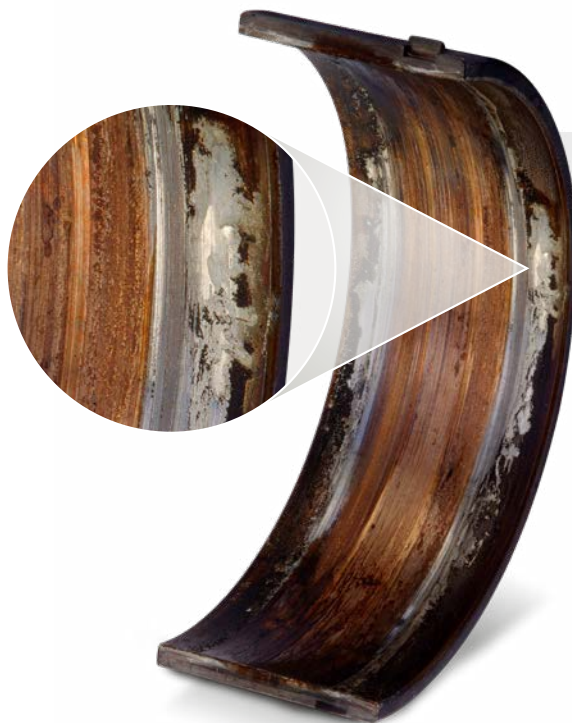
**Cap-side conrod bearing shell  
steel-bronze composite with  
galvanic coating**

White fusion deposits are visible in the galvanic layer.

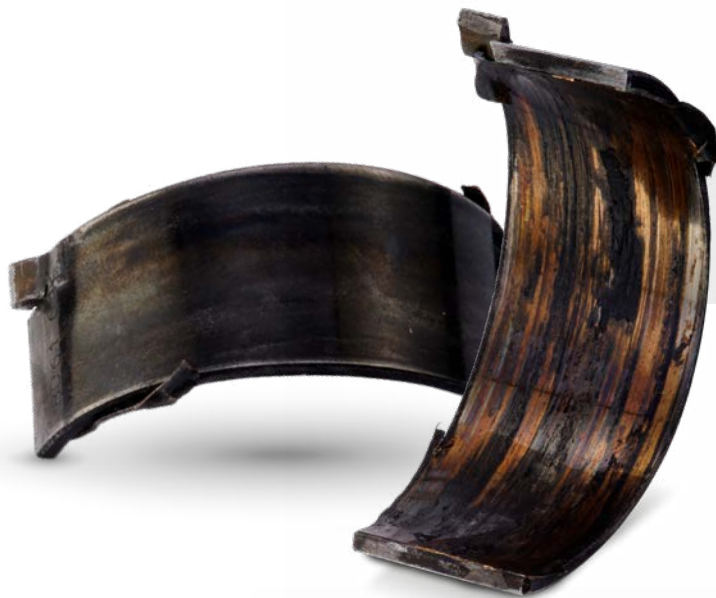
**Rod-side conrod bearing shell  
steel-bronze composite with  
galvanic coating**

Following bearing seizure, the back of the bearing is black in colour.

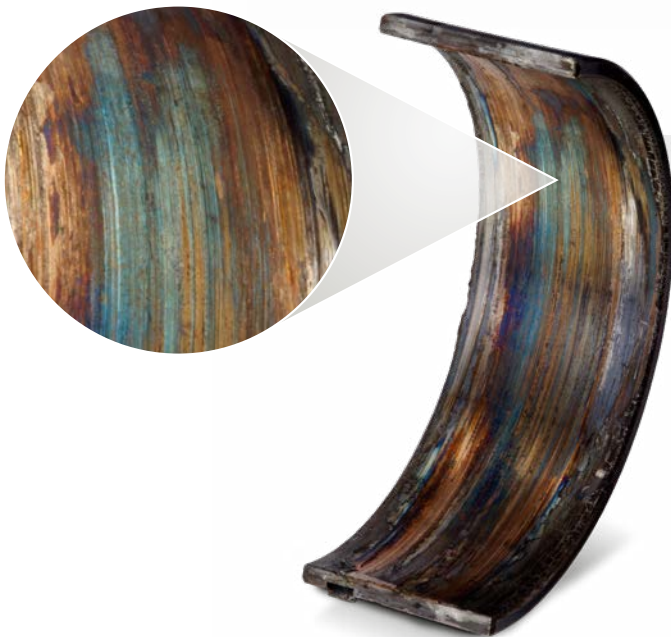
**Cap-side conrod bearing shell  
steel-bronze composite with  
galvanic coating**

The tarnishing colour can be seen in the sliding layer.

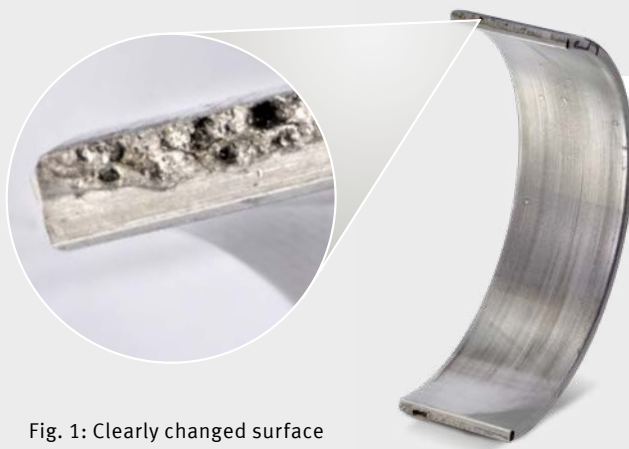
Fig. 1: Clearly changed surface

In the area of the parting face, signs of movement of the bearing shell in the form of frictional corrosion may also be visible. The material surface has clearly changed (Fig. 1).

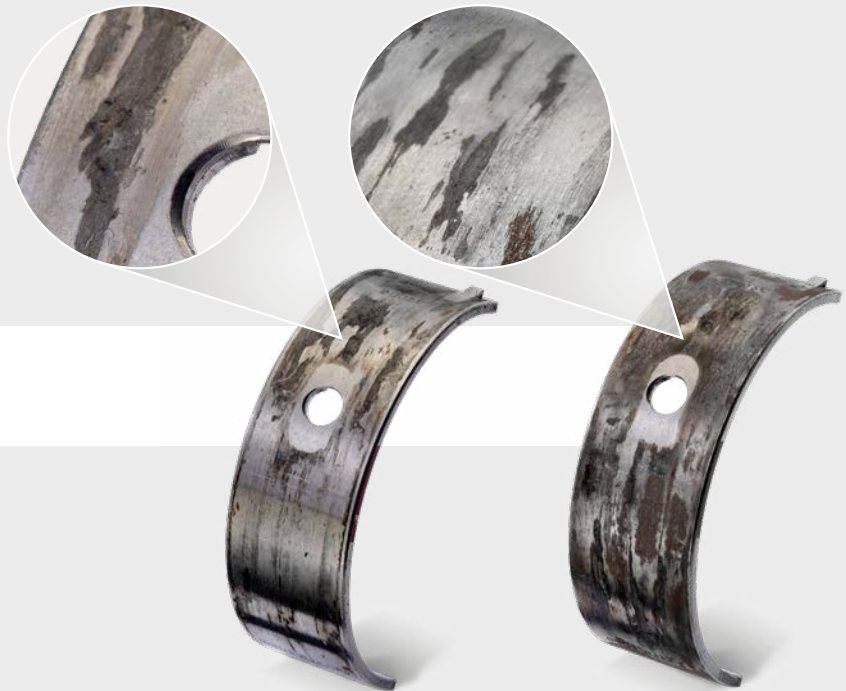
#### Upper main bearing shells steel-aluminium composite

Clear traces of frictional corrosion can be recognised – in part with areas of torn-out material (Fig. 2).

Here, the clear characteristics of surface frictional corrosion are recognisable: with areas of torn-out material and scarring of the surface (Fig. 3).

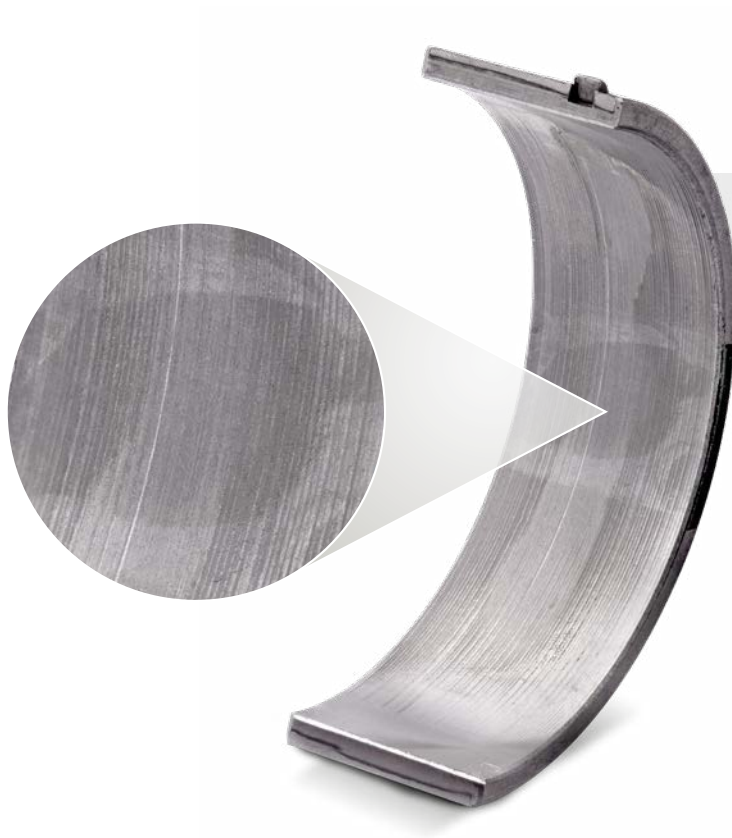
**Lower main bearing shell  
steel-aluminium composite**

Deposits from corrosion products are visible in the bearing sliding surface, especially pronounced in the centre of the bearing. The deposits appear in the formation of stains. When studied under a microscope, roughening of the bearing sliding surface can be seen in the corroded area.

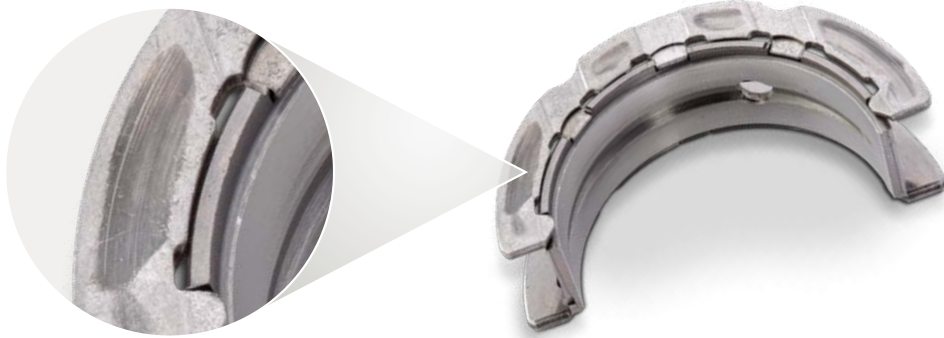
**Advanced sliding wear**

Material displacement and removal; oil groove hardly still there

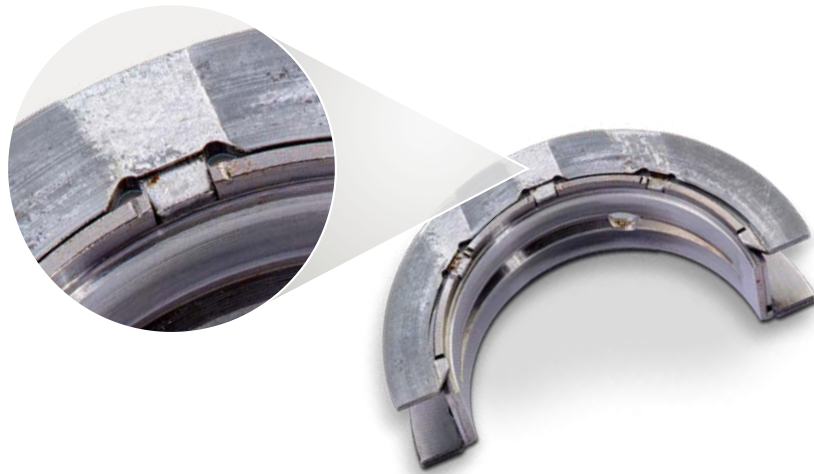
**Seizure**

Areas of torn-out material and pronounced scoring; oil grooves are no longer visible
