# KNOWLEDGE**POOL**

## DAMAGE TO ENGINE BEARINGS

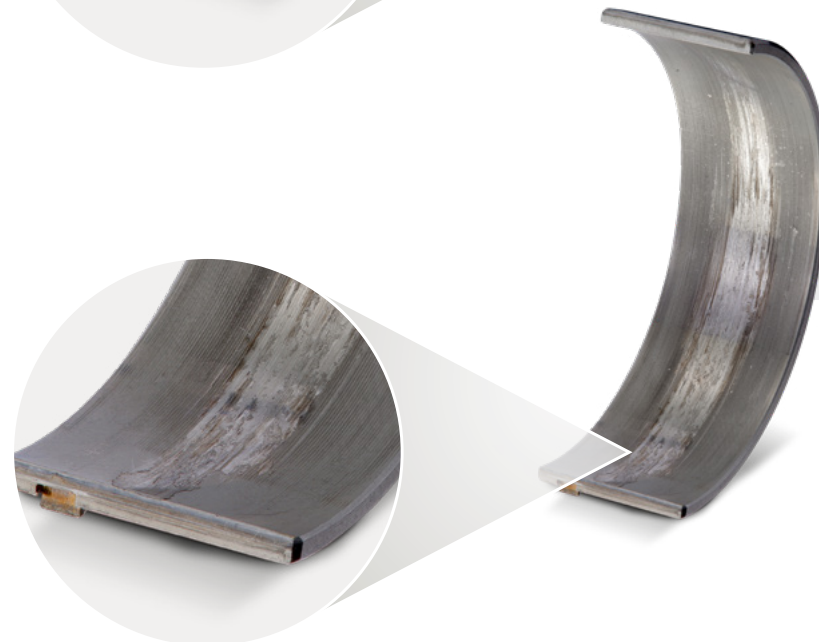
**Rod-side conrod bearing shell  
steel-brass composite with  
sputter coating**

A bright mark of mixed friction, with partial associated scoring, is recognisable. The sputter coating has been displaced out into the relief area. The area where the sputter coating has already seized has fused.

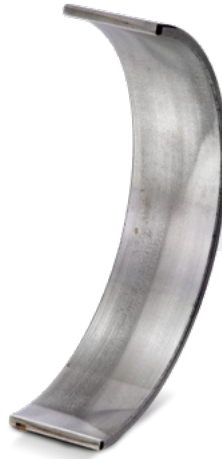
**Rod-side conrod bearing shell  
steel-brass composite with  
sputter coating**

The diagonally offset wear pattern can be recognised. At the edge of the bearing, the intensity of the wear is pronounced to differing degrees in different areas. The function of the bearing is not impaired.

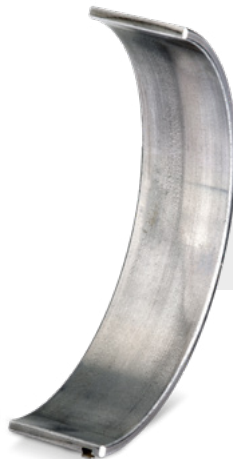
**Cap-side conrod bearing shell  
steel-aluminium composite**

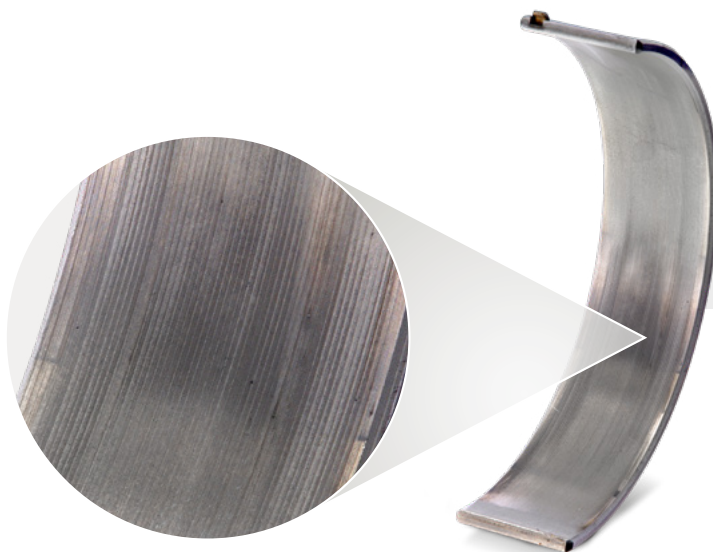
**Rod-side conrod bearing shell  
steel-brass composite with  
sputter coating**

Two-sided edge wear in the early stages – wear in the form of adaptive run-in wear.

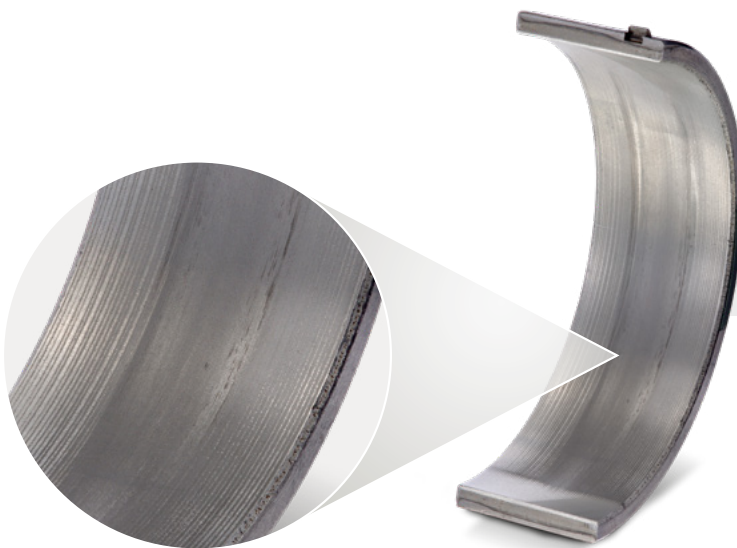
**Lower main bearing shell  
steel-aluminium composite**

Here, a strong wear pattern in the centre of the bearing which tapers off towards the relief can be identified. In terms of form, the wear pattern still corresponds to adaptive run-in wear.

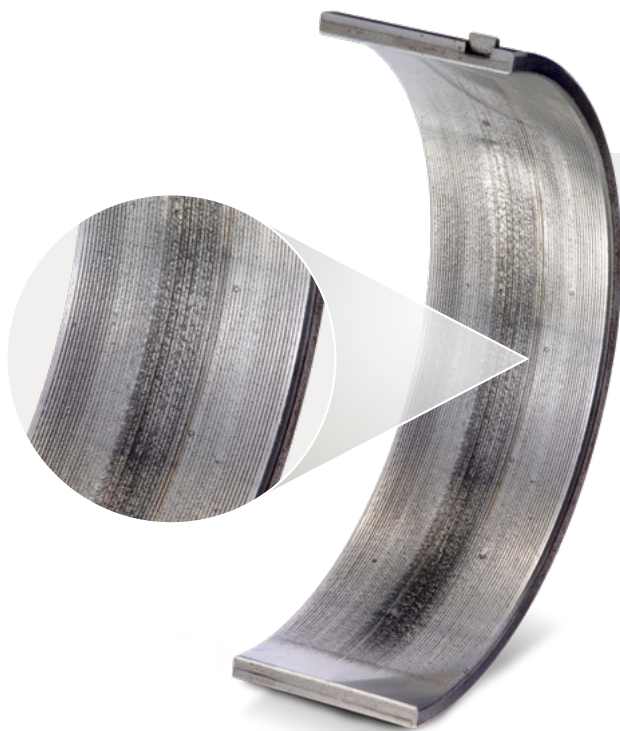
**Lower main bearing shell  
steel-aluminium composite**

Clearly delineated stripes can be seen in the centre of the bearing. This corresponds to the shape of the oil groove which is in the upper main bearing shell. The wear marks occur in the form of adaptive run-in wear.

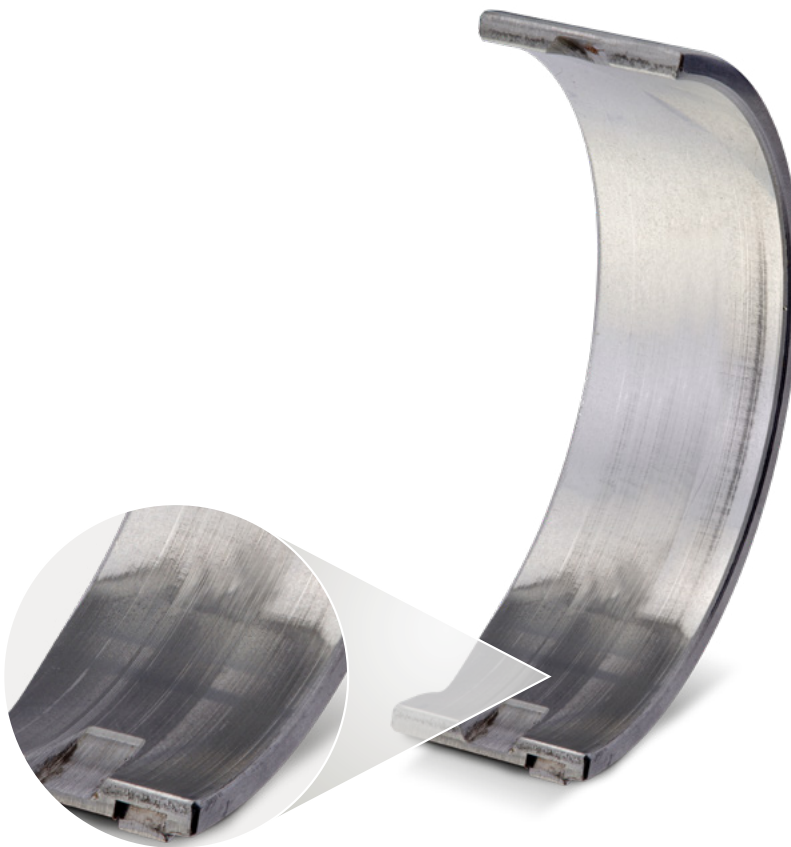
**Lower main bearing shell  
steel-aluminium composite**

Pronounced wear is visible in the relief, whilst the bearing crown is considerably less worn.

The bearing must be replaced and the cause rectified as the bearing is not designed to carry weight in this area:

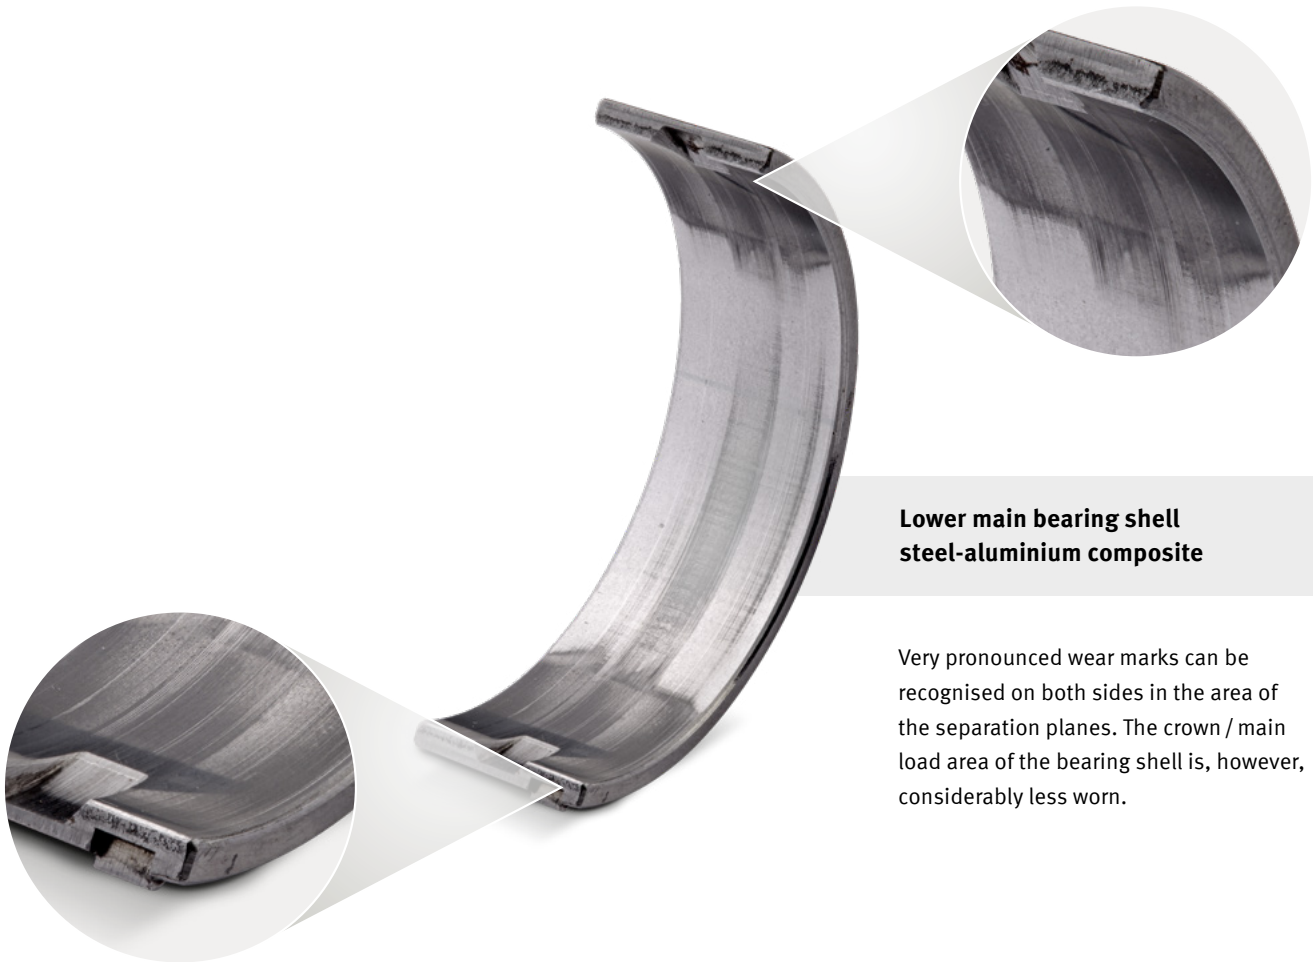
**Lower main bearing shell  
steel-aluminium composite**

Very pronounced wear marks can be recognised on both sides in the area of the separation planes. The crown / main load area of the bearing shell is, however, considerably less worn.

- Oval deformation of the bearing bore due to thermal or mechanical stress
- Connecting rod with oval connecting rod eye – connecting rods that have already been used have been reinstalled without the reworking required
- Wrong bolt tightening when boring the bore

- Check stress on the bearing bore
- Check bore: dimensions, roundness, cylindricity, surface must be within certain tolerances – rework used parts before reinstalling if necessary
- Tighten bolts in accordance with the manufacturer's specifications with regard to tightening torques and the tightening sequence

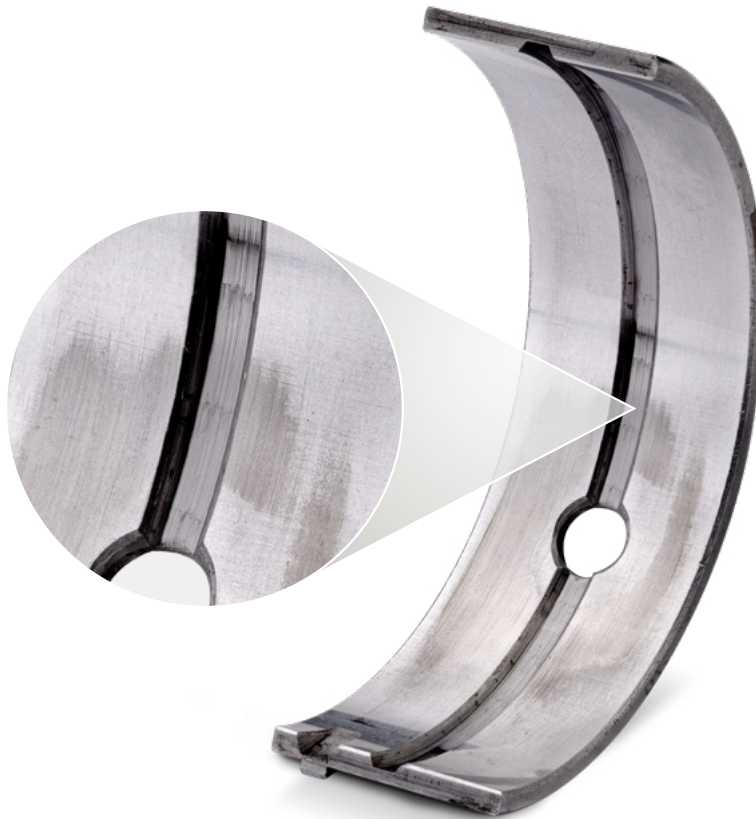
**Upper main bearing shell  
steel-aluminium composite**

Wear marks in the area of the crown in the form of adaptive run-in wear can be recognised. No other operating marks are visible in other parts of the bearing sliding surfaces.

This appearance is caused by a horizontal oval bore. This reduces the bearing clearance in the crown meaning that the lubricating film is not fully stable and mixed friction occurs in places. If the shortage of lubrication continues, the temperature increases due to the frictional heat that results.

The shortage of lubrication continues to intensify due to the increasing temperature level and the process reinforces itself until the first initial rubbing marks occur and fatigue damage occurs in this area due to increased surface pressure.

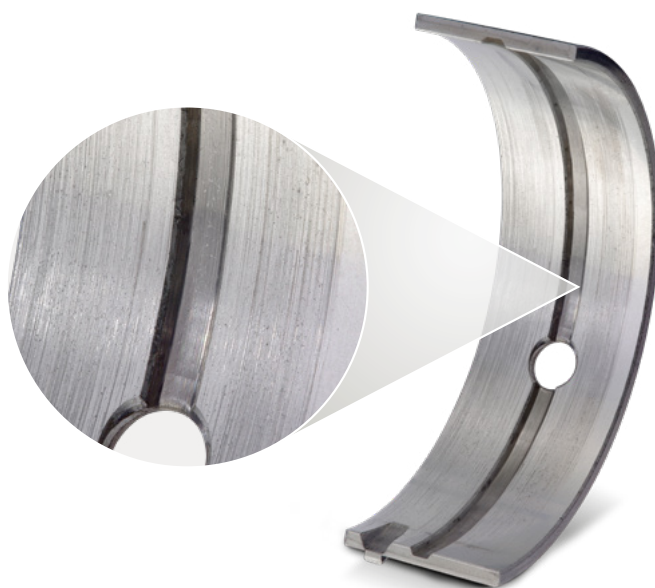
**Upper main bearing shell  
steel-aluminium composite**

One wear-free strip is recognisable at the edges of the bearings without any visible wear marks. The remaining part of the bearing has pronounced scoring.

Due to one-sided (Fig. 1) or two-sided (Fig. 2) axial protrusion of the bearing shells, narrow, wear-free strips at the edges of the bearings are formed, which also do not demonstrate the typical adaptive run-in wear. Irrespective of the speed of the journal, there is never any metallic contact in these areas.

The bearings can continue to be used depending on their wear condition. They should be replaced as soon as initial rubbing marks develop or indicators of material fatigue become visible and measures to determine the cause should be taken:

- Check for correct geometry of the crankshaft before installation: dimensions, roundness
- Replace the crankshaft or install new bearings which fit the crankshaft geometry

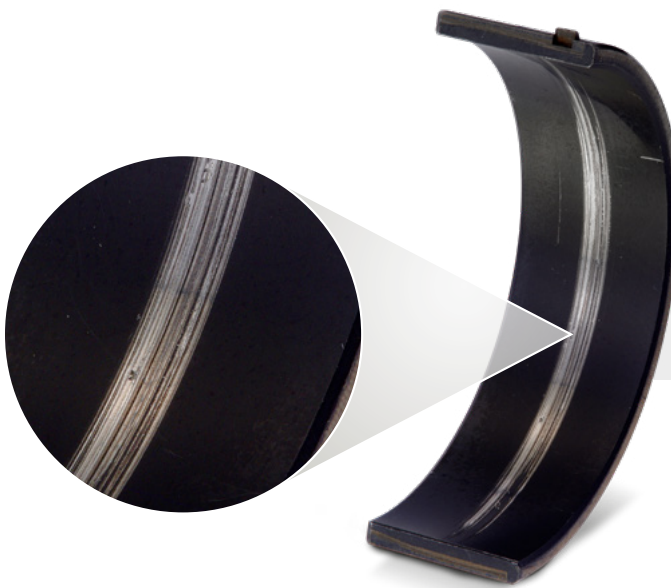
**Lower main bearing shell  
steel-aluminium composite  
with polymer coating**

The grooves are worn up to the aluminium  
alloy layer.

If grooves with pronounced material accumulation are present at the edges, the bearing must be replaced. If grooves are present with areas of material accumulation which have been flattened, and no further influence of particles can be expected, the bearings can still be used.

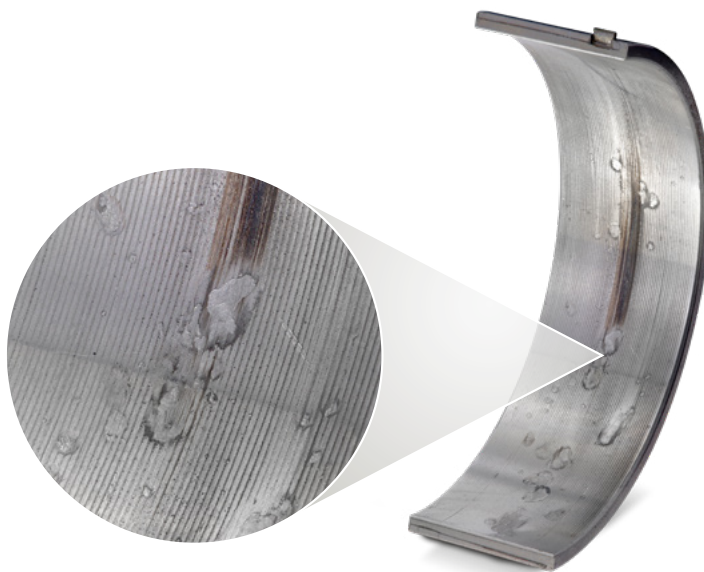
**Lower main bearing shell  
steel-aluminium composite**

Large particle imprints without embedded particles are visible. The particles have caused areas of material accumulation which have caused an initial rubbing mark in the centre of the bearing.

Particles which find their way into the lubricant gap may become embedded in the bearing material. Depending on the thickness of the sliding layer, we can differentiate between deep and shallow embedding. In the case of deep embedding, the particles are completely integrated into the sliding layer. This is only possible when the particle is smaller than the thickness of the layer. The material accumulation created during the embedding is flattened during the subsequent contact with the shaft due to wear. Shallow embedding takes place when the size of the particle is greater than the thickness of the layer. The particles are not completely embedded and protrude from the bearing surface. They cause wear and scoring on the journal surface.

Due to the material accumulations at the edges or protrusions from particles which are not completely embedded, the formation of the lubricant film is disrupted, and mixed friction conditions may be created. So-called „wire-wool“ wear is a possible consequence. Here the embedded particles cut into the surface of the shaft and remove material (chipping wool). The particles that break away, which are then embedded again, accelerate the bearing damage, and often complete failure of the journal and bearing cannot be avoided.

If large particle embedding in conjunction with initial wear of the journal and bearing is present, the bearing must be replaced.

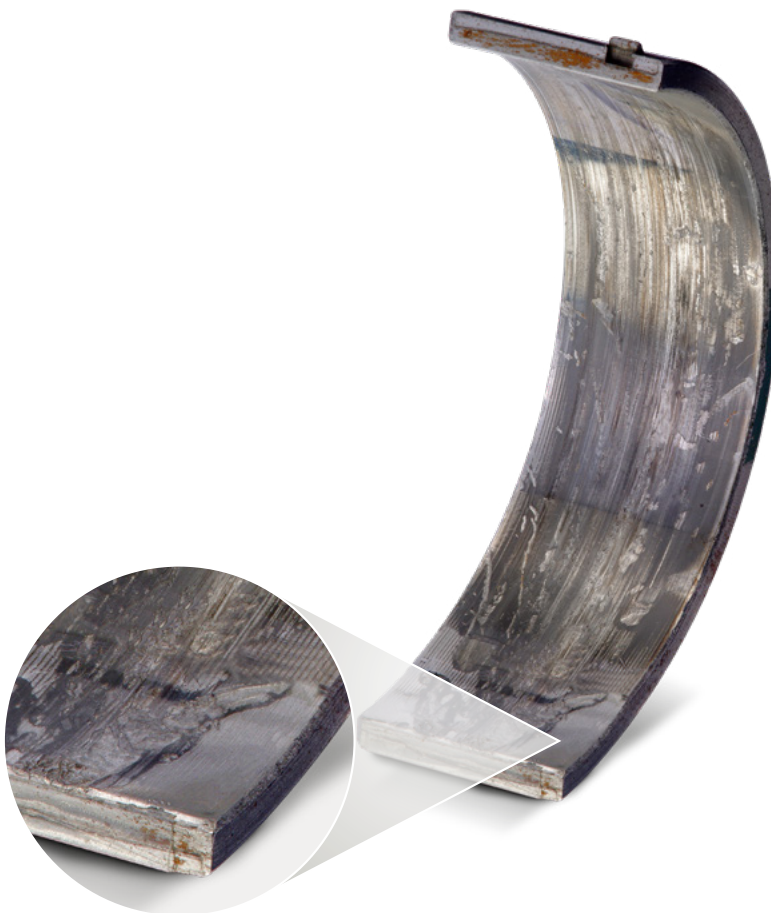
**Lower main bearing shell  
steel-aluminium composite**

A dirt progression mark, starting from the parting face, has occurred. Several large particle indents one after the other – running diagonally – are visible. Particles which are still embedded may be present in part.

Very large and hard particles which find their way into the lubricant gap cannot become embedded in the bearing material. They are forced through the lubricating gap, but then always become stuck again. Frequently, the pattern appears from oil grooves or oil bores as the particles were introduced here. Pronounced material accumulation along the progression track causes initial rubbing marks and seizure.

If there are pronounced areas of material accumulation along the progression track, or signs of an initial rubbing mark, the bearing must be replaced. The bearings can still be used, however, if the material accumulations have been flattened and there is no longer the risk of the influence of particles.

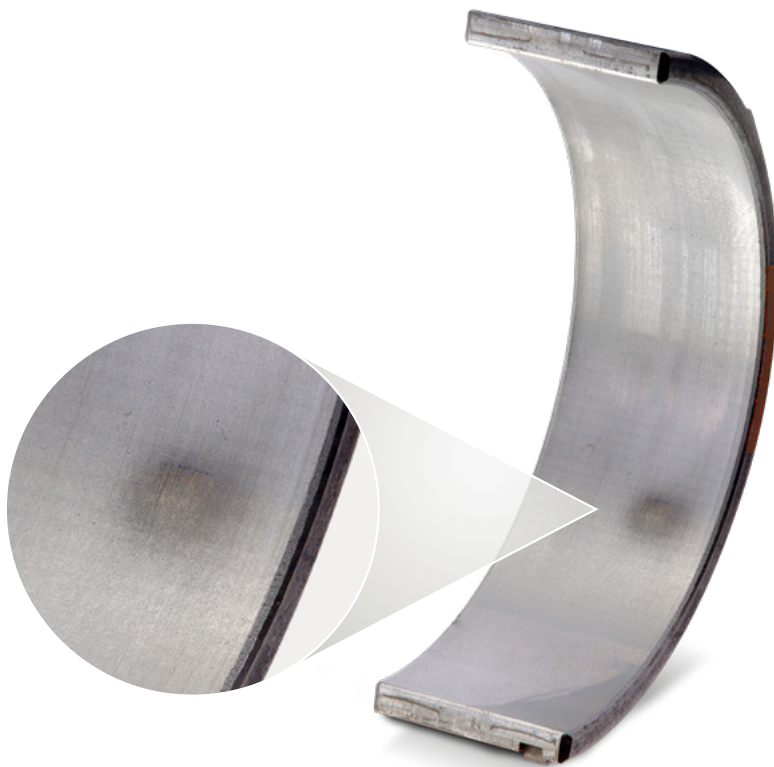
**Lower main bearing shell  
steel-aluminium composite**

A clear deviation in the wear pattern, as well as point-like wear in the sliding surface can be recognised. The pressure mark is the result of particles at the back of the bearing.

Due to dirt or oil residues (carbon) at the back of the bearing, local pressure points arise, which become noticeable on the bearing sliding surface. Due to the pressure, on the inside of the bearing there is increased wear compared to the remaining areas of the bearing. This can be recognised as a noticeable, mostly bright light deviation to the wear mark. Depending on the extent of the pressure points, initial rubbing marks and seizure, as well as fatigue damage, may be the result.

Whether the bearing can still be used depends on the progress of the wear of the sliding layer. As soon as initial rubbing marks or signs of material fatigue such as cracks or nicks in the area of the pressure point occur, the bearing should be replaced, otherwise there is the threat of complete failure. Broken-off material can cause consequential damage in the same or an adjacent bearing.

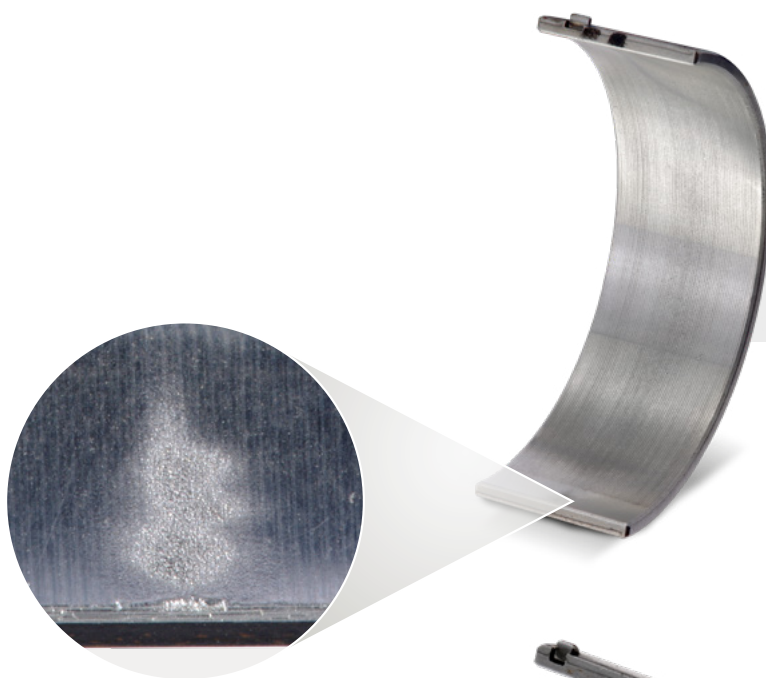
**Cap-side conrod bearing shell  
steel-aluminium composite**

Cavitation in the relief: material removal can clearly be seen – the area is matte compared to the surrounding material.

Pressure surges caused by the implosion of gas and vapour bubbles near to the surface of the bearing result in material nicks (see chapter: „4. Erosion and cavitation“). Cavitation often comes hand-in-hand with erosion and corrosion and can cause fine scoring in the same or adjacent bearings.

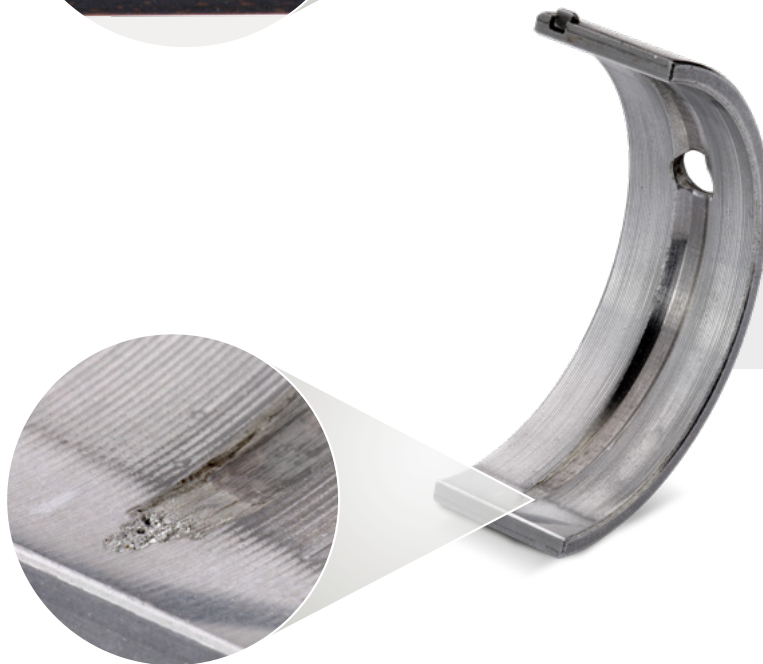
**Upper main bearing shells  
steel-aluminium composite**

Cavitation in the run-out of the oil groove: a mushroom-shaped nick in the bearing material can be seen. The area is much more matte and roughened compared to the surrounding material.

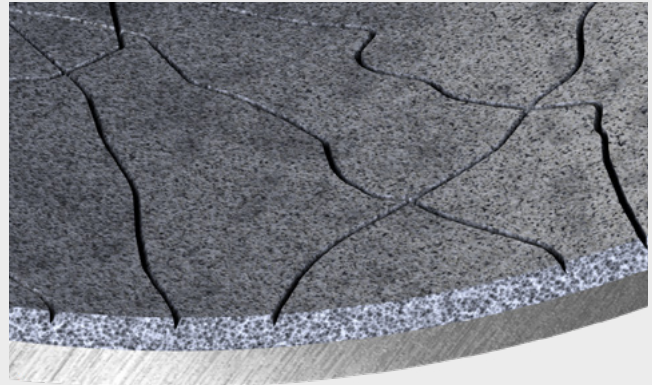
Fig. 1: First cracks

If the integrity of the material is exceeded locally, fatigue occurs. The first cracks form (Fig. 1), which continue to grow due to notch effect and a network of cracks develops (Fig. 2). In addition, nicks occur (Fig. 3) in the bearing metal. The network of cracks and the nicks reduce the strength of the bearing, meaning a fatigue fracture can be caused in the event of stress. The engine bearing has then lost its ability to function and complete failure occurs.

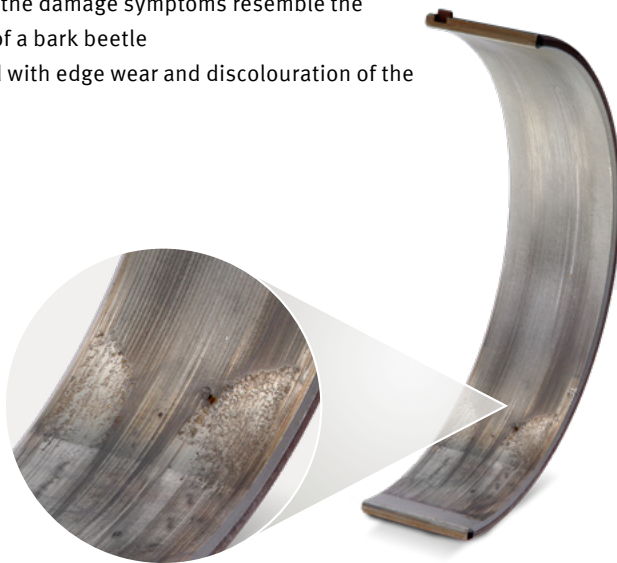
**Rod-side conrod bearing shell  
steel-brass composite with  
sputter coating**

The engine bearing demonstrates signs of fatigue towards the relief in the form of cracks and initial nicks up into the brass layer.

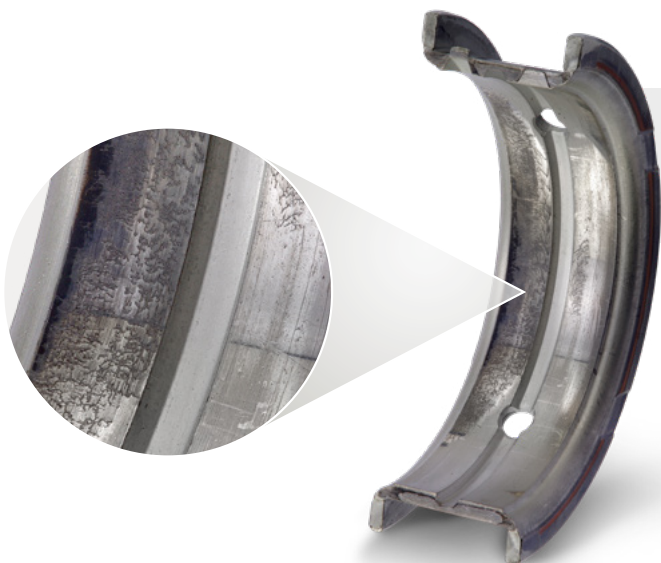
**Main bearing shell  
steel-bronze composite with  
galvanic coating**

One-sided edge wear on both bearing shells caused the fatigue of the galvanic layer and created the typical „bark beetle“ damage pattern.

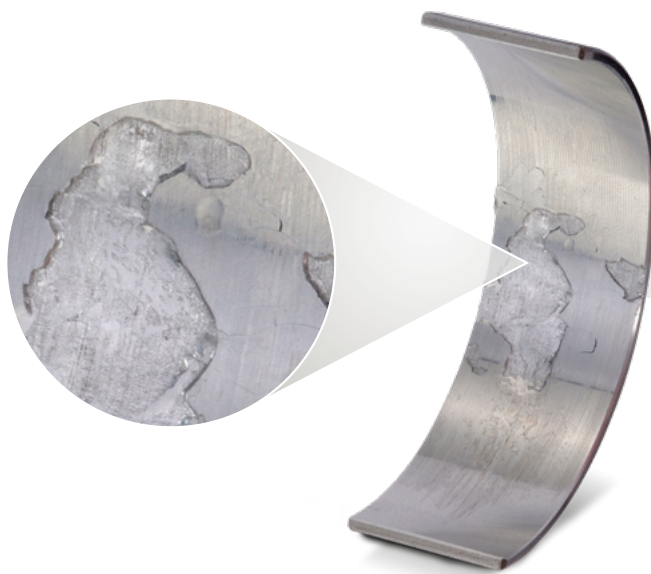
**Rod-side conrod bearing shell  
steel-aluminium composite**

Large nicks and cracks can be recognised.

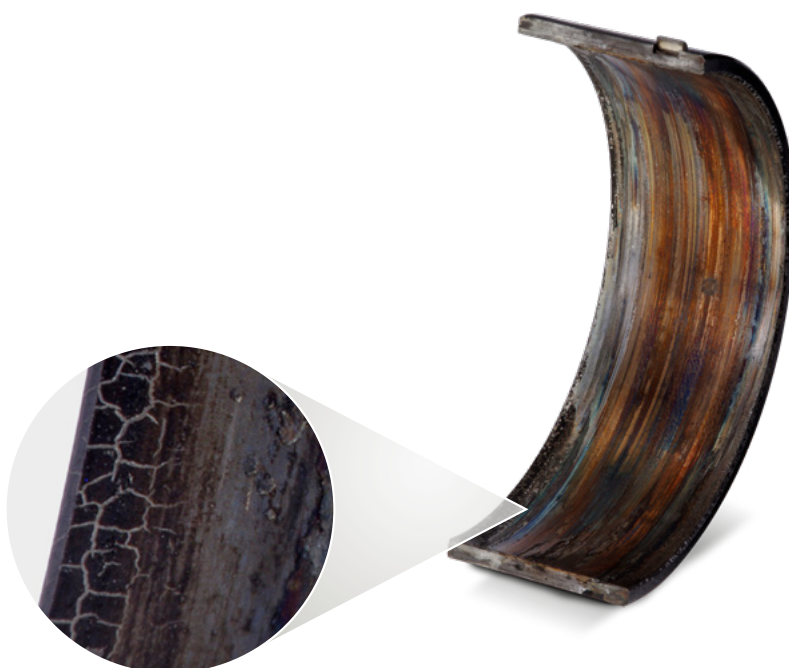
**Cap and rod-side conrod bearing shell steel-bronze composite with galvanic coating**

Clear discolouration and fusion is visible on the sliding layer of the seized bearing shells. The crack formation is above all recognisable in the area of the edge.

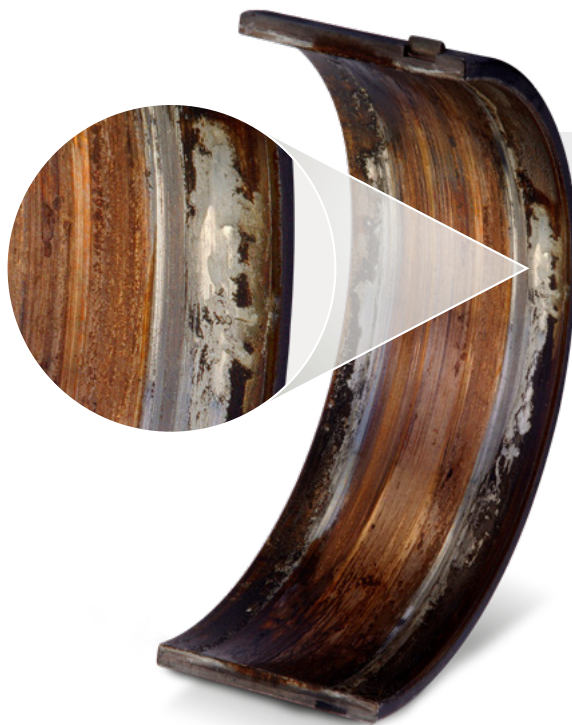
**Cap-side conrod bearing shell  
steel-bronze composite with  
galvanic coating**

White fusion deposits are visible in the galvanic layer.

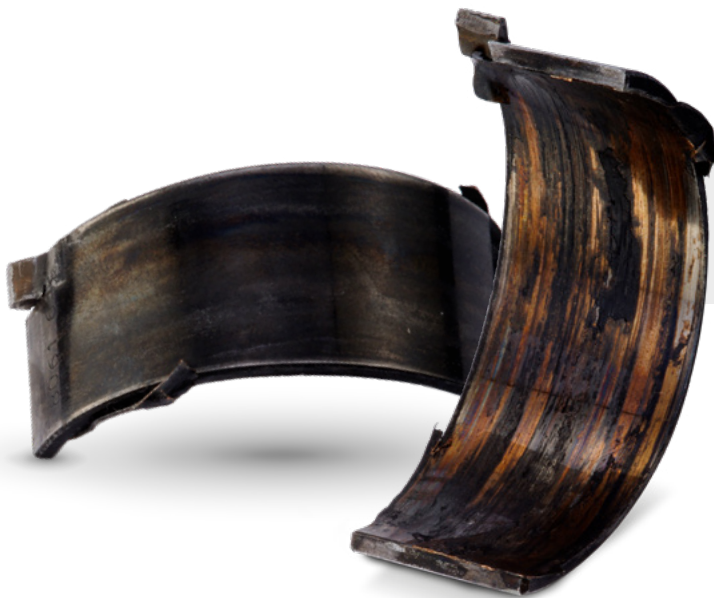
**Rod-side conrod bearing shell  
steel-bronze composite with  
galvanic coating**

Following bearing seizure, the back of the bearing is black in colour.

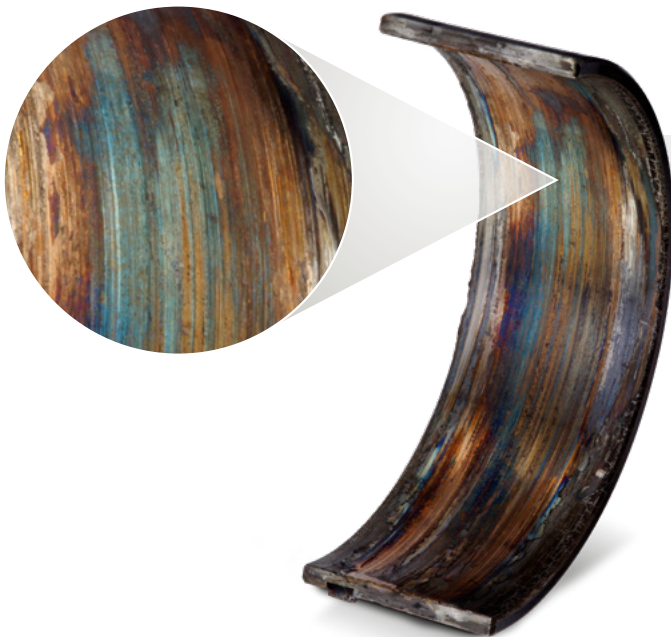
**Cap-side conrod bearing shell  
steel-bronze composite with  
galvanic coating**

The tarnishing colour can be seen in the sliding layer.

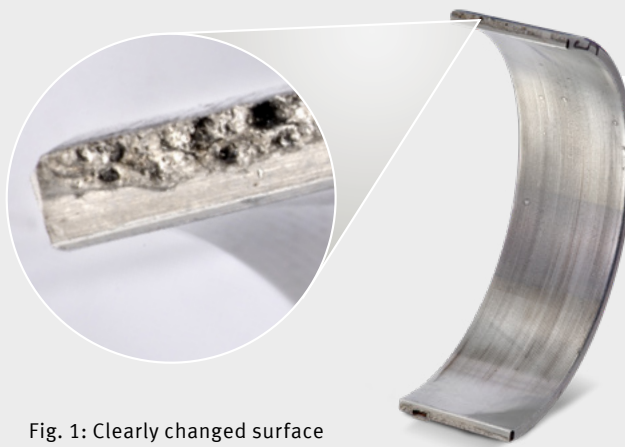
Fig. 1: Clearly changed surface

In the area of the parting face, signs of movement of the bearing shell in the form of frictional corrosion may also be visible. The material surface has clearly changed (Fig. 1).

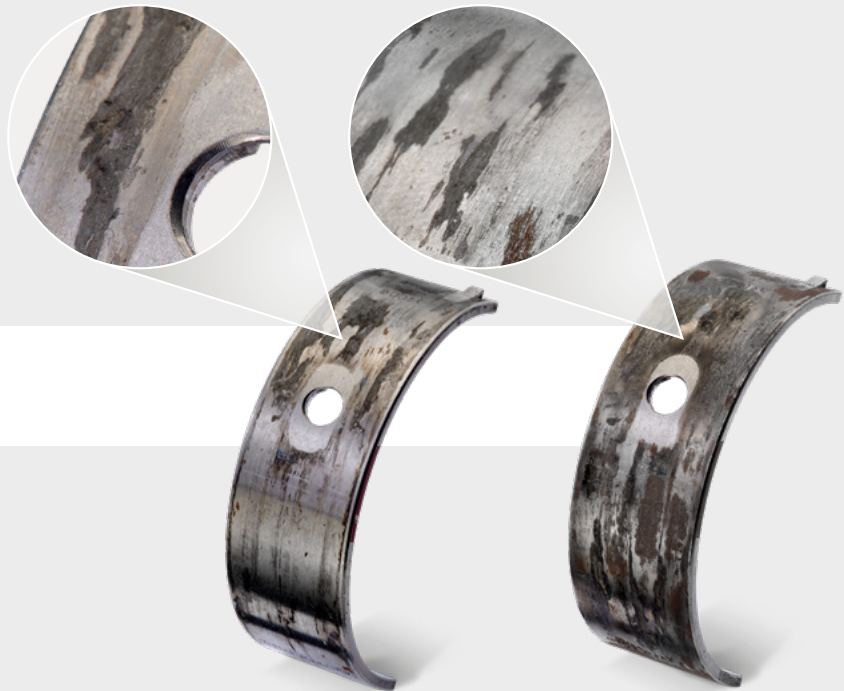
#### Upper main bearing shells steel-aluminium composite

Clear traces of frictional corrosion can be recognised – in part with areas of torn-out material (Fig. 2).

Here, the clear characteristics of surface frictional corrosion are recognisable: with areas of torn-out material and scarring of the surface (Fig. 3).

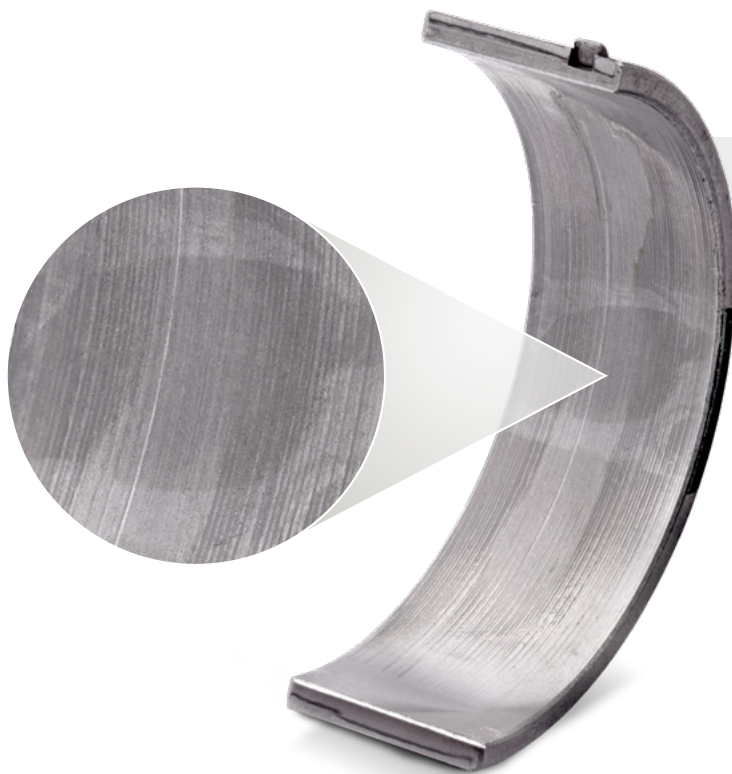
**Lower main bearing shell  
steel-aluminium composite**

Deposits from corrosion products are visible in the bearing sliding surface, especially pronounced in the centre of the bearing. The deposits appear in the formation of stains. When studied under a microscope, roughening of the bearing sliding surface can be seen in the corroded area.

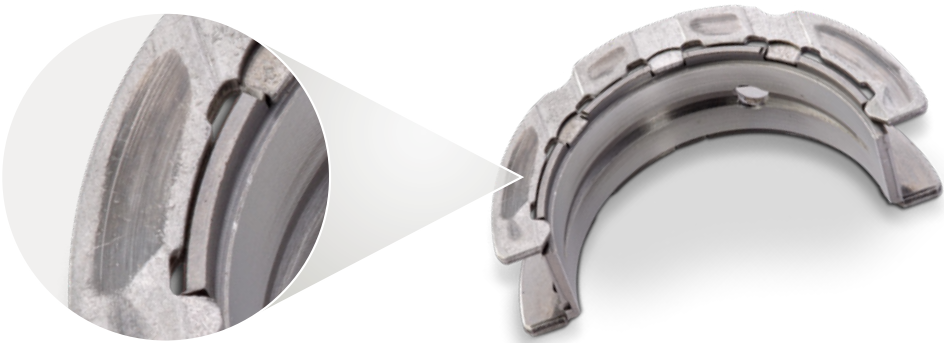
Wear marks are visible on the sliding surface of the thrust washer

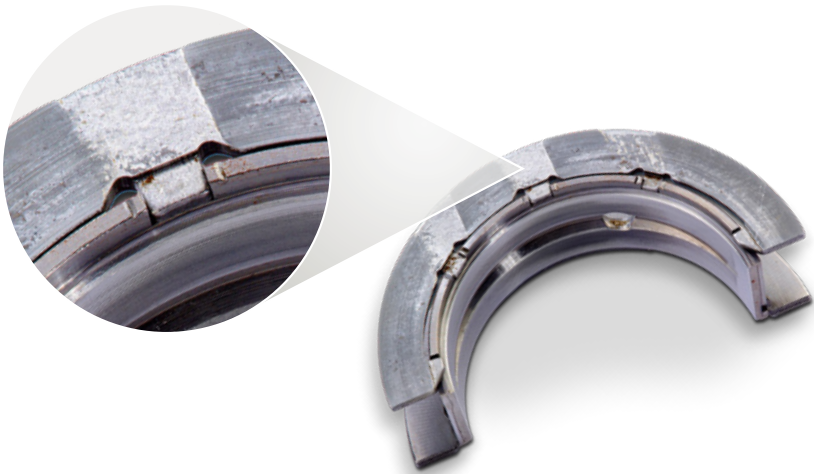
**Advanced sliding wear**

Material displacement and removal; oil groove hardly still there

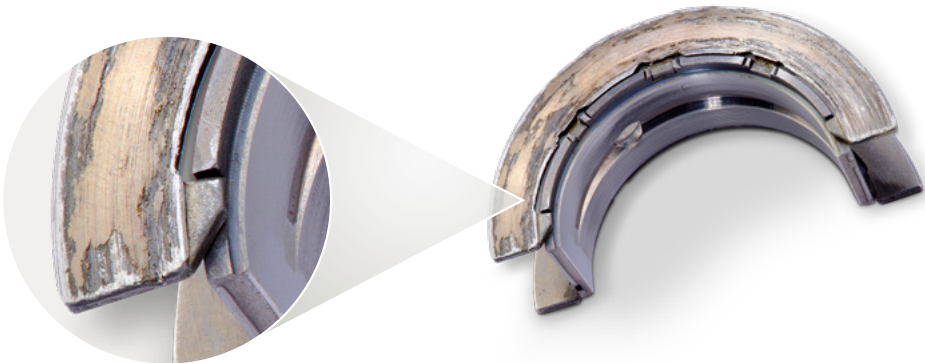
**Seizure**

Areas of torn-out material and pronounced scoring; oil grooves are no longer visible
