KNOWLEDGE POOL

PISTON DAMAGE – RECOGNISING AND RECTIFYING

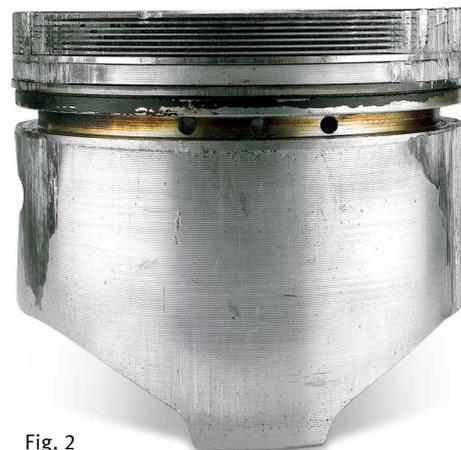
Fig. 2

- Seizure marks on both the pressure and anti-thrust sides, offset at approximately 45° to the piston pin axis.
- The seizure areas change from bright wear marks to relatively smooth, darkly discoloured areas of wear caused by rubbing (Fig. 1).
- Piston pin displays blue tempering colour (Fig. 3). Reason: piston pin bed has become hot due to insufficient clearance or a lack of oil.

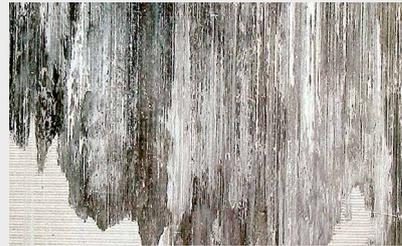
If the oil film is destroyed altogether:

Seamless areas of narrow seizure marks, mainly on the piston skirt, showing a severely worn and darkly discoloured surface.

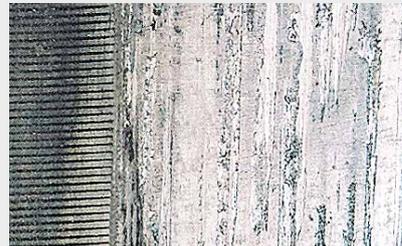
If there is a lack of oil:

Identical to those described above, apart from the discoloration of the surface. The surface of the seizure areas has an almost pure metallic finish, with no dark discoloration. As the lack of oil affects the entire surface of the cylinder, there are often seizure marks on both the pressure side and the anti-thrust side in the piston, in many cases even in the early stages.

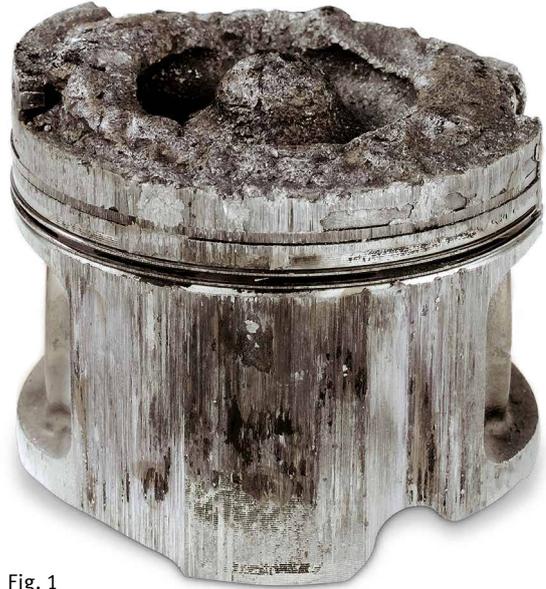
Fig. 1

- Erosive-type removal of material due to melting on the piston crown or the piston top land in the injection direction of the nozzle jets.
- No seizure marks on the piston skirt or the piston ring zone.

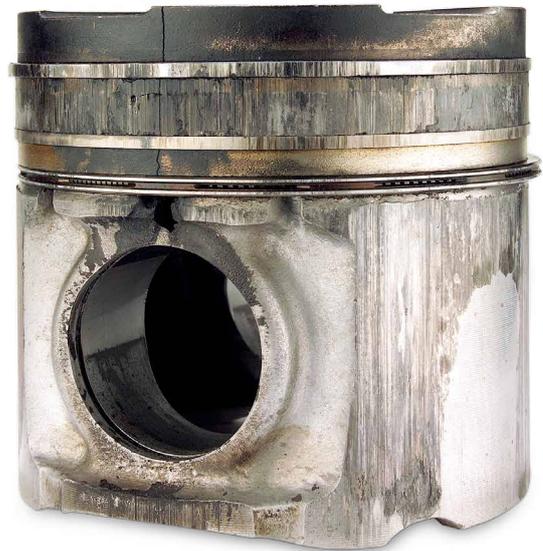
Fig. 2

The piston material is heated up significantly in localised areas – at the point where the prechamber jets make contact on prechamber engines (Fig. 3 and Fig. 4), and on the edge of the bowl on direct injection engines (Fig. 1). The material expands more than elsewhere in these areas. As the overheated areas are surrounded by colder materials, the material is plastically deformed here beyond its limit of elasticity. Exactly the opposite happens when it then cools down again: in the areas where before the material was previously buckled and forced away, there is now a shortage of material.

This results in tensile stresses, which ultimately cause stress cracks. If there are superimposed stresses caused by bending of the piston pin in addition to the thermal stresses, then the stress cracks turn into a much larger major crack, which causes complete breakage and failure of the piston.

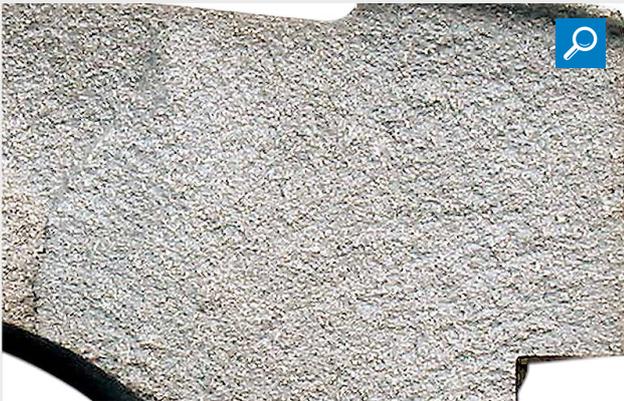
Fig. 1

A forced fracture (Fig. 1) is always caused by a foreign body that collides with the piston while the engine is running. These foreign bodies could be parts of the connecting rod, crankshaft or valves, etc. that have been torn off. A forced fracture of the piston can also occur if water or fuel gets into the cylinder.

The fracture surfaces of a forced fracture appear grey. They are not worn down and display no line markings. The piston breaks suddenly without any fracture development.

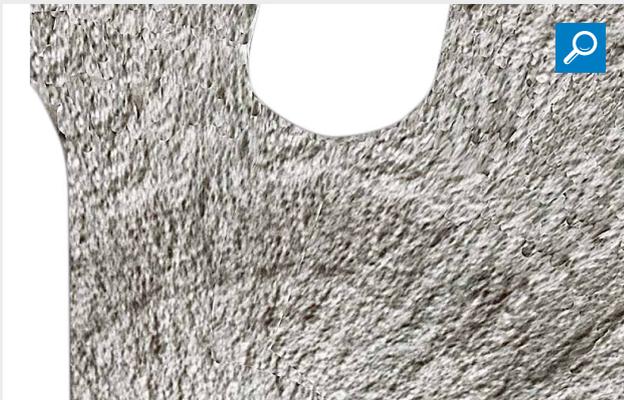
Fig. 2

In the case of a fatigue fracture (Fig. 2), line markings form on the fracture surface that reveal the starting point and the gradual progress of the fracture. The fracture surfaces are often worn to the point of being shiny. The cause for a fatigue fracture is overstressing of the piston material.

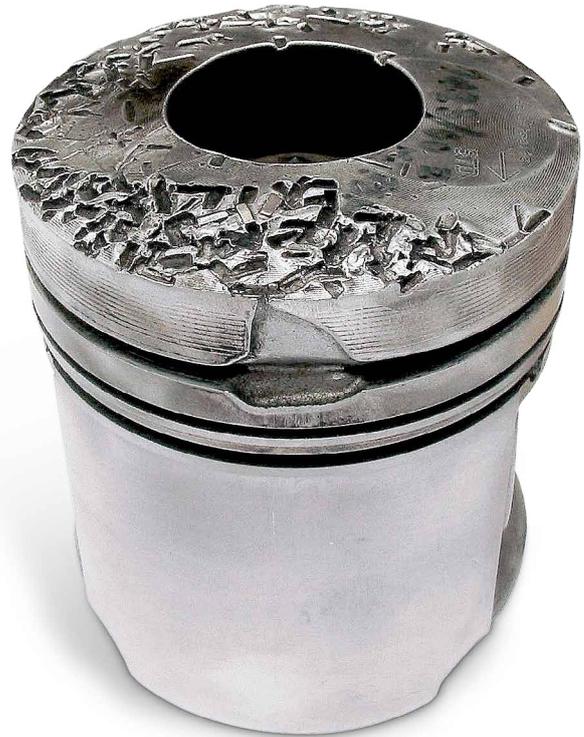
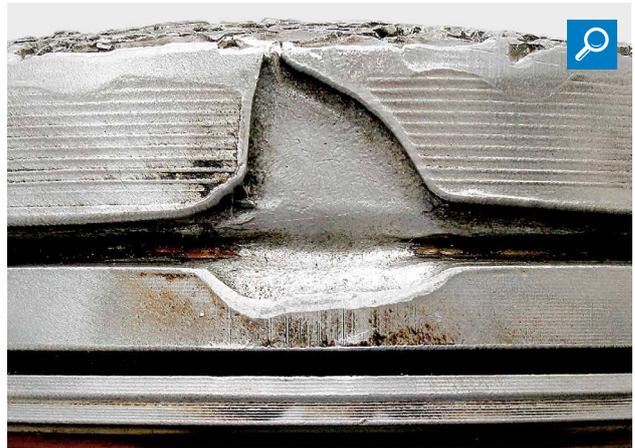
- Severe material washout reaching as far as the piston crown in the ring zone in the area of the first ring groove.
- Severe axial wear on the first ring groove.
- Severe mechanical damage on the piston crown.
- Running pattern of the piston skirt has a matt, buffed appearance.

The damage is caused by the ingress of contamination into the combustion chamber. This is indicated by the severe axial wear on the grooves and on the first ring groove in particular. The contamination was then also deposited in the ring groove, where they caused abrasive wear on the piston ring and the ring groove. The axial clearance of the piston rings increased steadily as a result. In terms of its cross section, the piston ring was severely weakened, and it could no longer withstand the pressures of the combustion process and broke. Consequently, the broken-off part of the piston ring could move around practically unhindered in the rapidly enlarging groove. The washout shown in the picture was caused as a result of continuous “hammering” of this broken-off part. Once the washout reached the piston crown, the fragments of the piston ring entered the combustion chamber where they caused more damage.

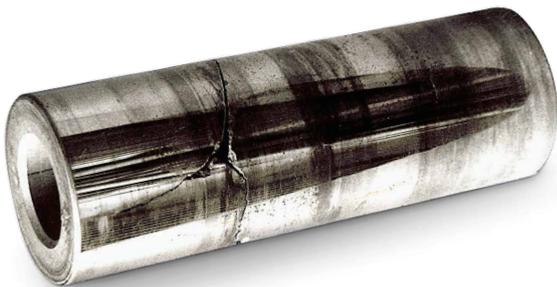
Fig. 1

- Lateral fracture on the piston pin (Fig. 1) at the transition between the connecting rod and the piston pin boss.
- Shorter fragment split along its length.
- Fracture surfaces display the characteristics of a fatigue fracture.

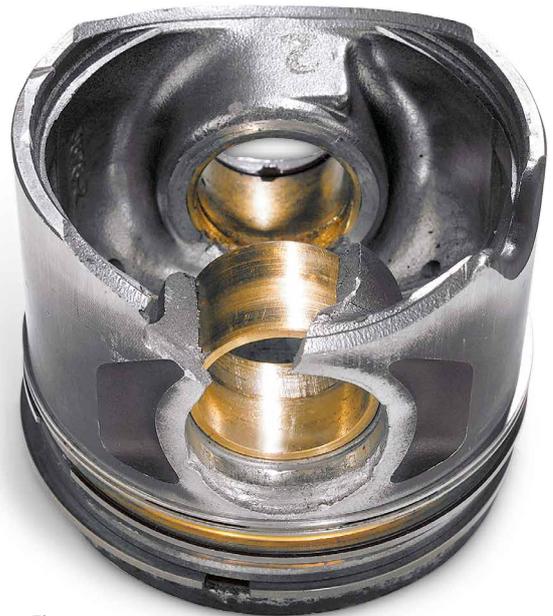
Fig. 5

- Asymmetrical piston wear pattern (Fig. 4).
- Piston pin boss and piston pin broken (Fig. 5 and 6).
- Pin bore hammered out in the area of the circlips.

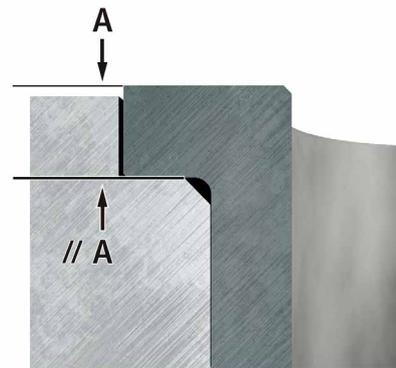
Fig. 2

- Worn liner flange seating surfaces on the engine after an extended running period.
- Dirty or corroded liner flange seating surfaces.
- Failure to ensure that the flange seat is perfectly rectangular and/or parallel (Fig. 2 and Fig. 5).
- Incorrect cylinder head gaskets.
- Non-compliance with the engine manufacturer's prescribed tightening torques and tightening angles when installing the cylinder head.
- Wrong number of sealing rings.

The distortion of the seating surface cannot be detected by visual inspection alone unless the appropriate measuring aids are used. One simple way to check for this distortion is the use of bearing ink: thinly apply the ink around the seating surface of the liner flange on the engine block. Then insert the new liner without gaskets and press it onto the seat. Remove the cylinder liner again. The seating surface on the cylinder liner should now be evenly coated with ink around the entire circumference. If this is not the case, the liner seat needs to be reworked. This reworking is best performed on a stationary boring machine or with a mobile liner flange seat facing attachment. This ensures parallelism with respect to the housing surface (Fig. 2).

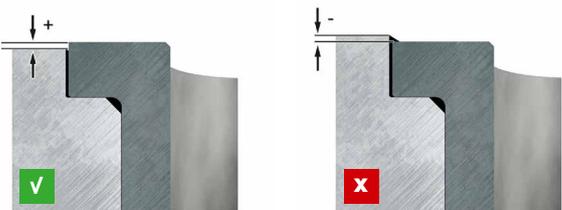
Fig. 6

- Prescribed liner protrusion not complied with (Fig. 6):
 - If the protrusion of the cylinder liner is too great, then the liner flange is pressed off when the cylinder head bolts are tightened.

When reworking the liner flange seating surface during engine reconditioning, the necessary protrusion of the cylinder liner over the cylinder surface must be ensured, either by inserting steel washers underneath or by using a cylinder liner with an oversized flange* (recommended).

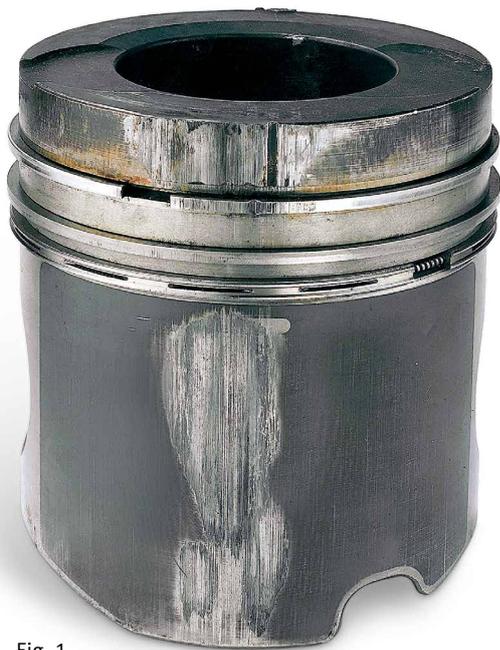
Fig. 1

- Upper area of cylinder liner displays severe damage due to a crack and seizure marks on the sliding surface (Fig. 2 and 3).
- Piston displays seizure marks on the pressure and anti-thrust sides.
- In the piston crown: bowl-shaped recess in the area of the seizure marks (Fig. 4).

The cylinder liner was damaged by a hydraulic lock, which burst the cylinder liner and pressed in a dent in the piston crown.

- Accidental intake of water while driving through water, or as a result of larger quantities of water being splashed up by passing vehicles or vehicles in front.
- While the engine is stopped, cylinder filling up with:
 - coolant due to leaks in the cylinder head gasket or cracks in components.
 - fuel due to leaking injection nozzles. The residual pressure in the fuel injection system is dissipated through the leaking nozzle into the cylinder. The damage occurs when the engine is started.

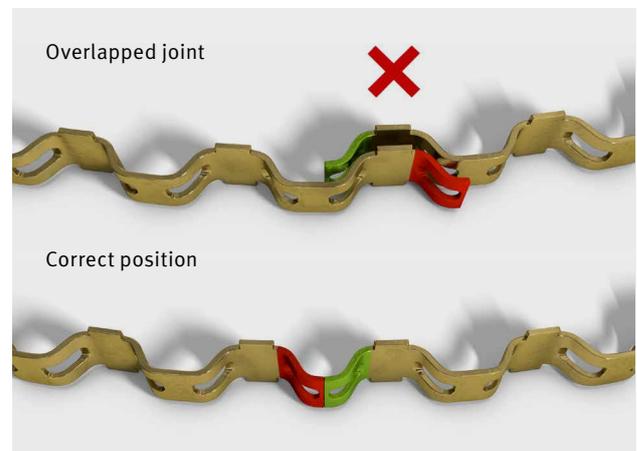
Fig. 2

- No signs of wear on piston rings or piston (Fig. 1).
- End of the expander spring of the 3-piece oil control ring broken off.
- Scratches in the groove base of the oil control ring.

Due to the overlapping of the expander spring during installation, its circumferential length is shortened. This results in a fracture in the expander spring and/or loss of tension for the 3-piece oil control rings. The blades are no longer pressed tightly against the cylinder wall and no longer scrape off the oil. Oil enters the combustion chamber, where it is burned. This results in excessive oil consumption.

- Incorrect oil control rings.
- Installation faults.

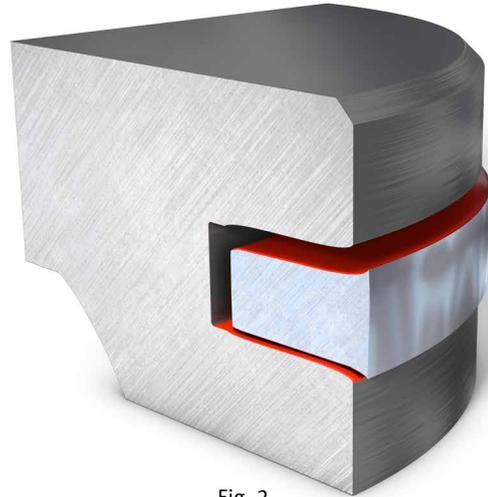
Fig. 2

- Piston: matt, ground wear pattern on the skirt with fine, small longitudinal scratches on the piston top land and the piston skirt.
- Tool marks created during machining worn away.
- Worn compression ring edges, on the first piston ring in particular as well as ring groove edges (Fig. 2).
- Axial clearance of the compression rings substantially increased, in particular on the first piston ring.

Abrasive foreign bodies in the oil circuit cause scratches on the piston and piston rings, a matt wear pattern on the piston skirt and roll marks on the ring flanks (Fig. 4 and 5). As the piston rings are worn on the running surfaces and edges, they can no longer seal the cylinder against oil passing into the combustion chamber. At the same time, the pressure in the crankcase increases as a result of combustion gases streaming past the cylinder. This may cause oil to escape at radial oil seals, valve stem seals and other sealing points. Roll marks on the piston rings are caused by dirt particles that become lodged in the ring groove. As the piston ring rotates in the groove it keeps running over the dirt particles, which creates the characteristic roll marks.

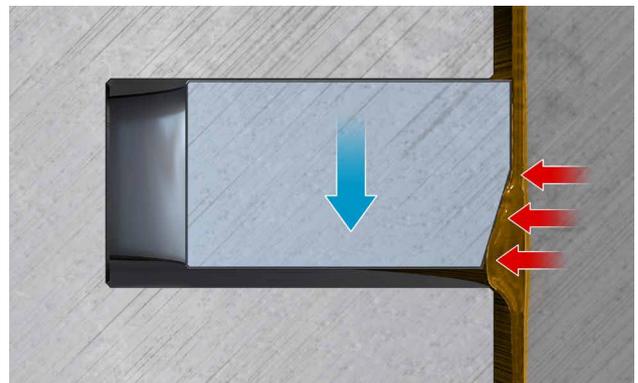
Fig. 2

The worn piston ring edges lead to high hydrodynamic forces (Fig. 2) between the running surfaces of the piston rings and the cylinder running surface as a result of the formation of an oil wedge.

The piston rings float on the oil film during the upward/downward motion of the piston and are lifted off slightly from the cylinder running surface. In this way, an increased quantity of lubricating oil reaches the combustion chamber where it is burned.
