Electric EGR Valves (e.g. Renault, Opel)

Stickiness at the valves

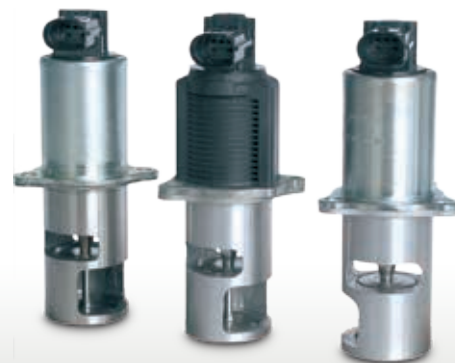
Through checks in the workshop the diagnosis "Malfunctioning EGR valve" was determined. The built-in electrical EGR valves suffer through oil-containing deposits.

- The valve is stiff.
- The valve is stuck and does not open.
- Due to the deposits the opening cross-section is reduced.
- The valve does not close fully.

EGR valve with sticky deposits and EGR valve as new

Exceptionally thick deposits may be due to several causes:

In the case of the EGR valves mentioned here, the most frequent causes of malfunctions are deposits at the valve disk or the valve seat. The EGR valve must be checked and replaced as required.

We do not recommend cleaning the EGR valve; when doing so, it might be damaged.
