# Intake manifold/electric drive module

## Possible fault cause and replacement

Vehicle	Product	Intake manifold	Electric drive module
Opel Astra H, Vectra C, Signum with 1.9 l CDTi engine (Z19DTH) Zafira B Alfa Romeo: 147, 156, 159, GT (1.9 JTD) Fiat: Stilo (1.9 JTD)	<b>PIERBURG No.</b>	<b>7.00373.12.0</b>	<b>7.00521.14.0</b>
	Replacement for	7.00373.1 0.0/7.01860.00.0	7.00521.00.0/.11.0
	O.E. No.*	58 50 119/93179055	8 50 440/93183260
		58 50 158/55206459	58 50 574/93185801
58 50 180/55210201		8 50 444/55205127

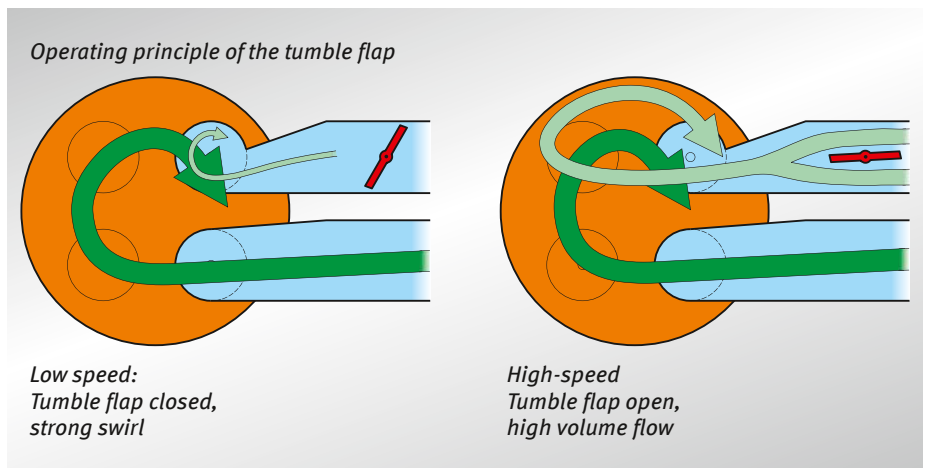
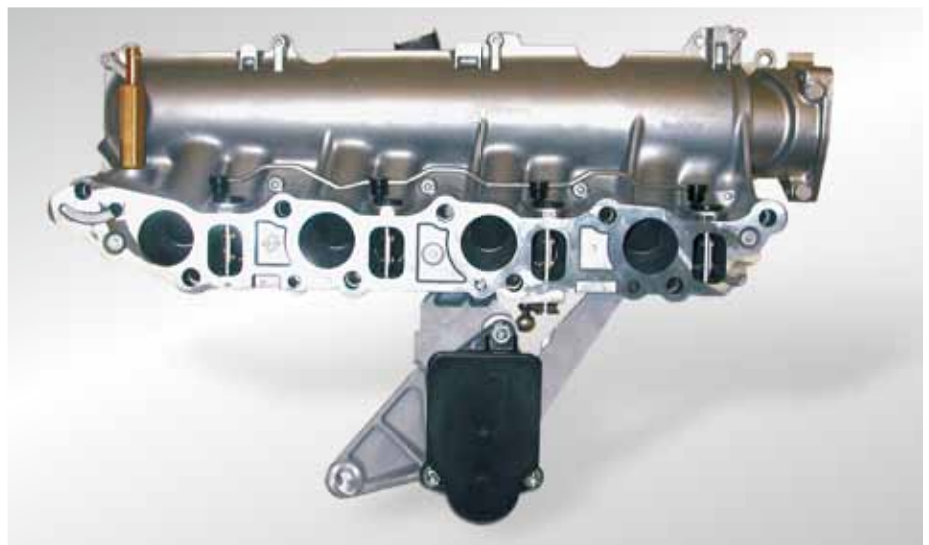
The true fault cause are often worn out, tight tumble flaps in the intake manifold. The drive module can no longer move the tight tumble flaps and indicates an error.

*Intake manifold 7.00373.12.0 with drive module 7.00521.14.0*

For this reason when exchanging the intake manifold, also the electric drive module must be replaced by a new one. The "old" drive module can no longer be used.

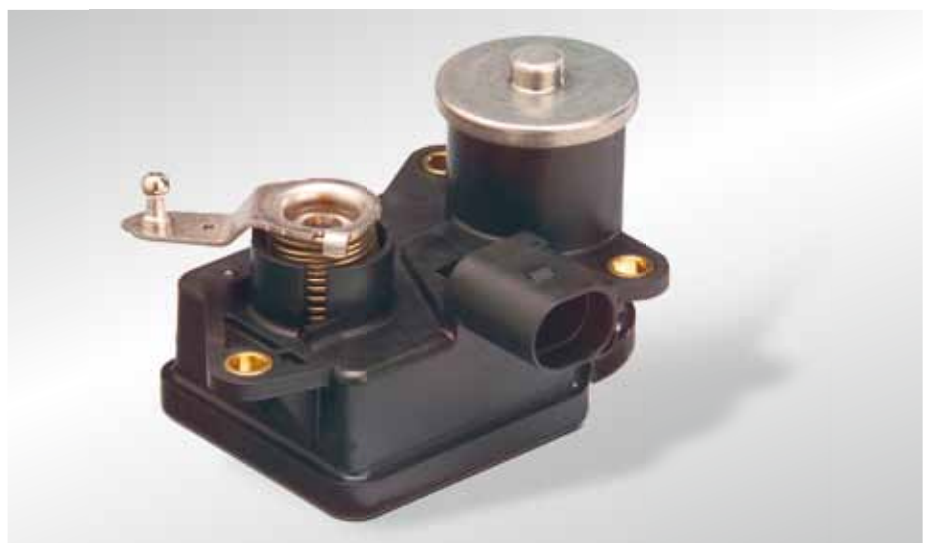
The position of the tumble flaps in the intake manifold itself is not acquired. This can only be performed indirectly through the angle position of the drive module.

For this reason malfunctions at the tumble flaps or at the lever the arrangement are sometimes attributed to the drive module.

*Electric drive module EAM-i*
