Turbocharger damage in PSA motors

1.6 HDi (9HX) and 1.6 HDi (9HY/9HZ)

An inadequate supply of oil often damages the turbocharger in 1.6 HDi-motors. This is caused by a high level of soiling to the engine lubricating system, i.e. when soot deposits and metal abrasion are carried there.

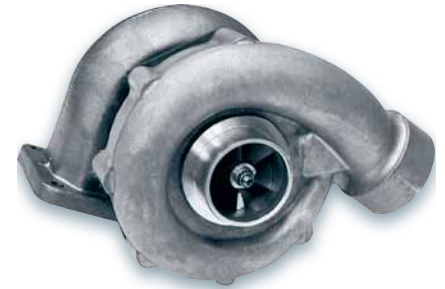
- Check oil level.
- Remove the hollow screw from the oil pressure pipe.
- Check the strainer, and clean or replace as necessary.
- Mount adapter for checking oil pressure.

Measure the oil pressure for at least 10 minutes at approx. 2,000 revs per minute. Average system pressure: at least 2 bar.
