SI 1458

SERVICE INFORMATION

LEAKING WATER PUMPS DUE TO INCORRECT COOLANT AGENT

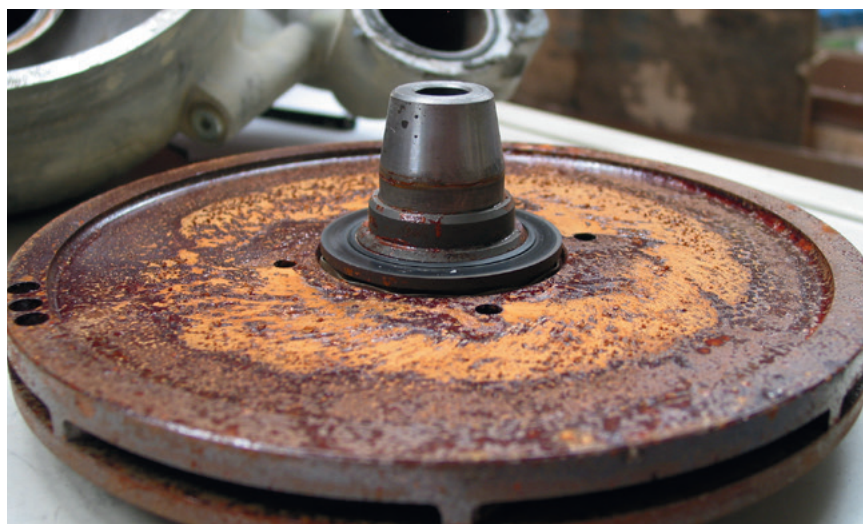
Corrosion in the cooling system is caused by using out-of-date or unsuitable coolant agent. Due to this connection, heavily corroded water pumps are not covered by the warranty.

Corroded impellers

Only use the coolant agent approved by the manufacturer for mixing the cooling liquid. Avoid water with a high hardness level ($> 20^\circ \text{dH}$) or water from sea water desalination plants.

Ensure that the cooling liquid is always mixed in a separate receptacle outside the cooling system.

durability of the water pump. For safety reasons, we recommend an air-fuel ratio of 50:50.
