SI 0090
For technical personnel only!
1/1

SERVICE INFORMATION

ELECTRIC EGR VALVES

MATCHING TO THE ENGINE CONTROLLER IS REQUIRED

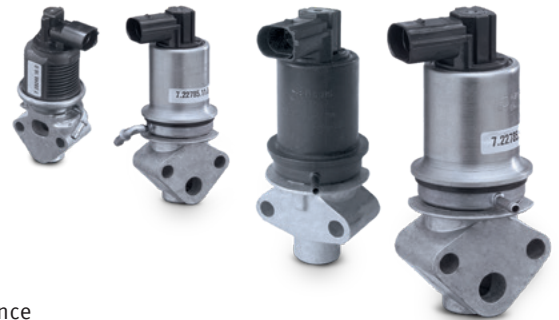
Different electric EGR valves

The electric EGR valve must be adapted to the engine controller!

This is done by selecting a special programme of the engine tester (“default setting”, for example). More information on this is provided in the manual for your engine tester.

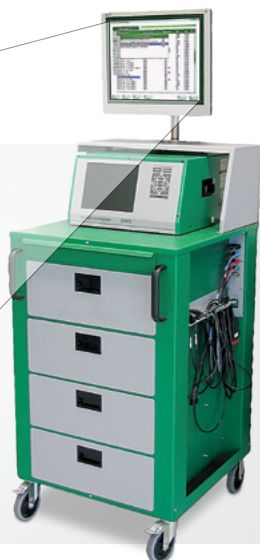
Basic adjustment	
Adaption throttle body control unit	: MO
Check Lambda Converting Bank 1	: MO
Adaption EGR valve	: MO
Reset gear data	: GE

Output for EGR valve matching
(Gutmann engine tester, for example)
