**SI 1441**  
For technical personnel only!  
1/2

# SERVICE INFORMATION

## PISTON RING JOINT CLEARANCE AND OIL CONSUMPTION

### MISCONCEPTIONS ABOUT PISTON RING JOINT CLEARANCES

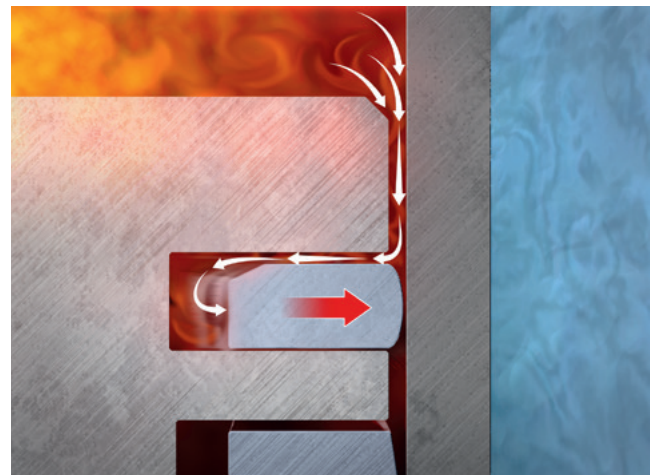
Up to 90 % of the total pressure force of the compression ring is generated by combustion pressure during the combustion cycle (Fig. 1). The combustion gases enter the ring grooves and pass to the rear of the piston ring. Here the combustion pressure boosts the pressure force of the piston rings on the cylinder wall. This pressure boost acts on the first compression ring and to a lesser degree on the second compression ring.

Fig. 1: Increase in pressure force due to combustion pressure

When idling and in part-load operation the combustion pressure is lower than in full-load operation. As a result, the compression rings are forced against the cylinder wall with reduced pressure. The effect of this is primarily seen in the oil scraping function of the second compression ring. In certain engines this will result in increased oil consumption.
